**IMPROVEMENT OF QUALITY MANAGEMENT FOR
HIGHWAY AND BRIDGE CONSTRUCTION AND
MAINTENANCE, PHASE II**

**BRIDGE INSPECTION MANUAL
FOR
CABLE STAYED BRIDGE
(SPECIAL BRIDGE)**

2014

Department of Public Works and Highways
Japan International Cooperation Agency

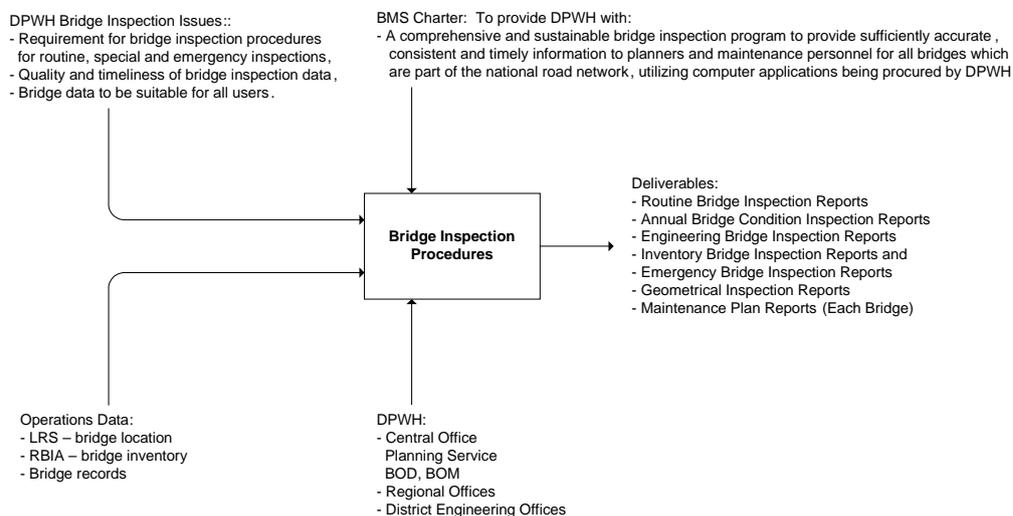
Figure 1-1
Bridge Inspection Procedures and Requirements

The bridge inspection procedures and requirements are shown in Figure 1-1.

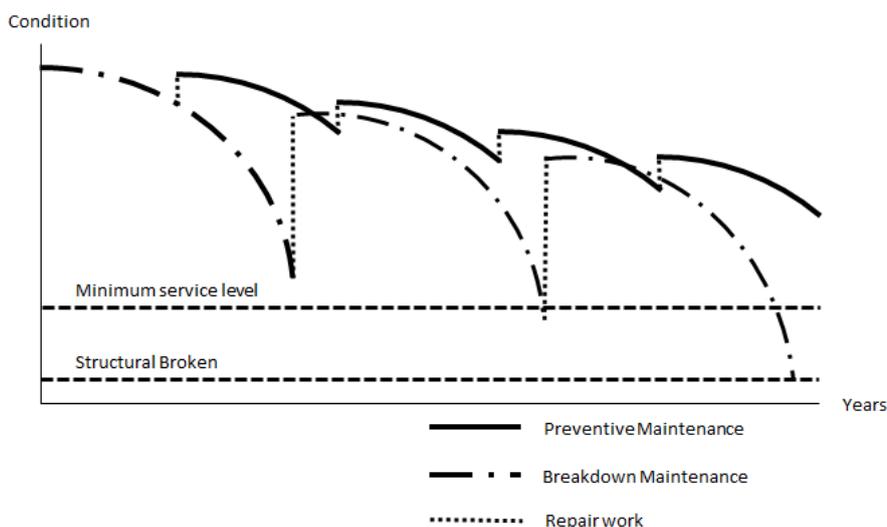
Figure 2-1
Deterioration of structure

There are two views in the maintenance method. One is Breakdown Maintenance. Another is Preventive Maintenance. Structure has been deteriorated during their service period and finally it would be broken. In case of Breakdown Maintenance, structure will be repaired after broken. Therefore, repair cost would be increased and long durability of structure would not be expected. On the other hand, in case of preventive maintenance, defects on structure should be found on the early stage and they will be repaired as the proactive approach. As a result of quick action to defects, repair cost would be hold down and long durability would be expected. Bridge should be properly maintained by the preventive maintenance. In this process, inspection plays the most important role to find defects on the early stage.

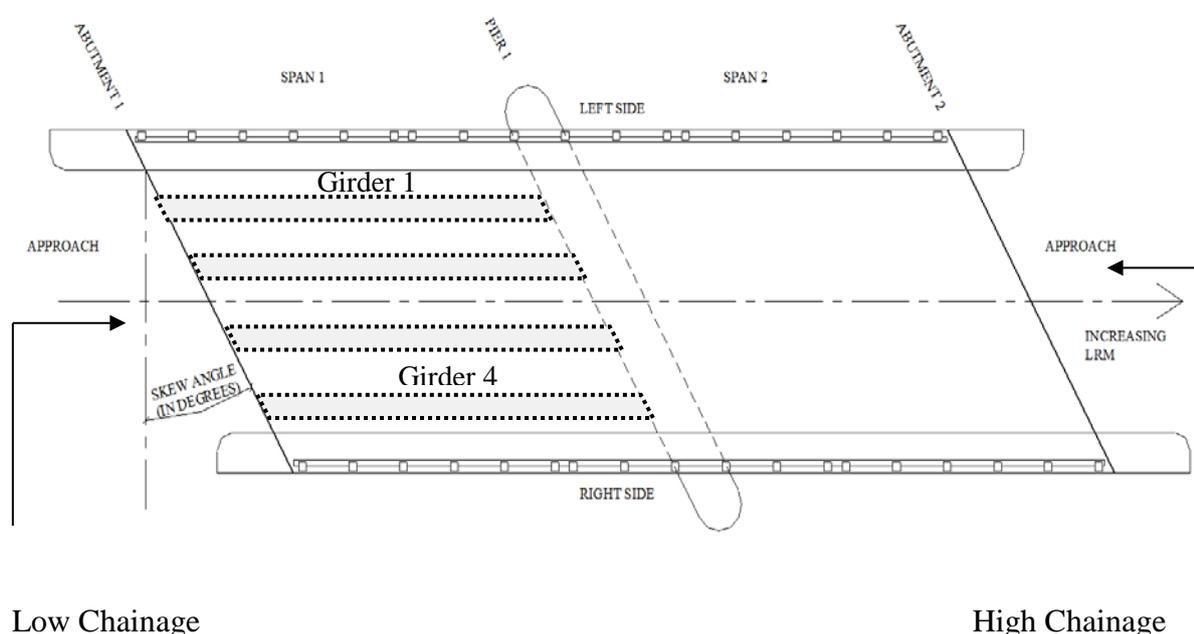
Figure 2-2
Bridge Geometry Definition

The standardized geometrical definition in the BMS Manual has been adopted by this Manual which is based on the Local Referencing System (LRS) used by the DPWH. The bridge is assessed in the direction of increasing chainage. Refer to Figure 2-2.

HC	-	High Chainage
LC	-	Low Chainage
S	-	Span
P	-	Pier
A	-	Abutment
G	-	Girder

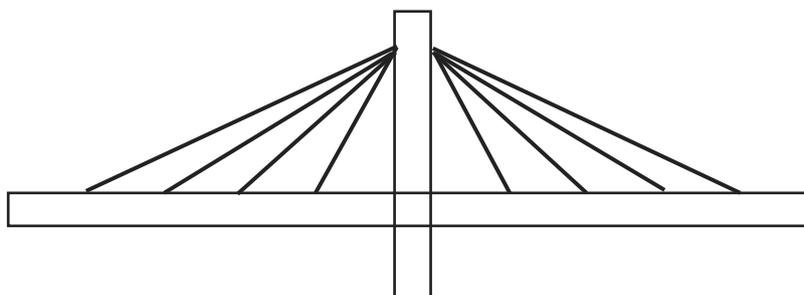
**Figure 2-4
Cable Stayed Bridge (Fan Design)**

There are two cable arrangements in Cable Stayed Bridge. Firstly, a fan design, cables are extended from several points on the girder to a single point at the top of the tower. Secondly, a harp design, cables are attached at different heights along the tower, running parallel to one another. Diosdado Macapagal Bridge is a harp design cable arrangement.

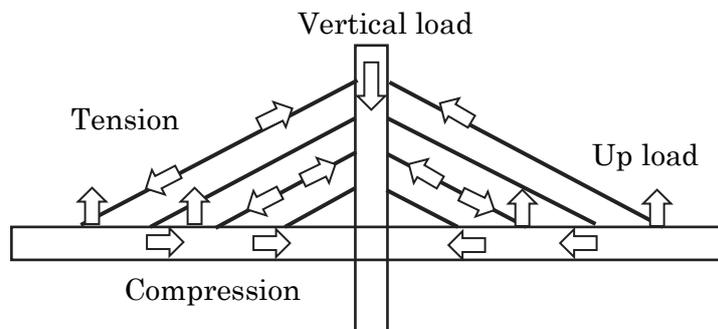
Figure 2-6
Load Distribution System in Cable Stayed Bridge

For the support of girder, a cantilever approach is often used near the tower, but lengths further from the tower are supported by stay cables. All horizontal forces from Stay Cables are balanced at the tower, and no anchorage needed to resist a horizontal tension from the main suspension cables.

Due to the diagonally tensioned stay cables, compressive forces and bending moments are imposed on the girder and the tower. The towers are the load-bearing structures which transmit vertical loads to the ground. The bridge girder should be stronger to resist the resulting axial compression loads, so greater stiffness is necessary. At the same time, it reduces the deformation of the girder, and the bridge could resist wind load.

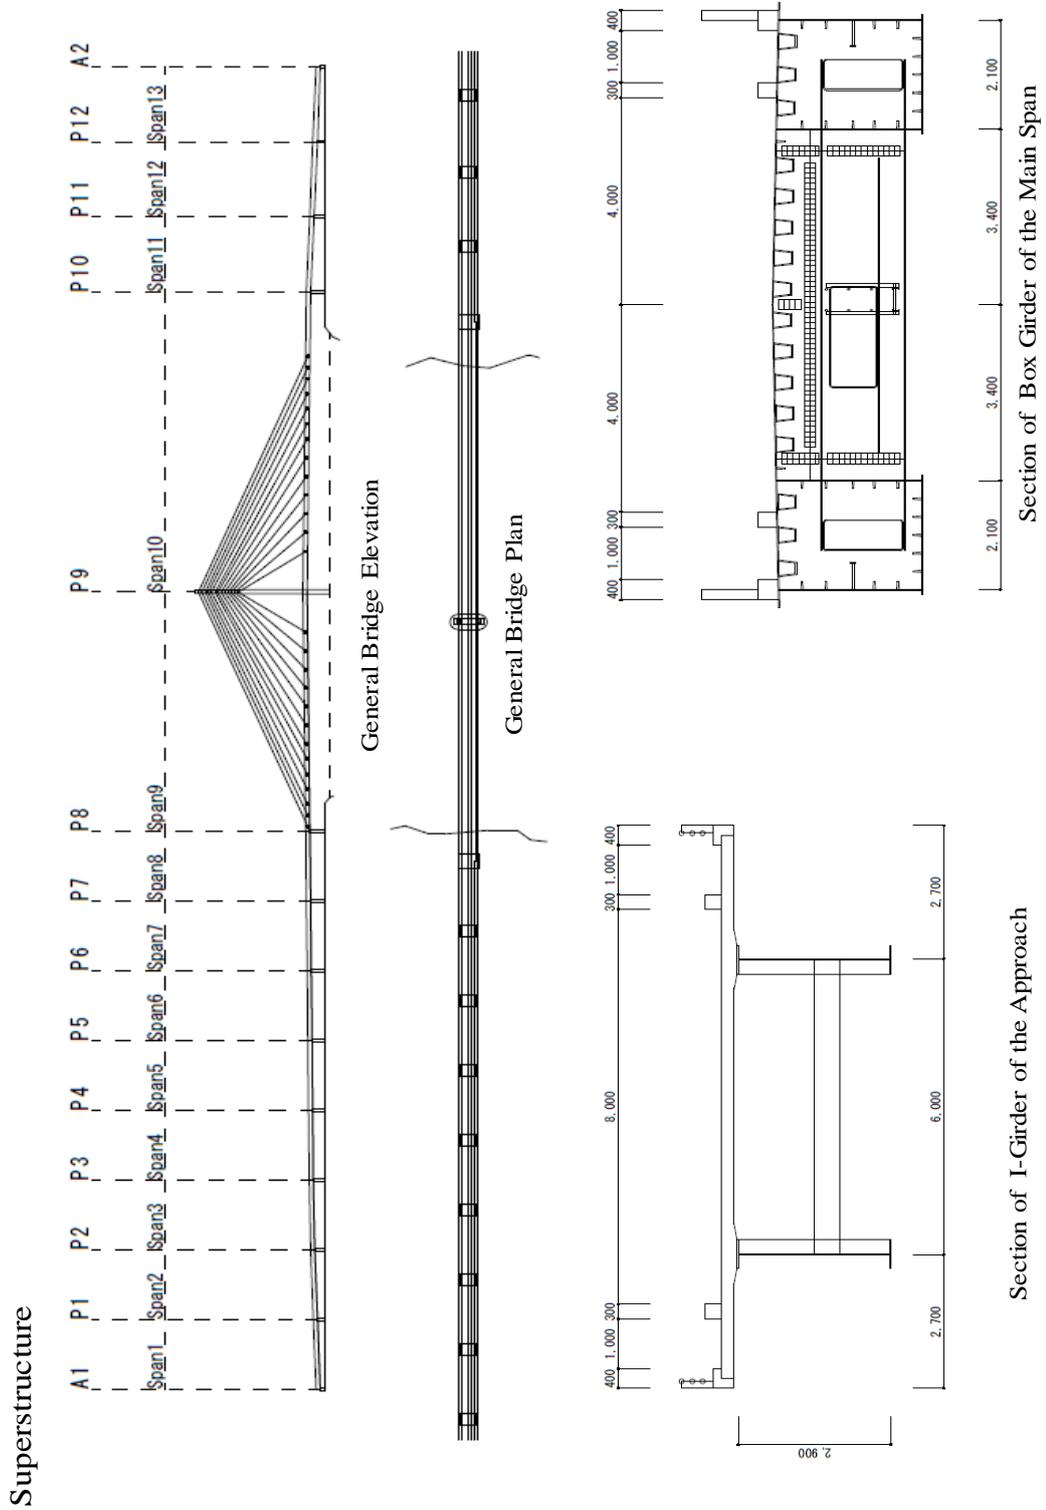
**Figure 2-7 General View of Diosdado Macapagal Bridge
(1 of 4)**

Shown in Figure 2-7, 2-8, 2-9 and 2-10 are the General Views of Diosdado Macapagal Bridge.

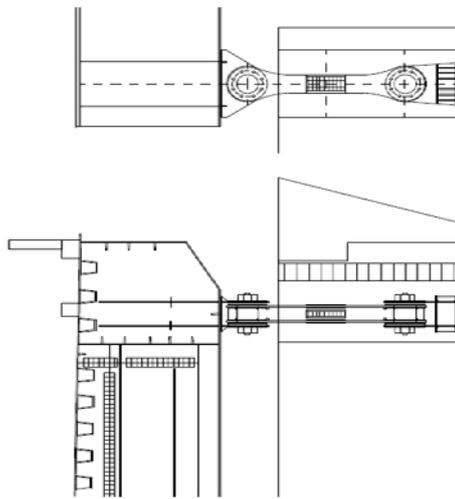
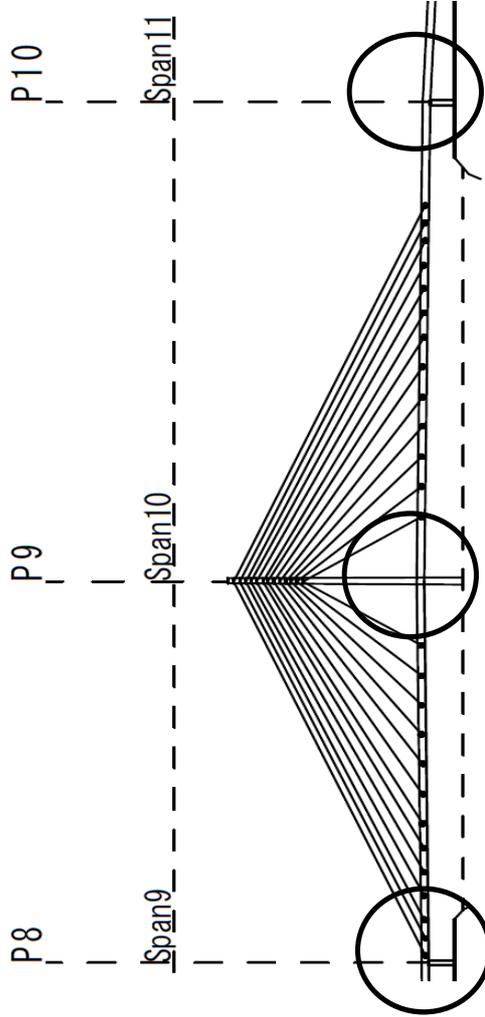
**Figure 2-9 General View of Diosdado Macapagal Bridge
(3 of 4)**

Bearings in the Main Span and Approach Viaduct

Pendulum Bearing (P8)

Seismic Isolation Bearing (P8, 9, 10)

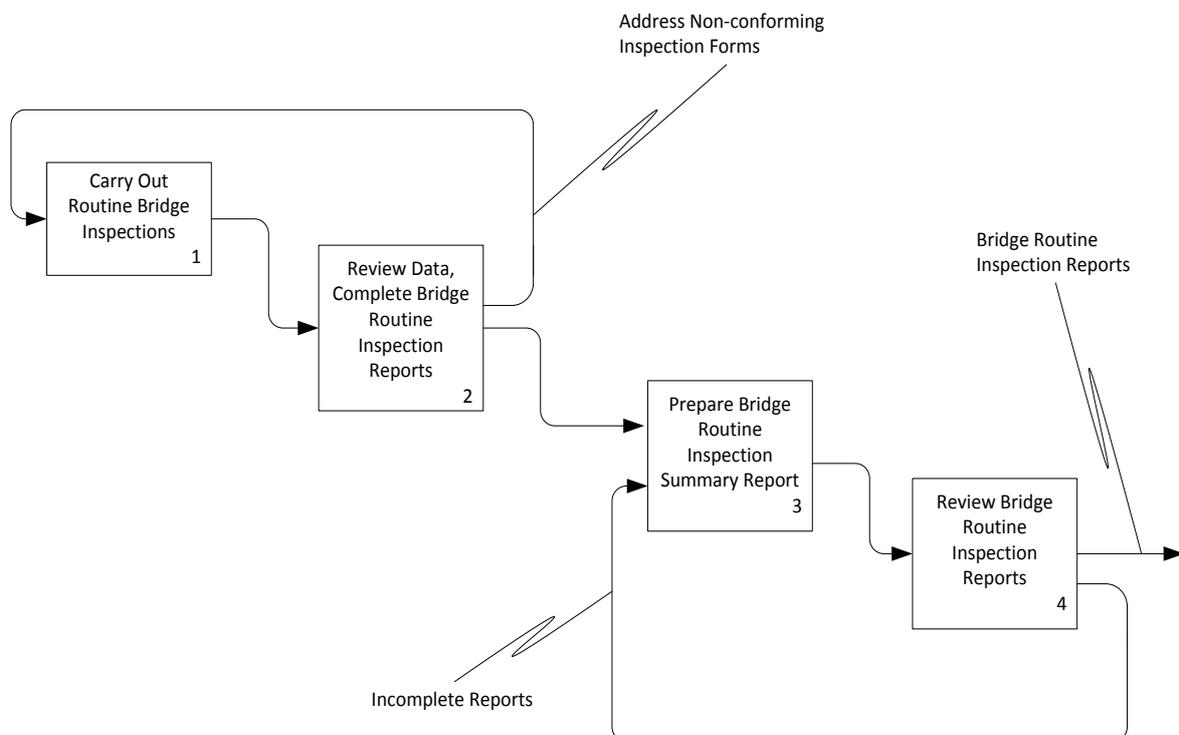
Figure 3-1
Routine Inspections (Type 1)

The process for conducting Routine Inspection (Type 1) is shown in Figure 3-1.

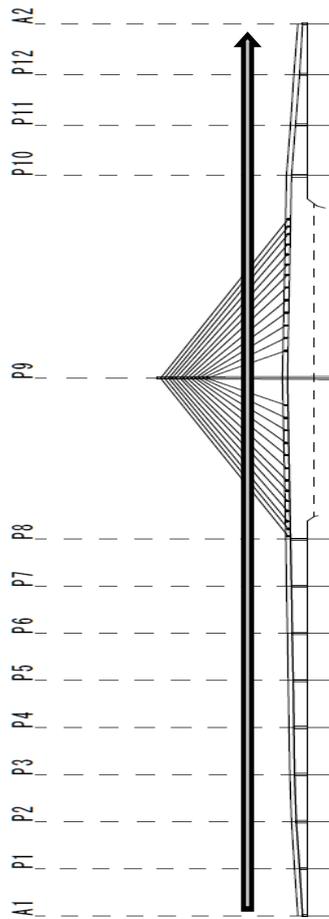
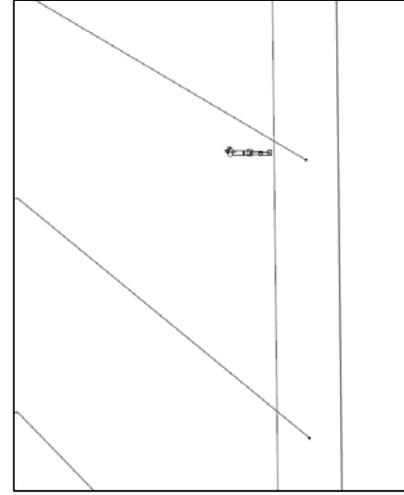
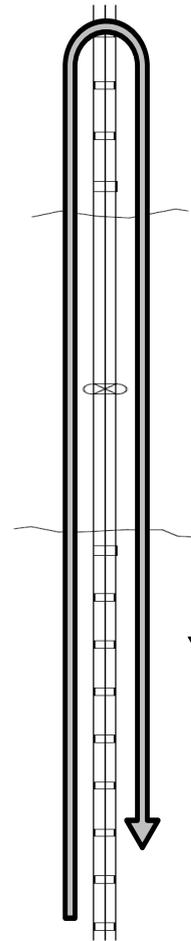
**Figure 3-1 Routine Inspection Route of Diosdado Macapagal Bridge
(1 of 2)**

Inspection of Upperside

Main Members to be Inspected
 Cable
 Cable Cover, Socket, Anchorage
 Tower
 Railing
 Curb
 Stabilizer
 Pavement
 Drainage
 Expansion Joint

Inspection from Upperdeck

As a reference, the Bridge Routine Inspection Routes are shown in Figures 3-2 and 3-3 while the Check Points of Routine Inspection are shown in Figures 3-4, 3-5 and 3-6. Routine Inspection Forms and Sketch Drawings of Diosdado Macapagal Bridge are shown in Appendix E. The copy of above mentioned documents and the latest routine inspection report should be brought to the site as reference.

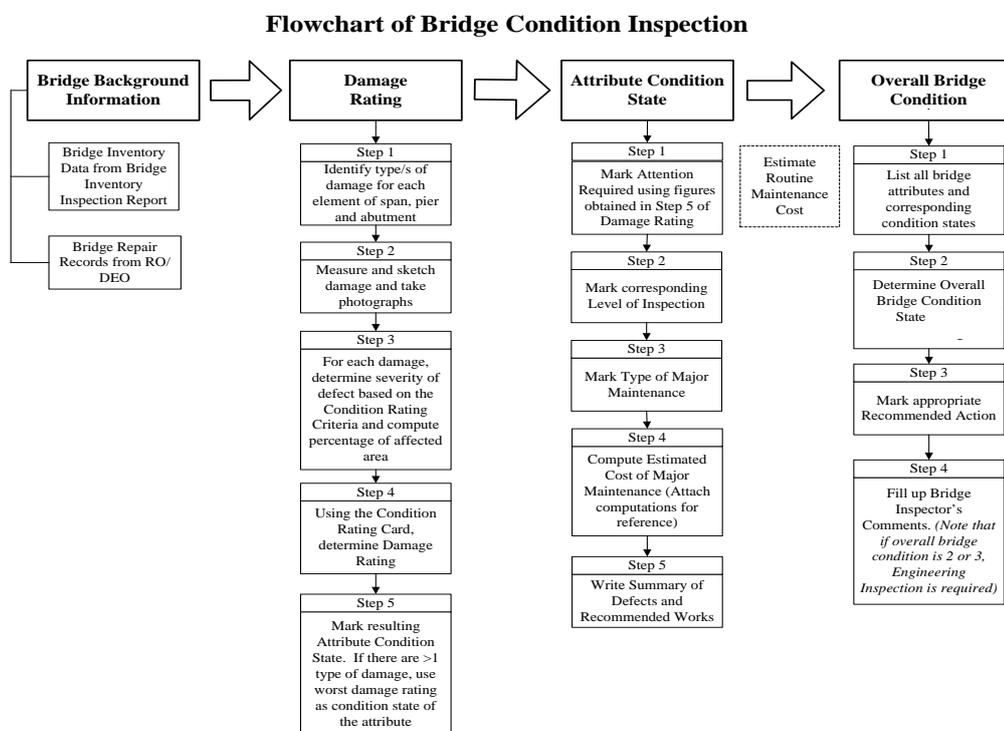
Figure 4-2

The step-by-step procedure for conducting the Condition Inspection is illustrated in the following flowchart.

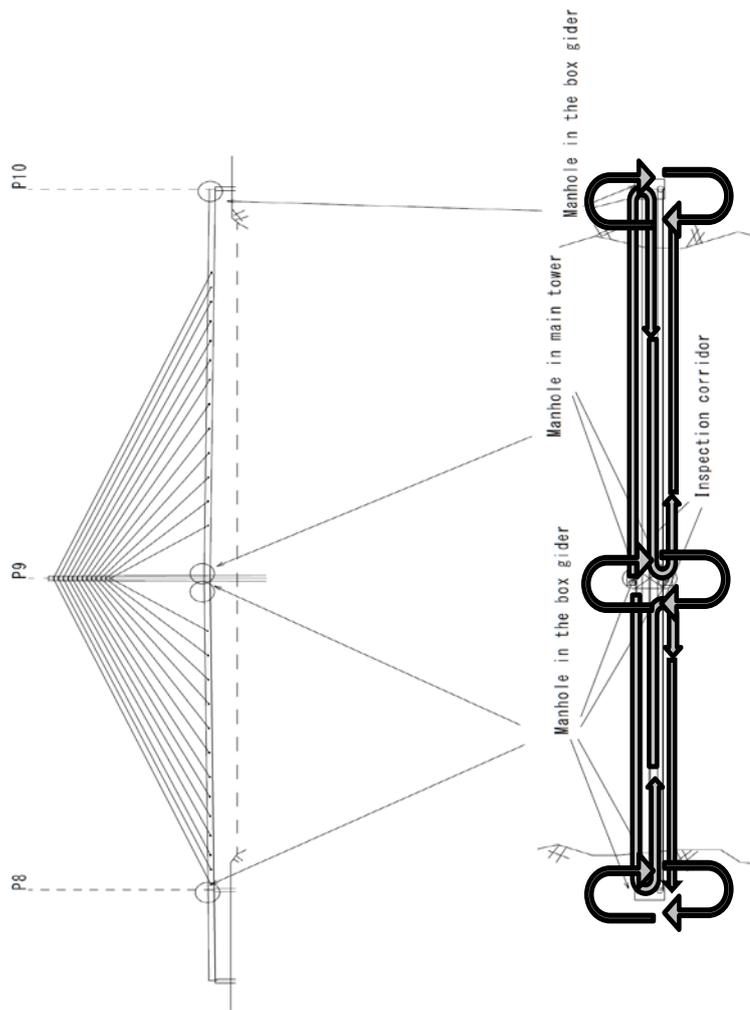
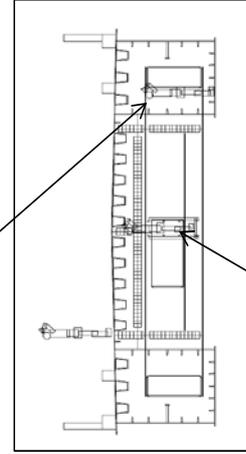
**Figure 4-5 Condition Inspection Route of Diosdado Macapagal Bridge
(3 of 5)**

Inspection on Corridor and Inside Box Girder

Inspection on corridor and inside the box girder
Inspection around the top of piers

Main Members to be Inspected

- Deck
- Rib (L, U and Transverse)
- Diaphragm
- Cross Beam
- Girder (Web, Flange)
- Connection
- Bolt
- Inspection Corridor
- Bearing (Pendulum)
- Bearing (Lateral)
- Bearing (Vertical)
- Bearing (Seismic Isolation)
- Restraimer

Inspection inside box girder

Inspection on corridor

The Bridge Condition Inspection Routes of Diosdado Macapagal Bridge are shown in Figures 4-3, 4-4, 4-5, 4-6 and 4-7 and the Check Points of the Condition Inspection are shown in Figures 4-8, 4-9, 4-10 and 4-11. As a breakdown, the CIF is composed of forms shown in Table 4-1.

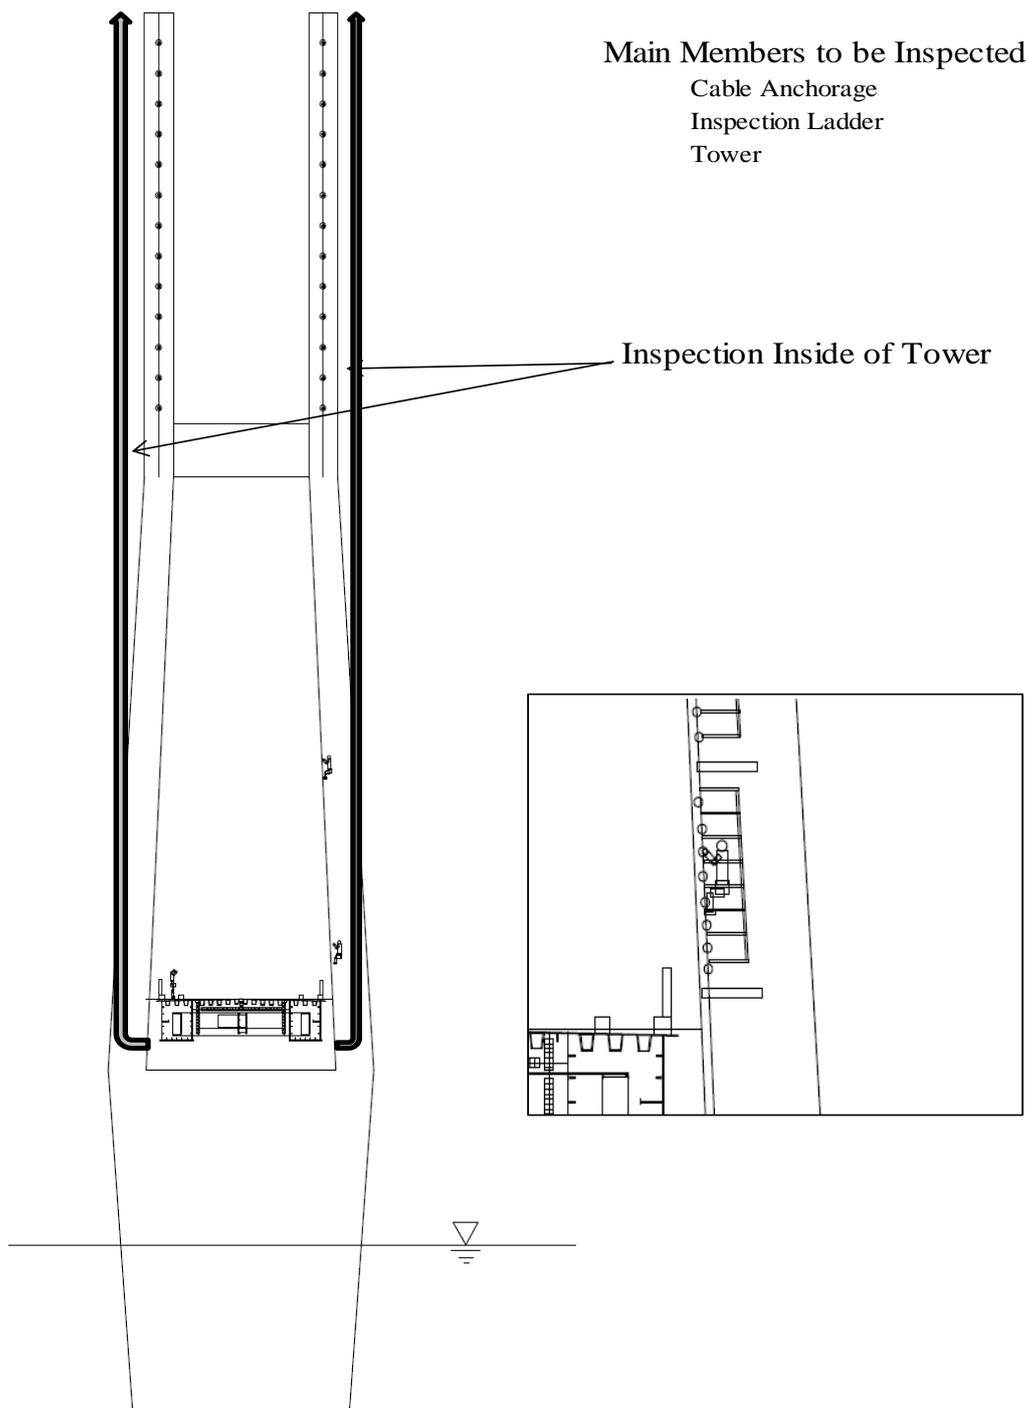
**Figure 4-6 Condition Inspection Route of Diosdado Macapagal Bridge
(4 of 5)**

Inspection Inside of Tower

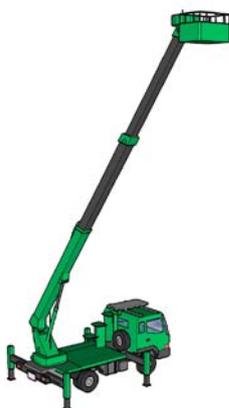
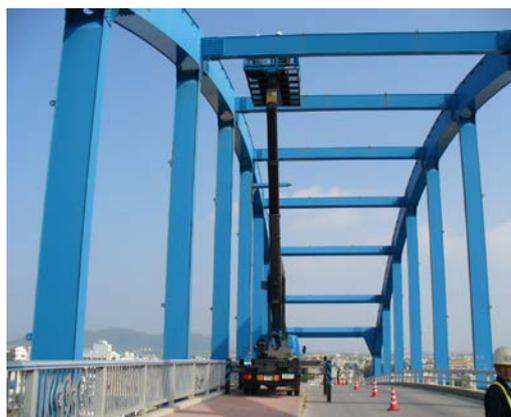
Figure 4-14
Photos of Bucket Type BIV

Generally, two types of BIV are used in the inspection of bridges. One type is Bucket Type BIV which is also called Aerial Work Platform. This type of BIV is widely used for maintenance and construction of bridge and also for power and telecommunications industries. They can lift inspectors up to high level to inspect tower, cable band chord and etc. Figure 4-14 shows the picture of the Bucket Type BIV.

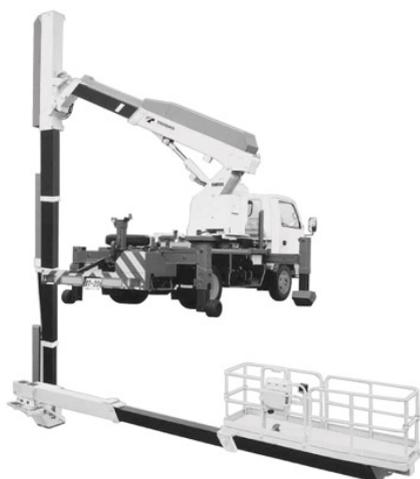
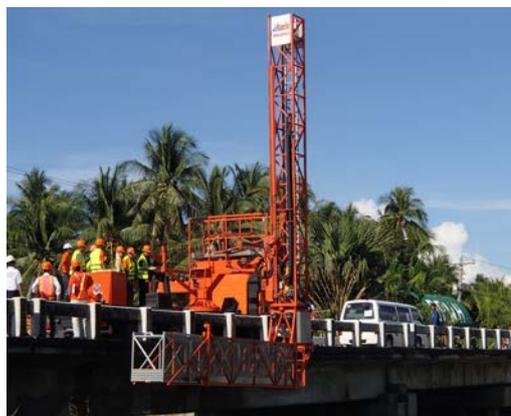
Figure 4-15
Photos of Telescoping Articulated Platform Type BIV

Another type of BIV is Telescoping Articulated Platform. This type can carry the inspector underneath the bridge to check girders, bottom of slab and etc. Figure 4-15 shows the picture of Telescoping Articulated Platform Type BIV.

When BIV is used, a designated vehicle operator should accompany the inspection and operate the vehicle. Inspectors should be tied to the rigid frame by safety belt during lifting.

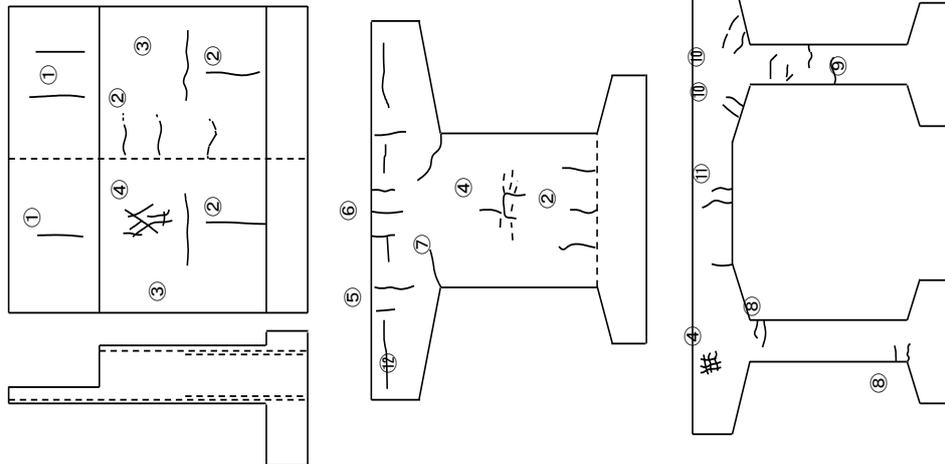
General Patterns of Crack Defects on Abutment and Pier

Number	Pattern
1	Crack by regular interval
2	Crack on the concrete casting joint
3	Crack around the changing point of density of reinforcement bar
4	Crack like mesh
5	Crack on top side of overhang beam(coping)
6	Vertical crack on pier center
7	Crack on bottom side of overhang beam(coping)
8	Crack on upper and bottom part of column
9	Crack on column
10	Crack on haunch
11	Bending crack on the span center of beam
12	Horizontal crack on beam

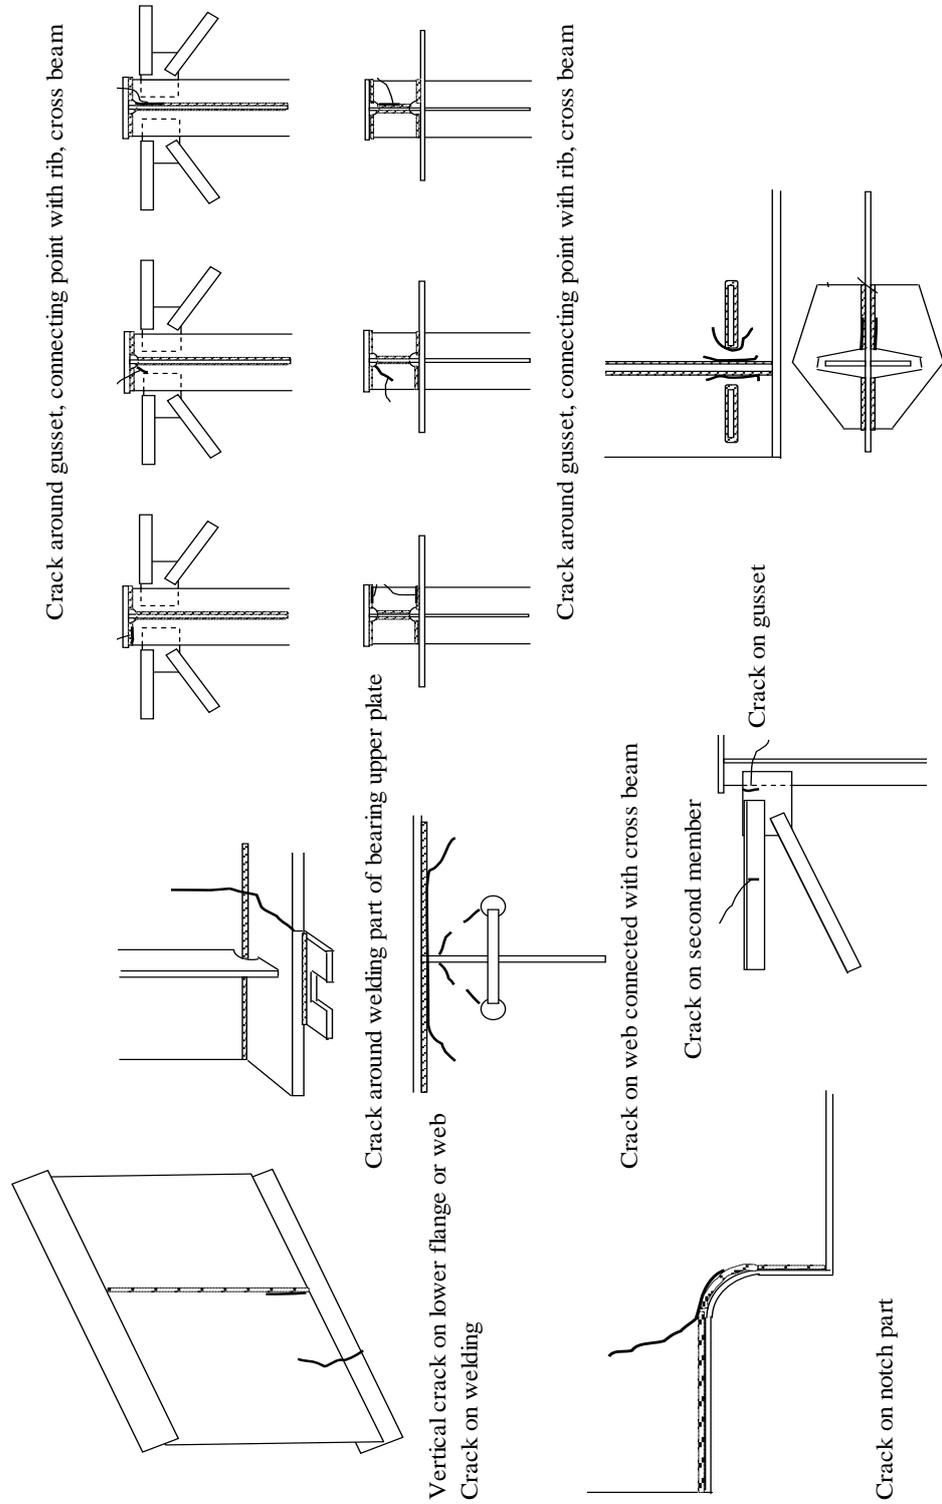
Figure 4-18 General Patterns of Defects (3 of 7)

General Patterns of Crack Defects on Steel Bridge

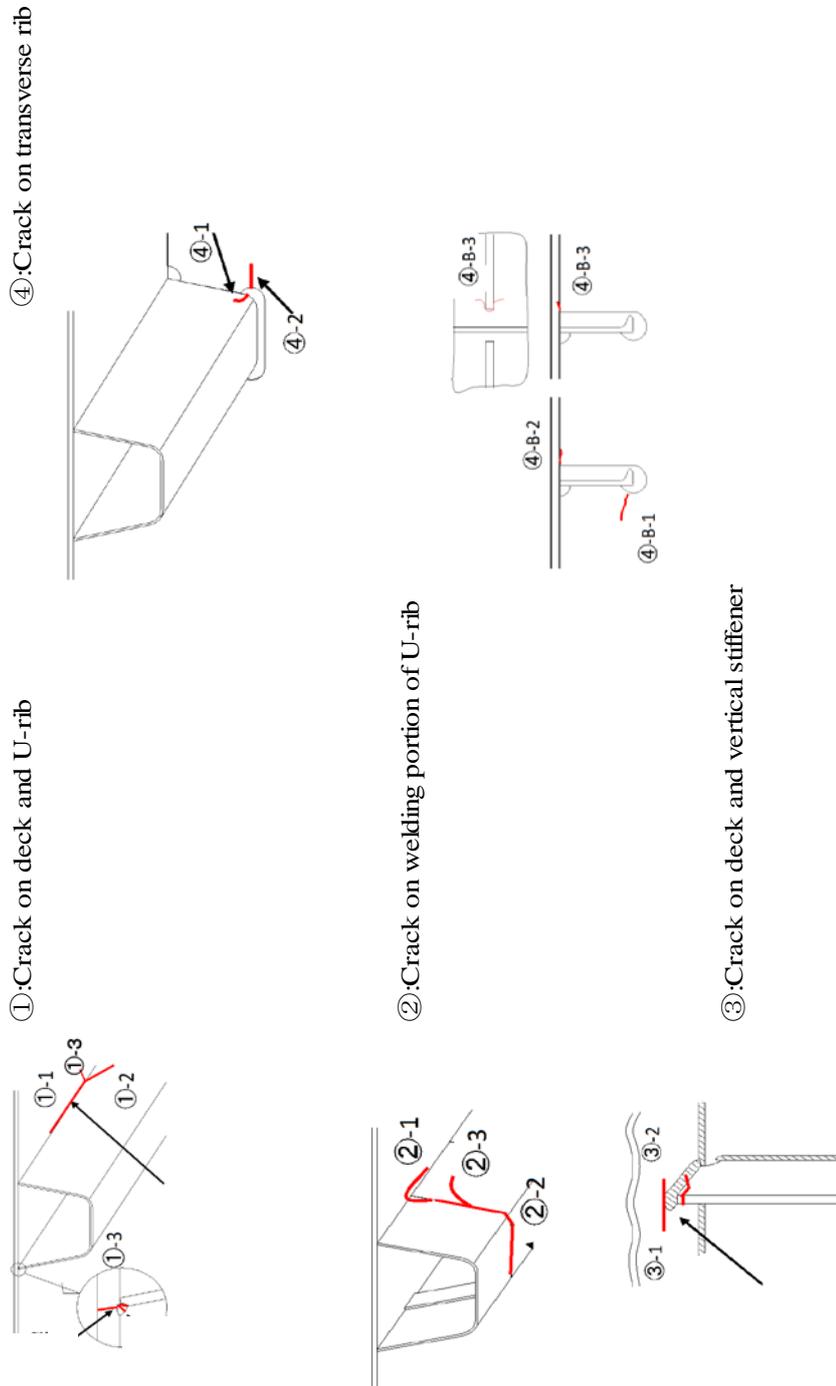
Figure 4-19 General Patterns of Defects (4 of 7)

General Patterns of Crack Defects on Steel Deck Plate

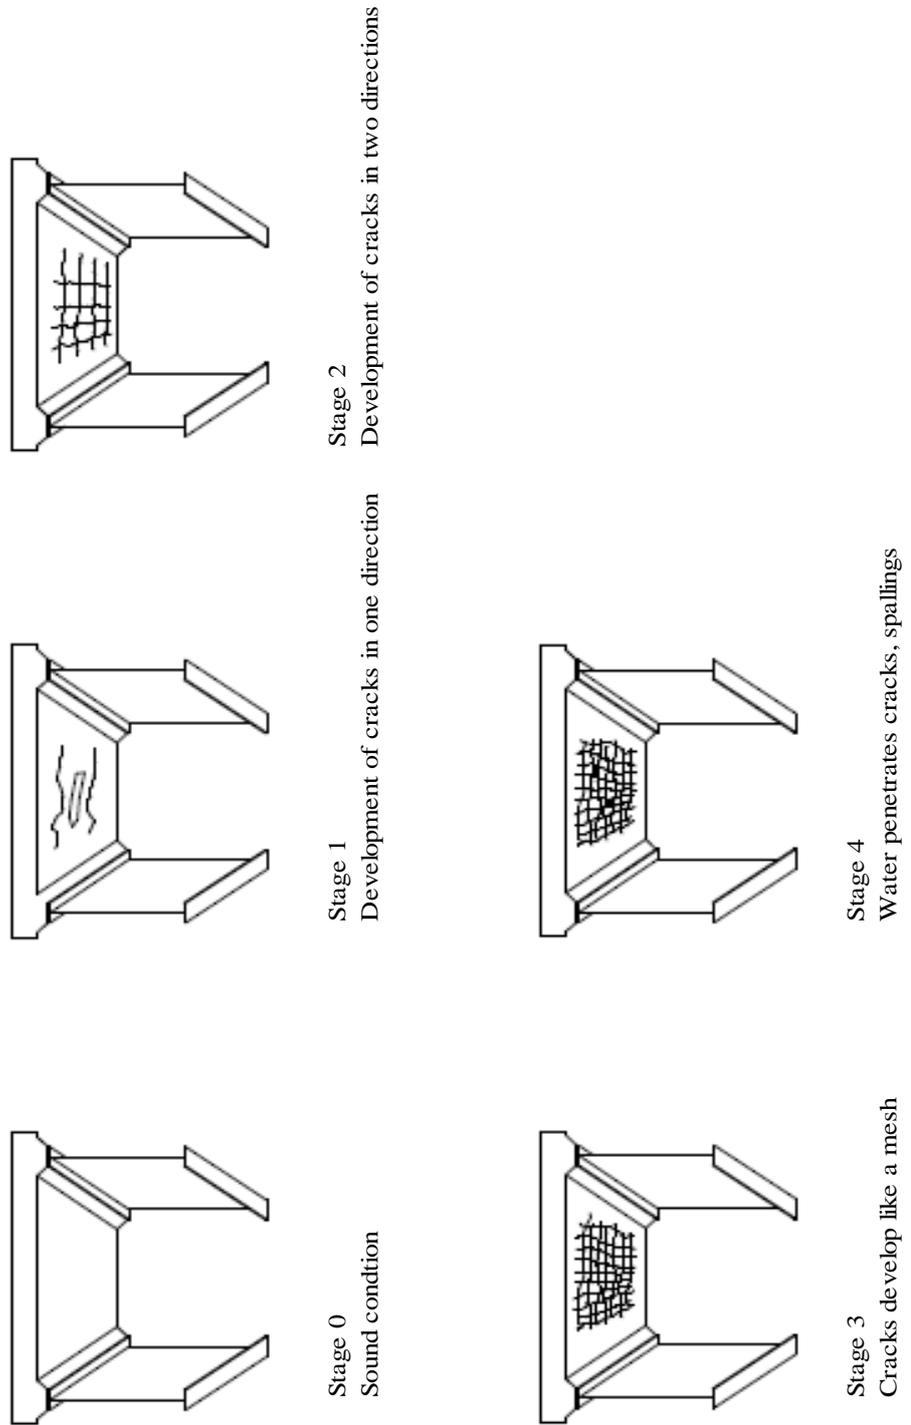
Figure 4-20 General Patterns of Defects (5 of 7)

General Patterns of Crack Defects on Concrete Deck

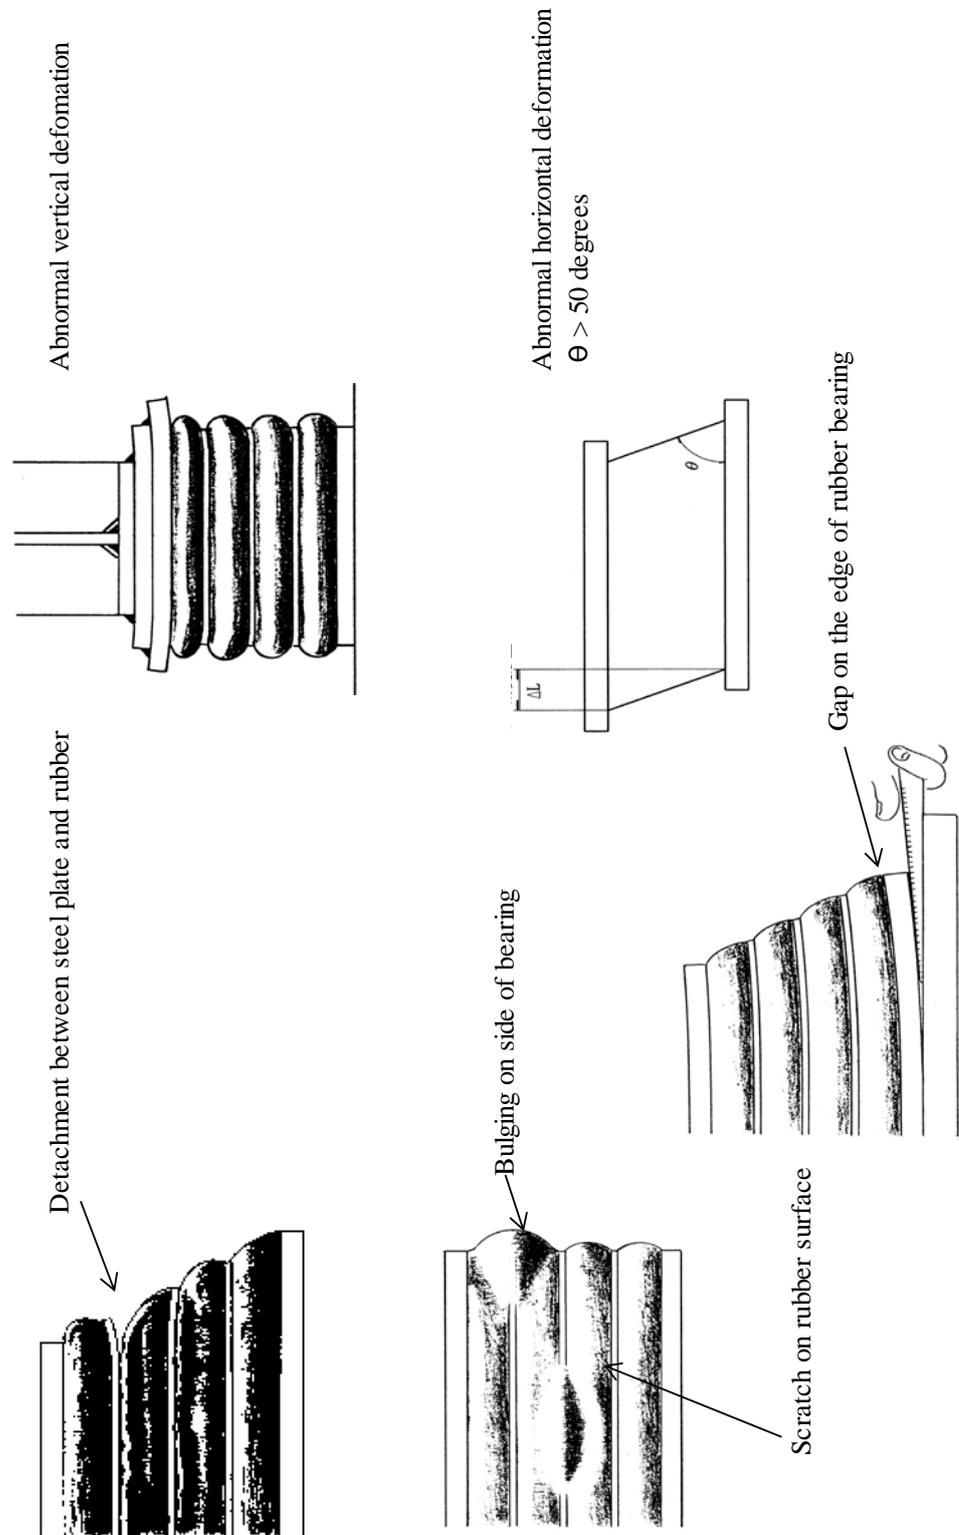
Figure 4-21 General Patterns of Defects (6 of 7)

General Patterns of Defects of Rubber Bearing

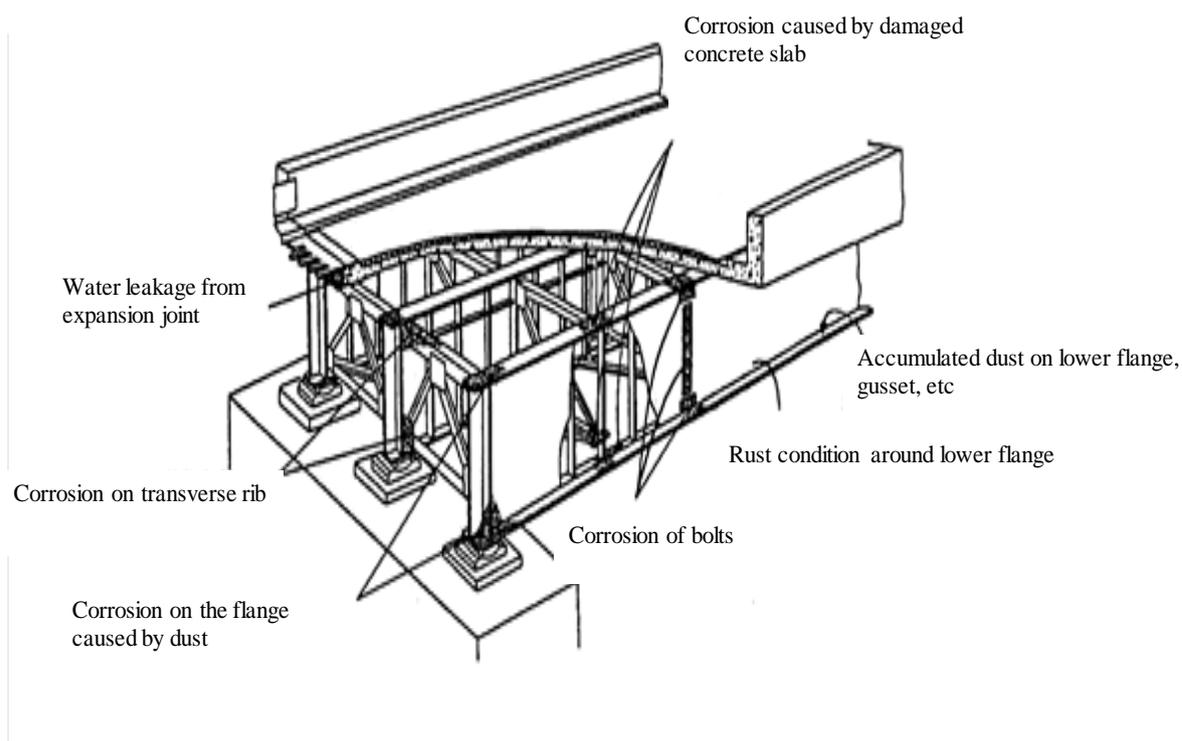
Figure 4-22 General Patterns of Defects (7 of 7)

Important Inspection Points for Bridges Using Weathering Steel

1	Slab (Concrete, Steel), in particular damaged area where there is water leakage
2	Area around drainage
3	Area around Girder end and middle pier
4	Area with accumulated dust like upperside on lower flange, gusset and so on
5	Joint area and bolts

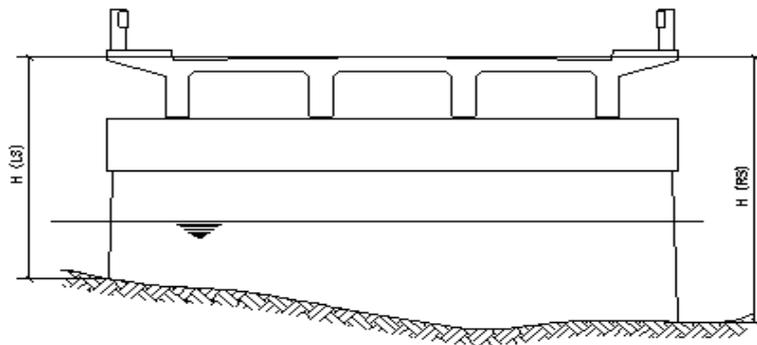
Figure 4-22
Measurement of Pier Scour Check

The scour check at a pier is undertaken as shown in Figure 4-22. The Bridge Inspector is required to measure the height from the top of the concrete deck or parapet to the ground or stream bed level on each side of the bridge on the centerline of each pier.

Scour checks are made at the piers and abutments in each annual condition survey. These record the level of the ground surface at the piers and abutments. This data will be available to monitor changes in surface levels under bridges over a longer period and therefore will indicate whether erosion or accretion is taking place.

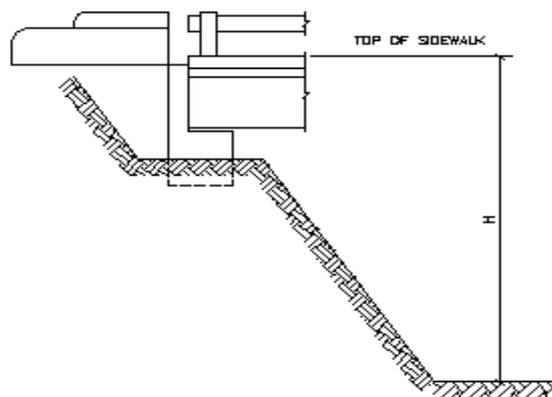
Figure 4-23
Measurement of Abutment Scour Check

The scour check at an abutment is undertaken as shown in Figure 4-23. The bridge inspector is required to measure the height from the top of the concrete deck or parapet to the ground or streambed level on each side of the bridge to the natural surface immediately adjacent to the abutment.

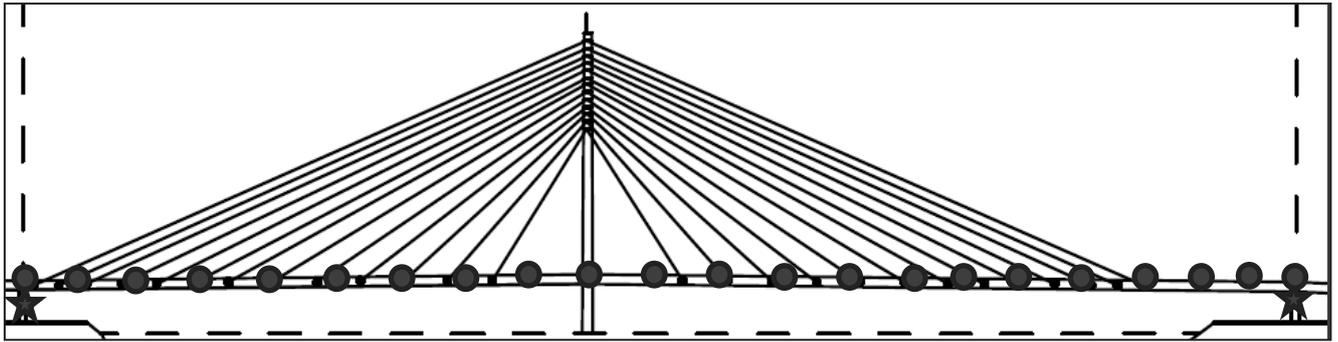
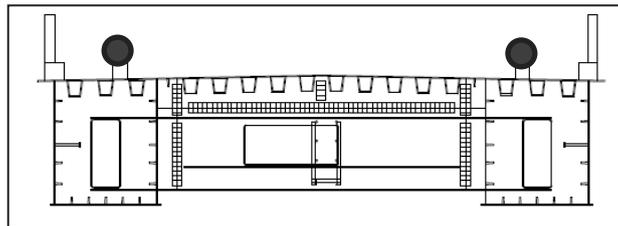
Figure 8-1
Geometrical Inspection:
Leveling of Abutments and longitudinal alignment of deck surface

● : Leveling measure point for deck surface

★ : Leveling measure point for deck surface

Geometrical Inspection methods are shown in Figure 8-1,8-2 and 8-3. As a reference, forms of Geometrical Inspection of Diosdado Macapagal Bridge are shown in Appendix J.

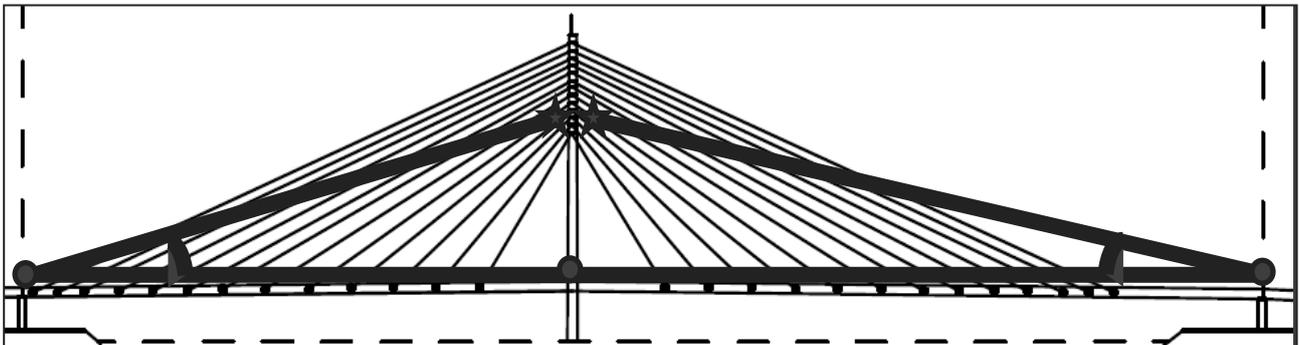
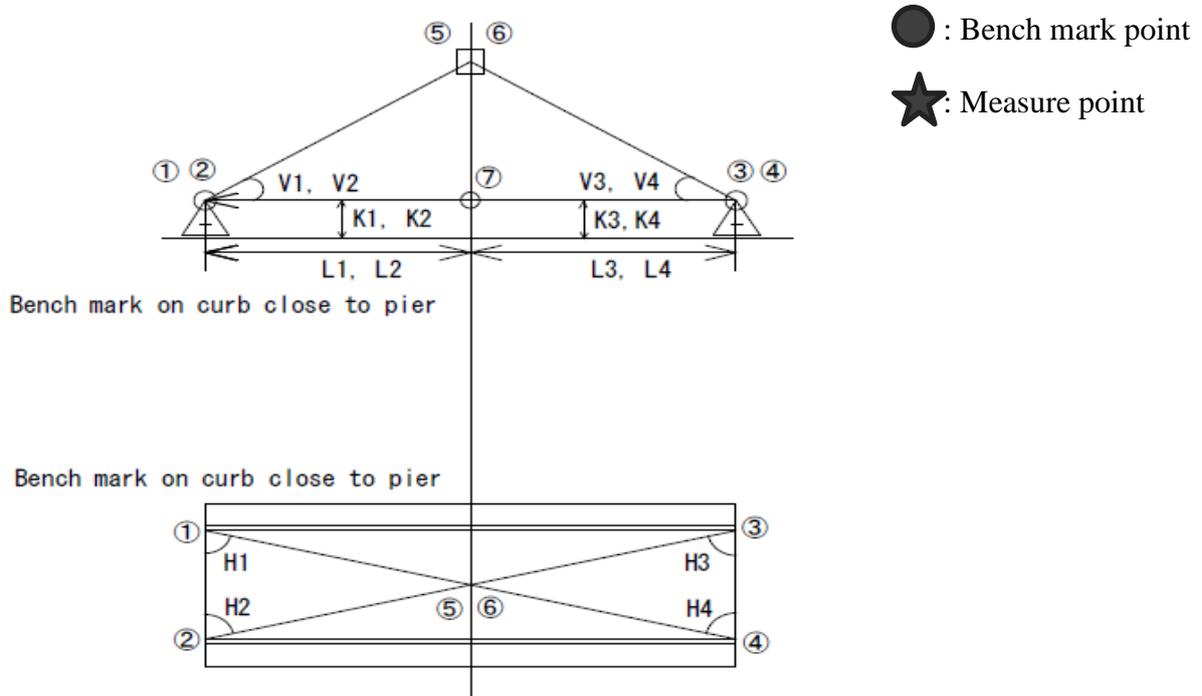
Figure 8-2
Geometrical Inspection:
Slope of Vertical Alignment of Arch Chord

Measure: Angle (Vertical): $V1', V2', V3', V4'$
 Angle(Horizontal): $H1', H2', H3', H4'$
 Length: $L1', L2', L3', L4'$
 Height: $K1', K2', K3', K4'$

Raise:	$K1' + \tan V1' * L1'$	Slope:	$L1' / \tan H1'$
	$K2' + \tan V2' * L2'$		$L2' / \tan H2'$
	$K3' + \tan V3' * L3'$		$L3' / \tan H3'$
	$K4' + \tan V4' * L4'$		$L4' / \tan H4'$

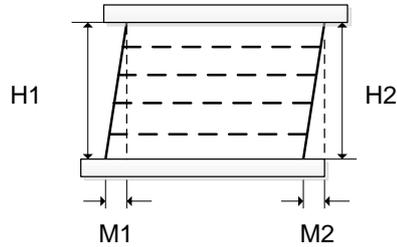
Figure 8-3
Geometrical Inspection: Movement of Bearing and Expansion Joint

Bearing

Measure every bearing (every time use same marking point)

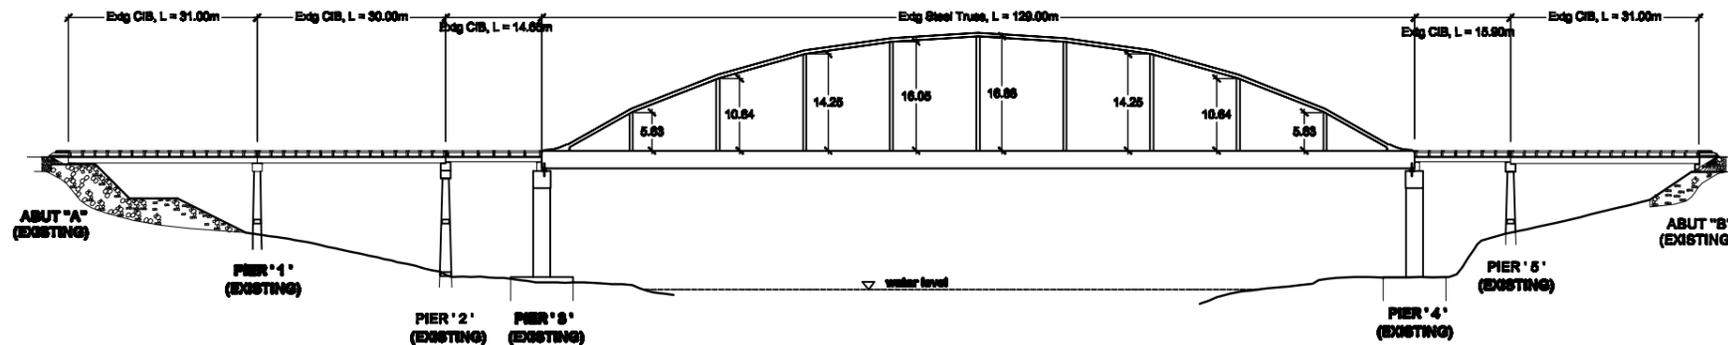
GENERAL ELEVATION

SCALE: 1:500 m

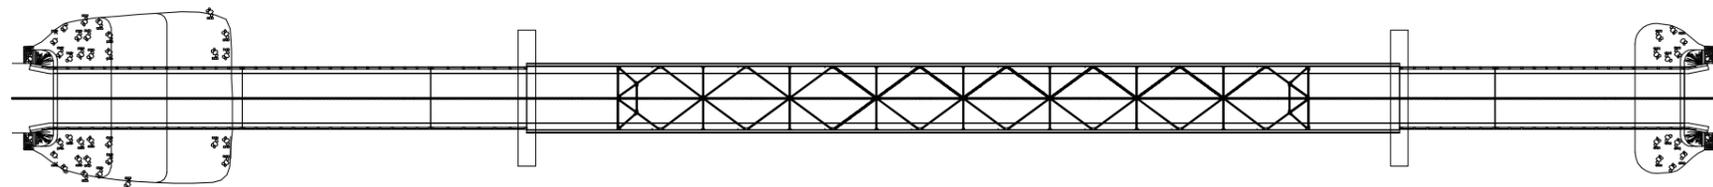
GENERAL PLAN

SCALE: 1:500 m

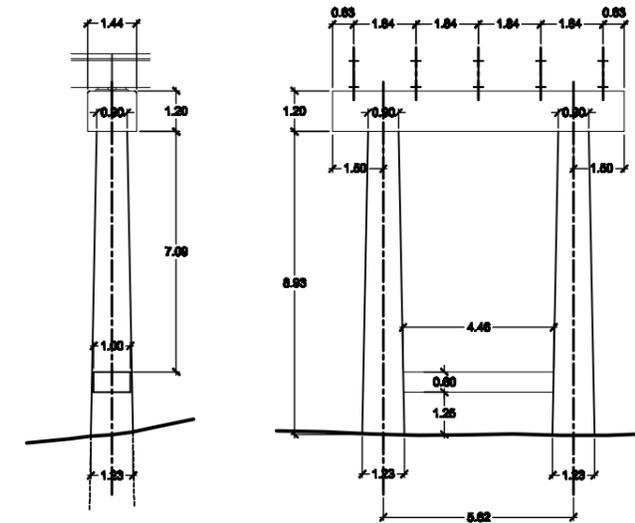
DETAIL OF PIER 5

Scale 1:100 mts

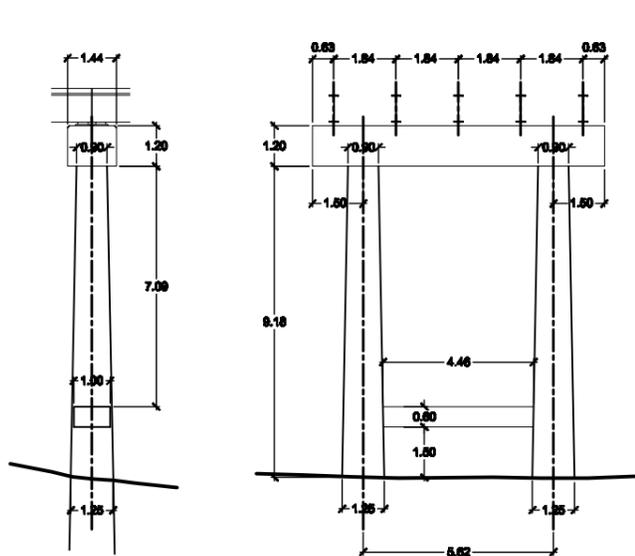
DETAIL OF PIER 1

Scale 1:100 mts
