**IMPROVEMENT OF QUALITY MANAGEMENT FOR
HIGHWAY AND BRIDGE CONSTRUCTION AND
MAINTENANCE, PHASE II**

**BRIDGE INSPECTION MANUAL
FOR
CABLE STAYED BRIDGE
(SPECIAL BRIDGE)**

2014

Department of Public Works and Highways
Japan International Cooperation Agency

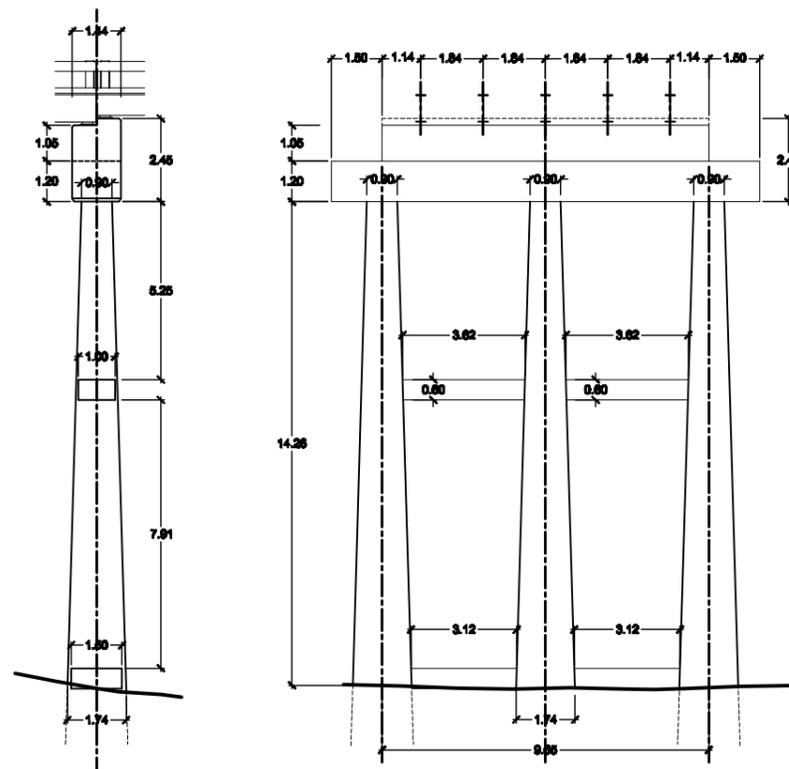
DETAIL OF PIER 2

Scale 1:100 mts

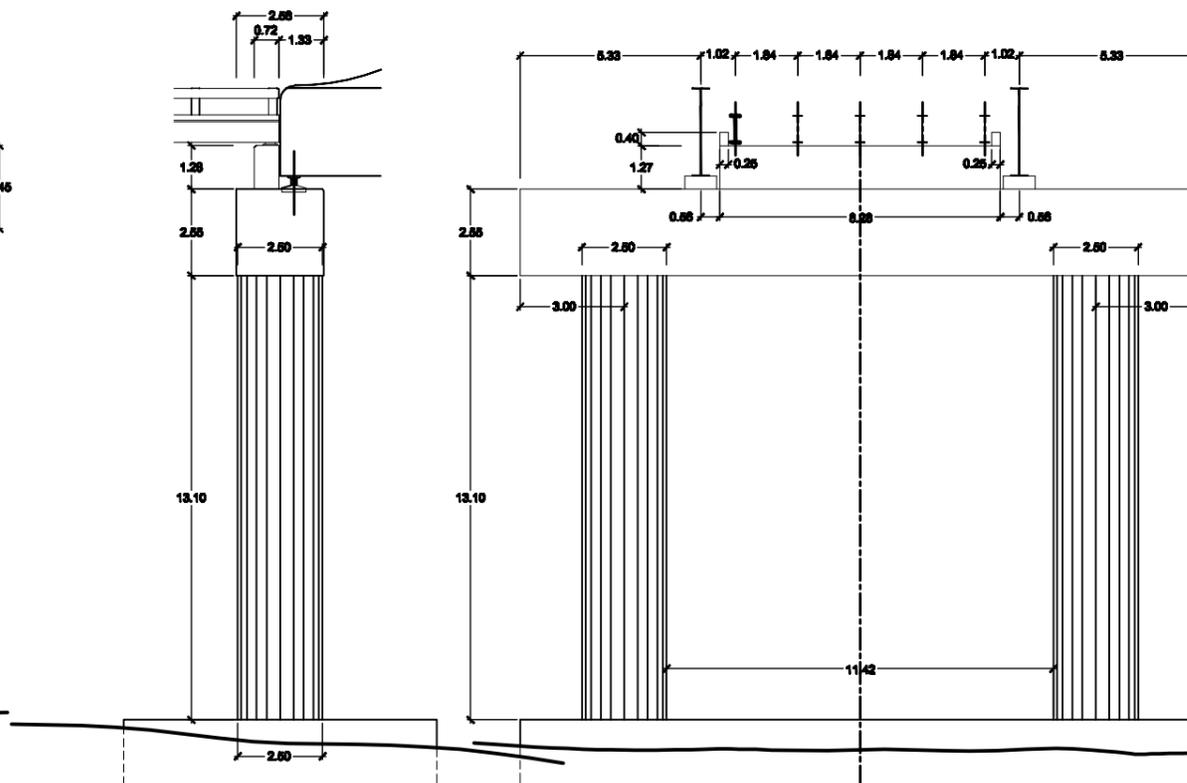
DETAIL OF PIER 3 & 4

Scale 1:100 mts

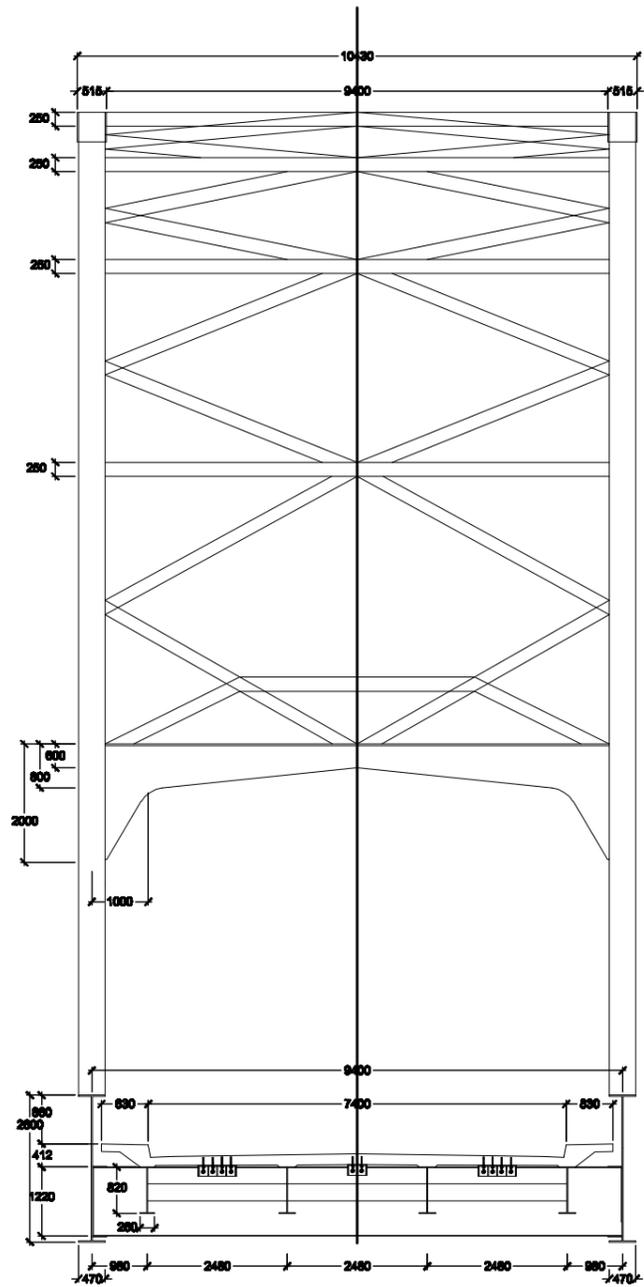
SECTION STEEL TRUSS SPAN
Scale 1:40 mtr

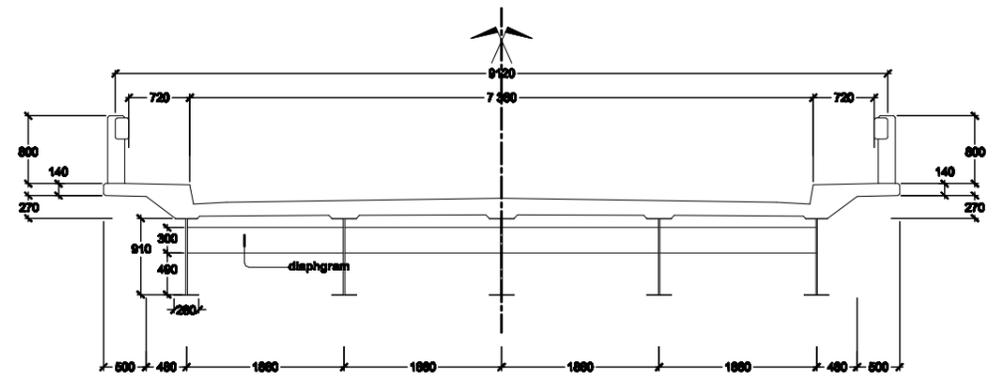
SECTION of SPAN 1 & SPAN 2 & SPAN 6
Scale 1:40 mtr

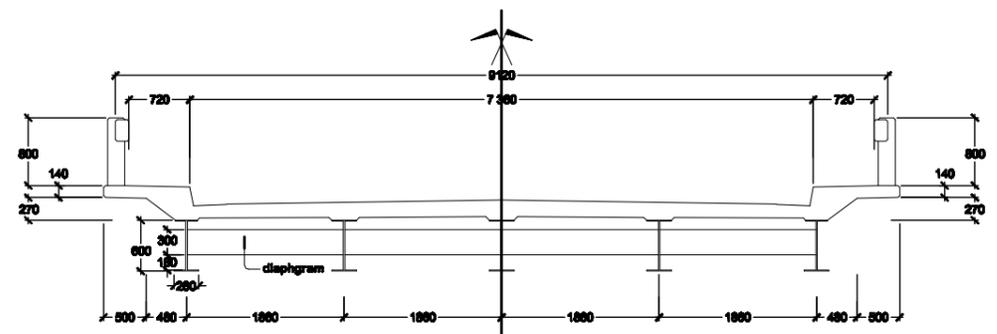
SECTION of SPAN 3 & SPAN 5
Scale 1:40 mtr

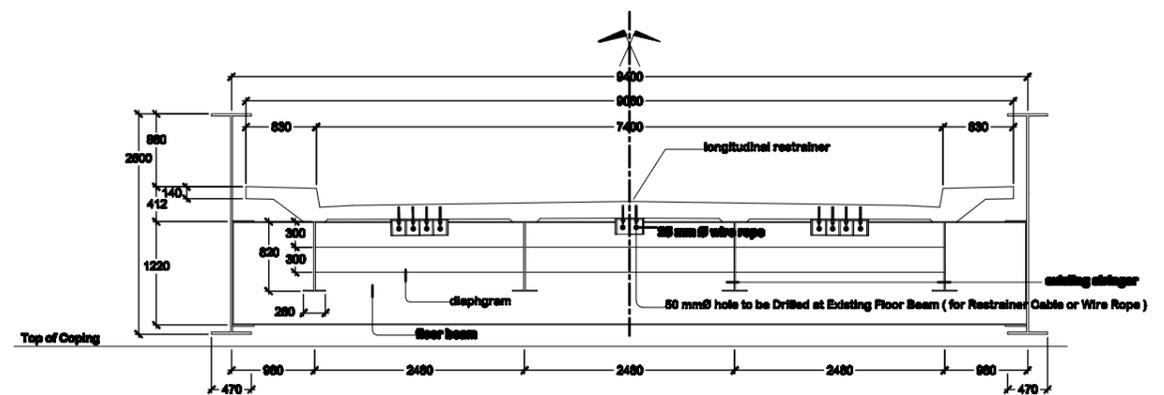
SECTION STEEL TRUSS SPAN
Scale 1:40 mtr

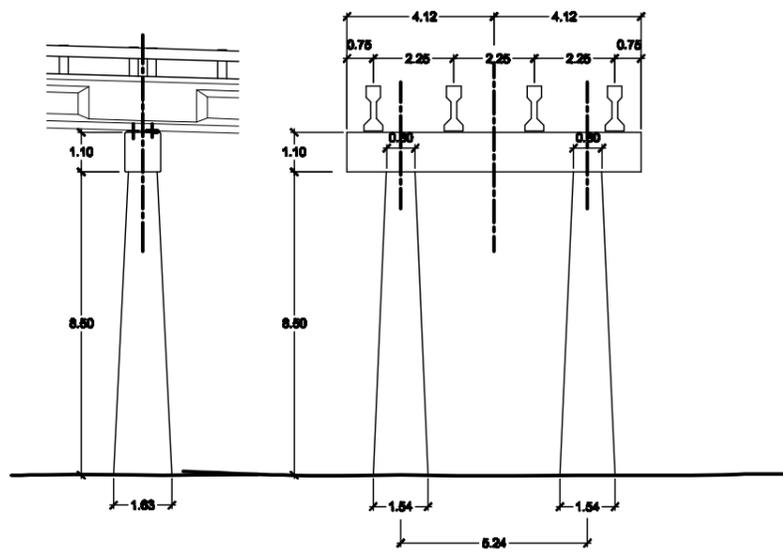
DETAIL OF PIER 4
Scale 1:100 mts

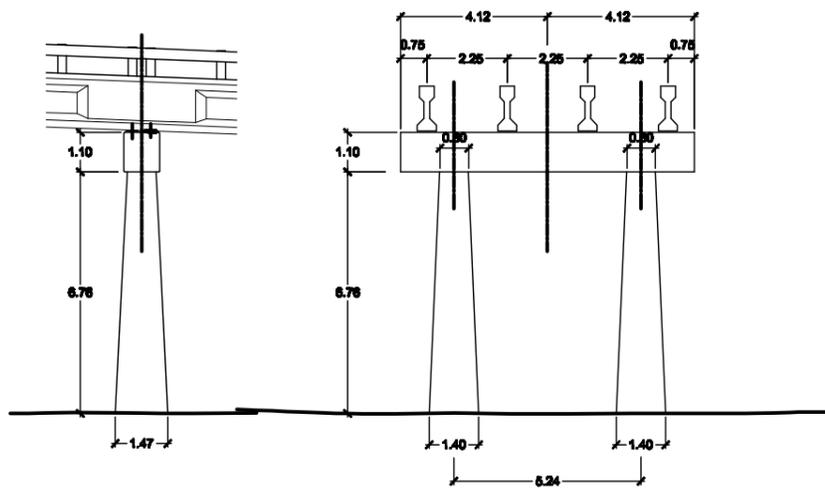
DETAIL OF PIER 5
Scale 1:100 mts

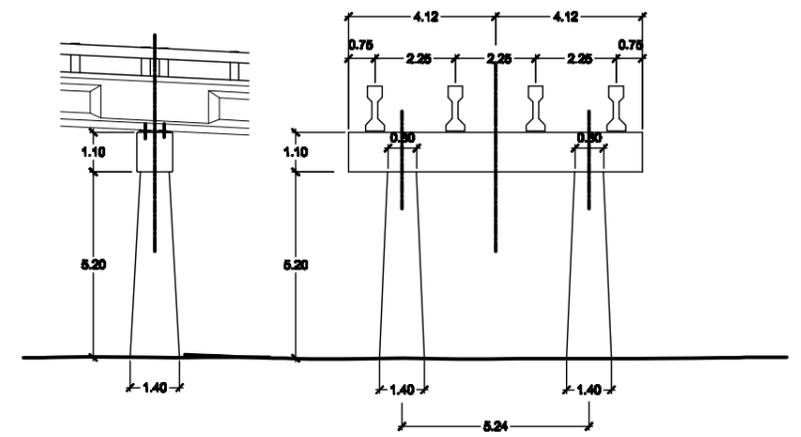
DETAIL OF PIER 6
Scale 1:100 mts

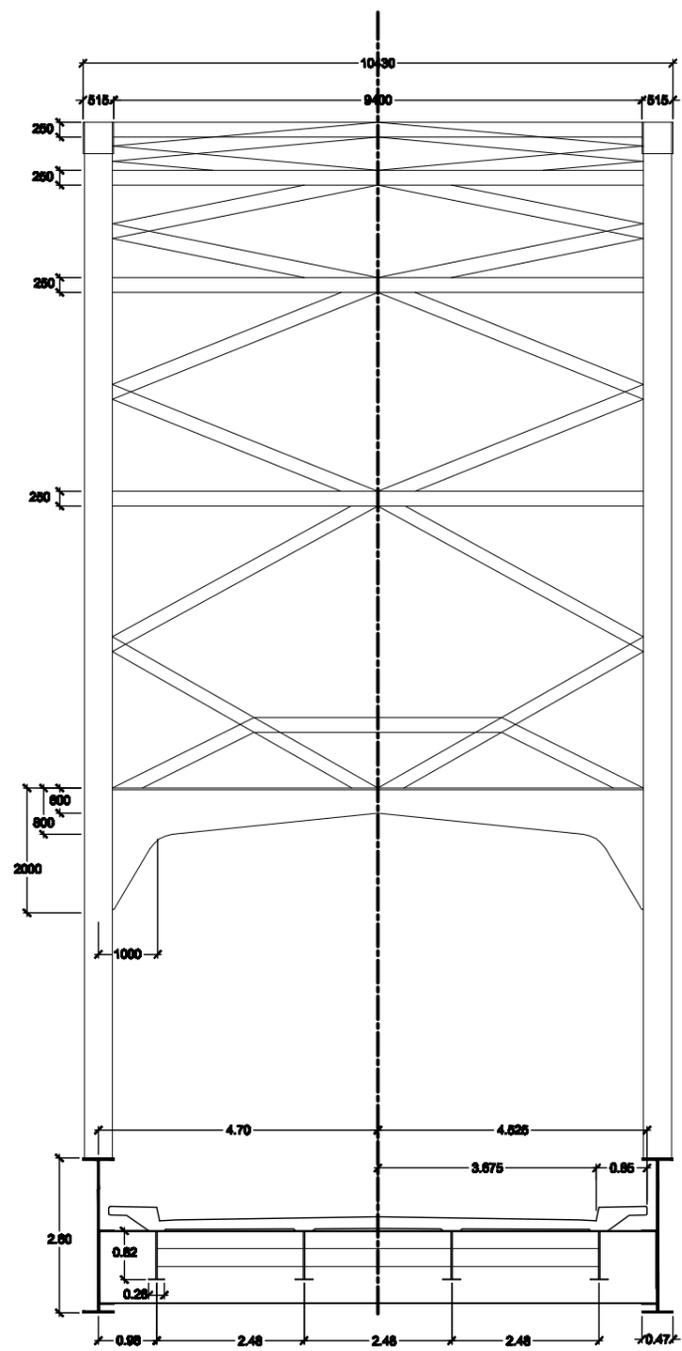
SECTION STEEL TRUSS SPAN
Scale 1:50 mtr

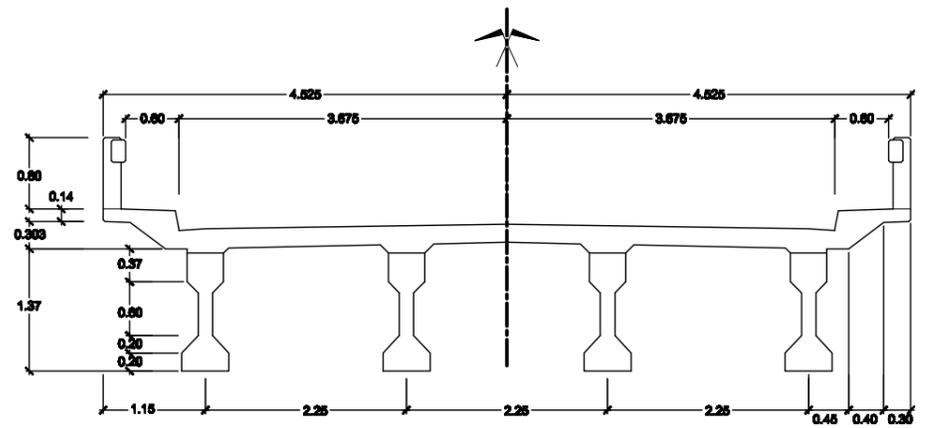
SECTION of SPAN 2 to SPAN 7
Scale 1:40 mtr

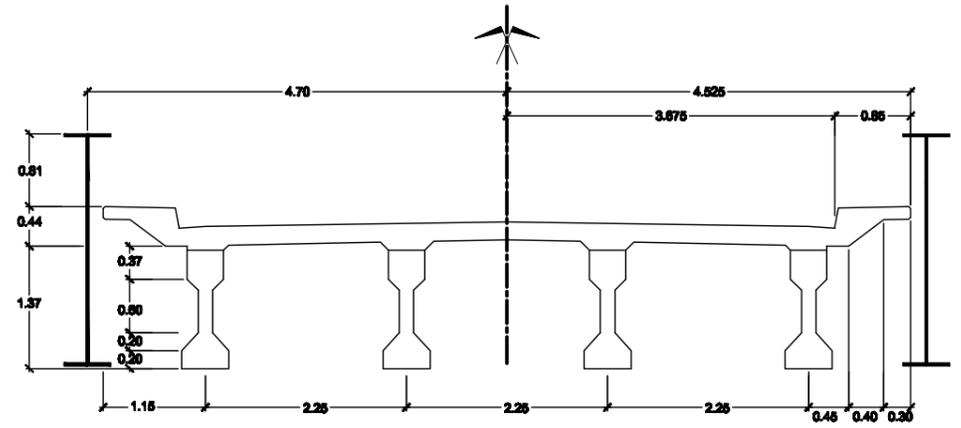
SECTION of MAIN SPAN
Scale 1:40 mtr

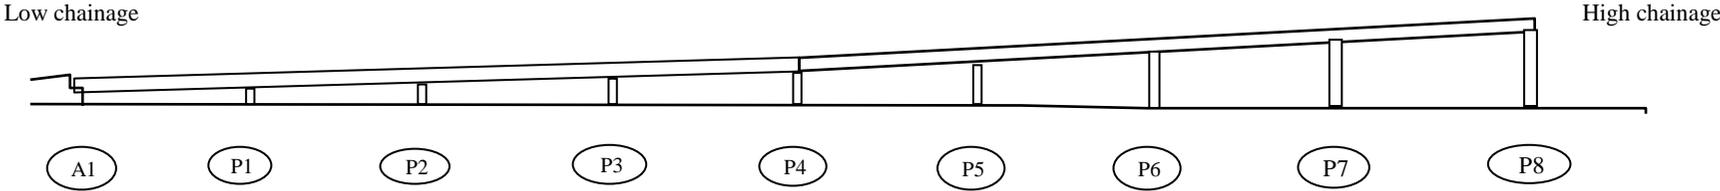
Sketch of Bridge Routine Inspection (1 of 8) Diosdado Macapagal Bridge

Railing	Impact/Accident Damage, Missing Railings, Paint Peel-off and Others (refers to the presence of trash, graffiti, posters and lush vegetation.)
Asphalt Wearing Surface, Drainage, Expansion Joint and Signage	Asphalt Wearing Surface: <u>Potholes, Cracking and Others</u> Sidewalk: <u>Unevenness, Cracking and Others</u> Drainage & Expansion Joint: <u>Accumulation of Dirt, Water Leakage, Abnormal Space/Noise</u> Signage: <u>Incorrect Location Visibility, Not Good Condition</u>
Route → Expansion Joint Route ←	
Railing

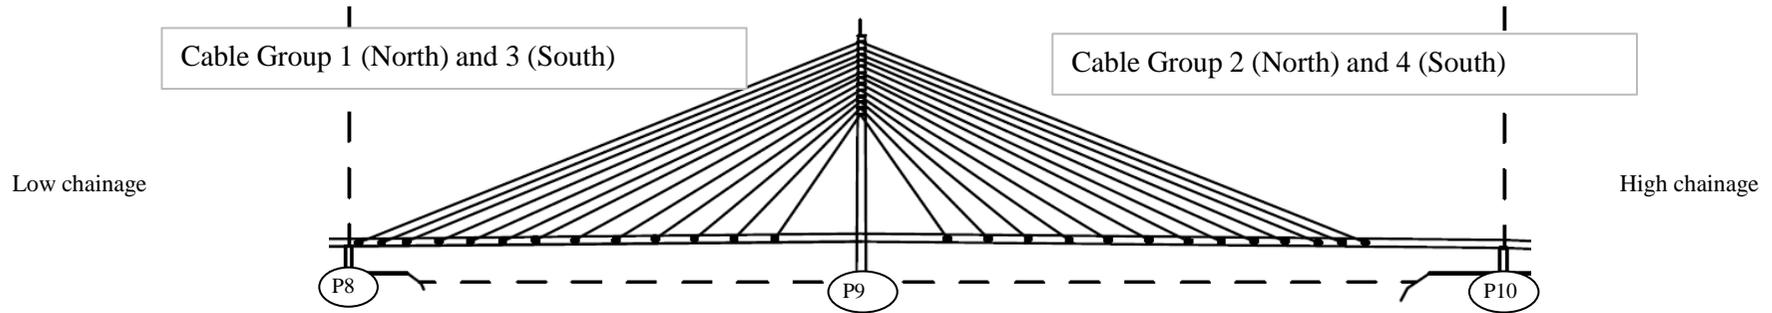
Sketch of Bridge Routine Inspection (2 of 8) Diosdado Macapagal Bridge

Railing	Impact/Accident Damage, Missing Railings, Paint Peel Off and Others (which refers to the presence of trash, graffiti, posters and lush vegetation.)
Asphalt Wearing Surface, Drainage, Expansion Joint and Signage	Asphalt Wearing Surface: <u>Potholes, Cracking and Others</u> Sidewalk: <u>Unevenness, Cracking and Others</u> Drainage & Expansion Joint: <u>Accumulation of dirt, Water leakage, Abnormal space/noise</u> Signage: <u>Incorrect Location Visibility, Not Good Condition</u>
Railing

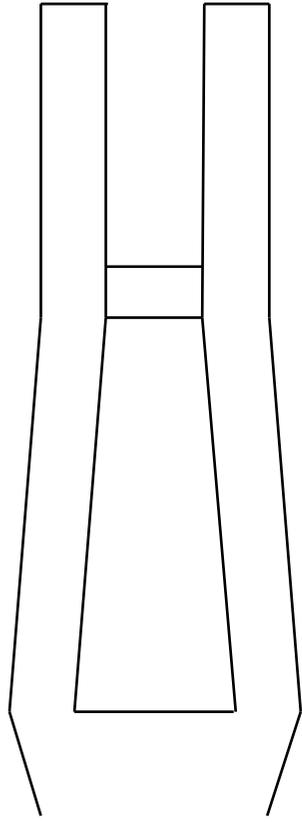
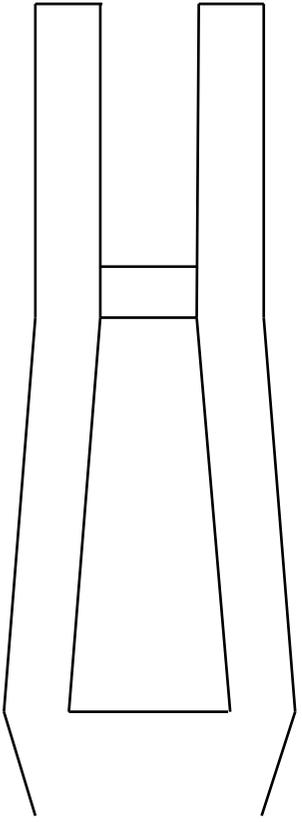
Sketch of Bridge Routine Inspection (4 of 8)
Diosdado Macapagal Bridge

<div style="border: 1px solid black; display: inline-block; padding: 2px;">Tower</div>		Tower: <u>Water Leakage, Rebar Exposure</u>			
Low Chainage	High Chainage	Right Tower		Left Tower	
		Right Side	Left Side	Right Side	Left Side

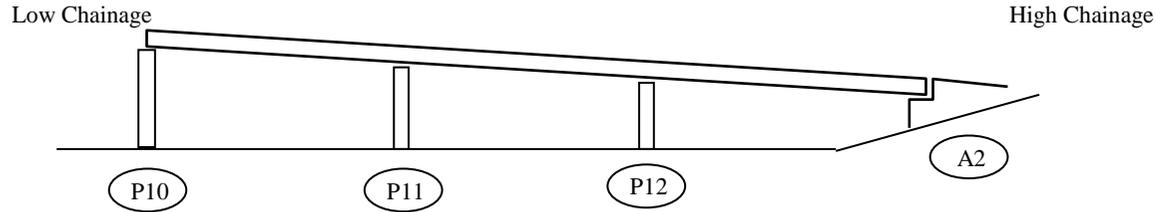
Sketch of Bridge Routine Inspection (5 of 8) Diosdado Macapagal Bridge

Railing	Impact/Accident Damage, Missing Railings, Paint Peel-off and Others (refers to the presence of trash, graffiti, posters and lush vegetation.)

Asphalt Wearing Surface, Drainage, Expansion Joint and Signage	Asphalt Wearing Surface: <u>Potholes, Cracking and Others</u> Sidewalk: <u>Unevenness, Cracking and Others</u> Drainage & Expansion Joint: <u>Accumulation of Dirt, Water Leakage, Abnormal Space/Noise</u> Signage: <u>Incorrect Location Visibility, Not Good Condition</u>	
Expansion Joint

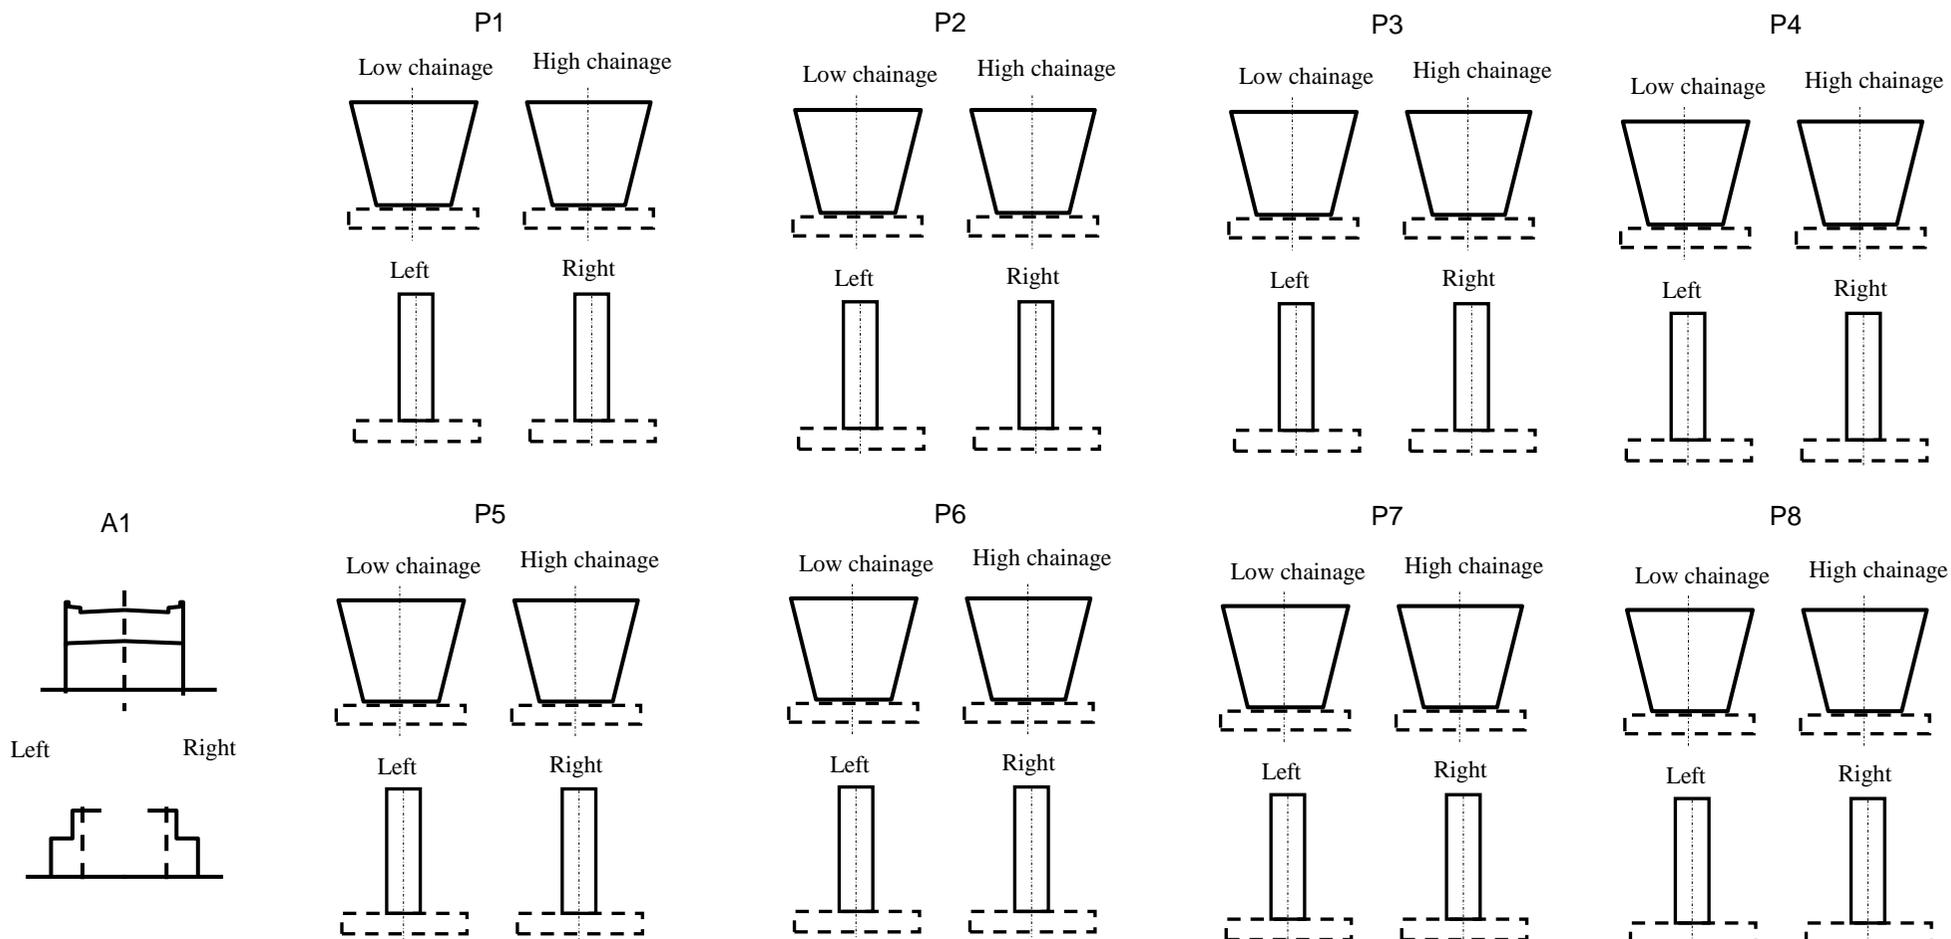
Pier and Abutment

Abutment and Pier: Rebar Exposure, Settlement and Water Leakage

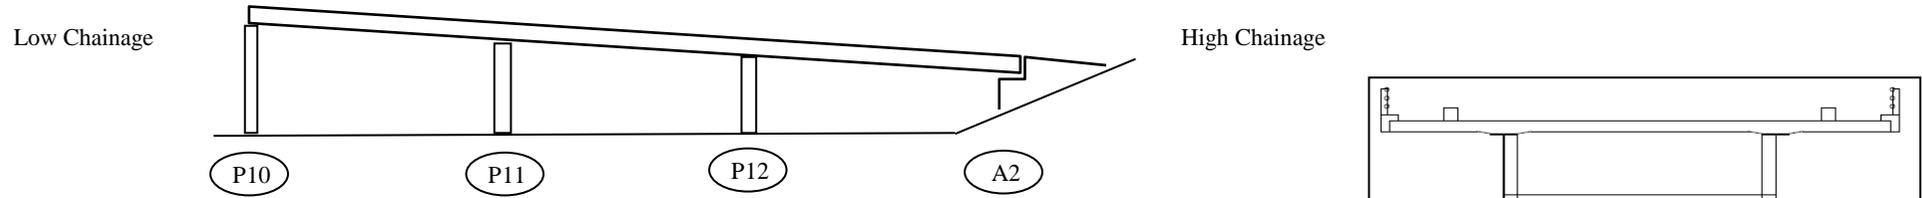
Sketch of Bridge Routine Inspection (8 of 8) Diosdado Macapagal Bridge

Girder and Beam: Corrosion, Weathering Steel, Loose Connection
 Deck Slab: Rebar Exposure, Water Leakage
 Abutment and Pier: Rebar Exposure, Settlement and Water Leakage

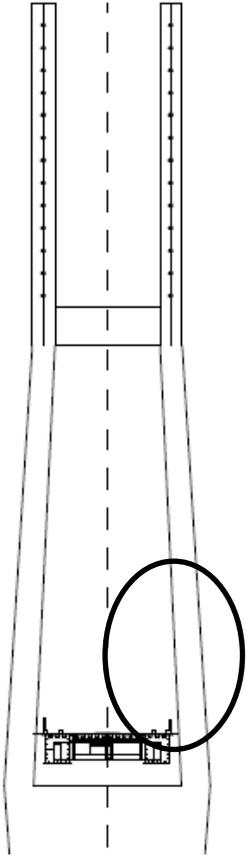
Sketch of Bridge Condition Inspection from Inside Tower (1 of 12)
Diosado Macapagal Bridge

Inside of Right Tower		Left side	Right side	Low chainage	High chainage

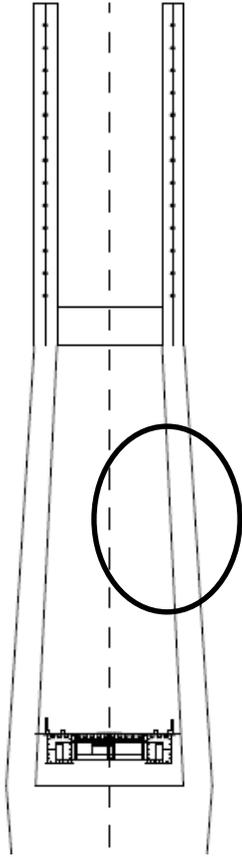
Sketch of Bridge Condition Inspection from Inside Tower (2 of 12)
Diosdado Macapagal Bridge

Inside of Right Tower		Left side	Right side	Low chainage	High chainage	
Step 7

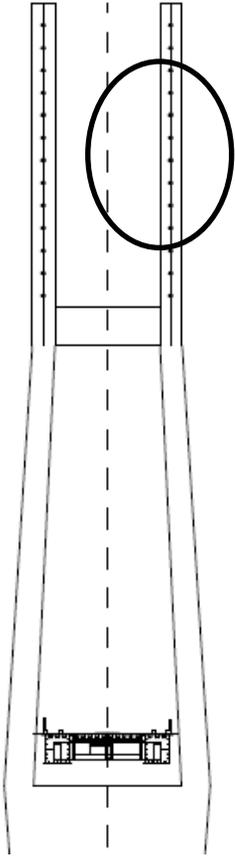
Sketch of Bridge Condition Inspection from Inside Tower (4 of 12)
Diosdado Macapagal Bridge

Inside of Right Tower					
	Left side	Right side	Low chainage	High chainage	
Step 12

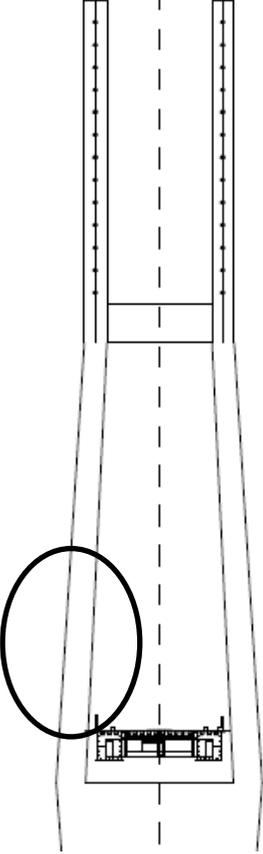
Sketch of Bridge Condition Inspection from Inside Tower (6 of 12)
Diosdado Macapagal Bridge

Inside of Left Tower		Right side	Left side	Low chainage	High chainage

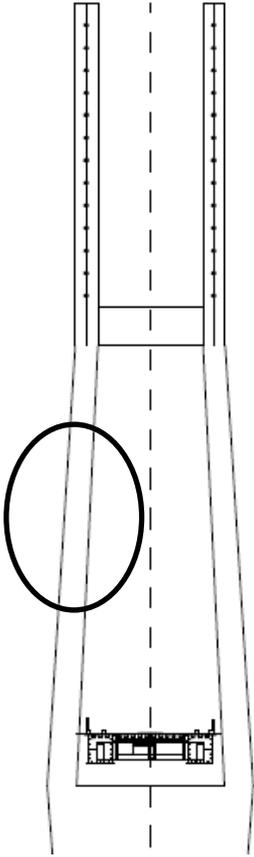
Sketch of Bridge Condition Inspection from Inside Tower (7 of 12)
Diosdado Macapagal Bridge

Inside of Left Tower		Right side	Left side	Low chainage	High chainage	
Step 7	Step 6

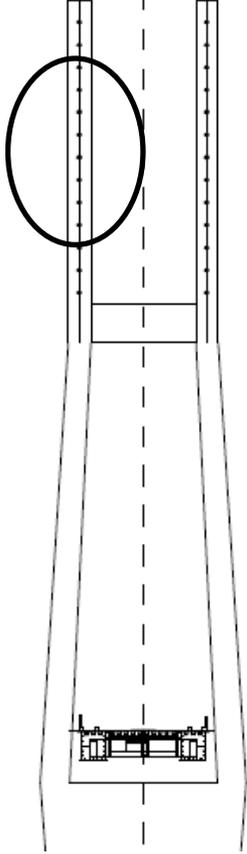
Sketch of Bridge Condition Inspection from Inside Tower (9 of 12)
Diosdado Macapagal Bridge

Inside of Left Tower					
	Right side	Left side	Low chainage	High chainage	
Step 12

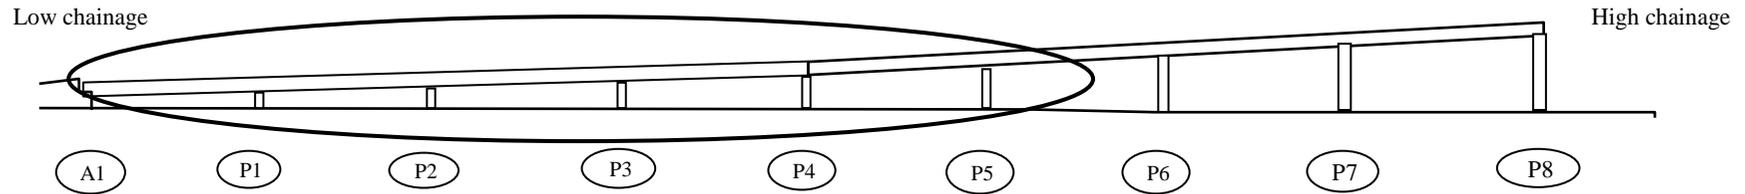
Sketch of Bridge Condition Inspection from Pier (1 of 8) Diosdado Macapagal Bridge

A1 Left side	P2 Left side	P4 Left side
A1 Right side	P2 Right side	P4 Right side
P1 Left side	P3 Left side	P5 Left side
P1 Right side	P3 Right side	P5 Right side

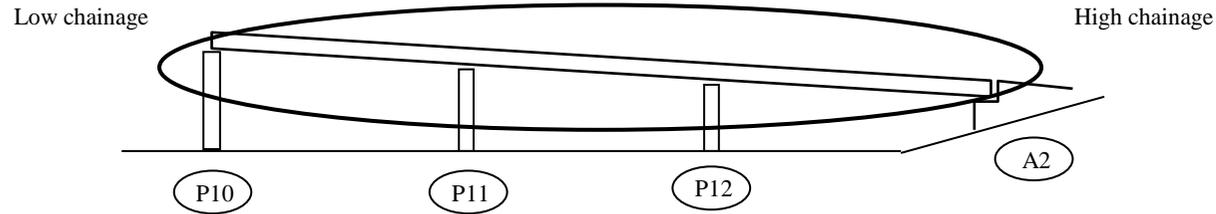
Sketch of Bridge Condition Inspection from Pier (3 of 8) Diosdado Macapagal Bridge

P10 Left side	P12 Left side

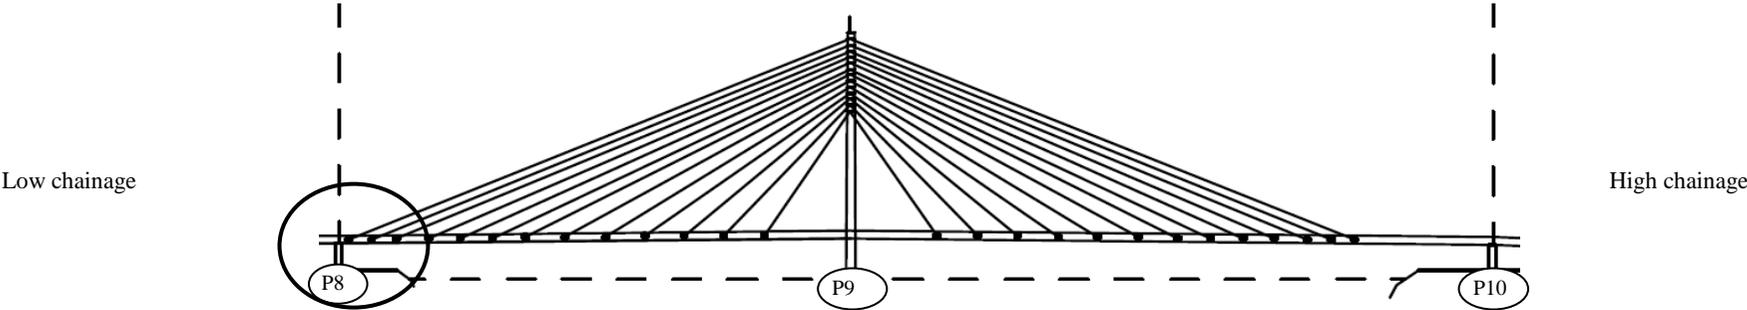
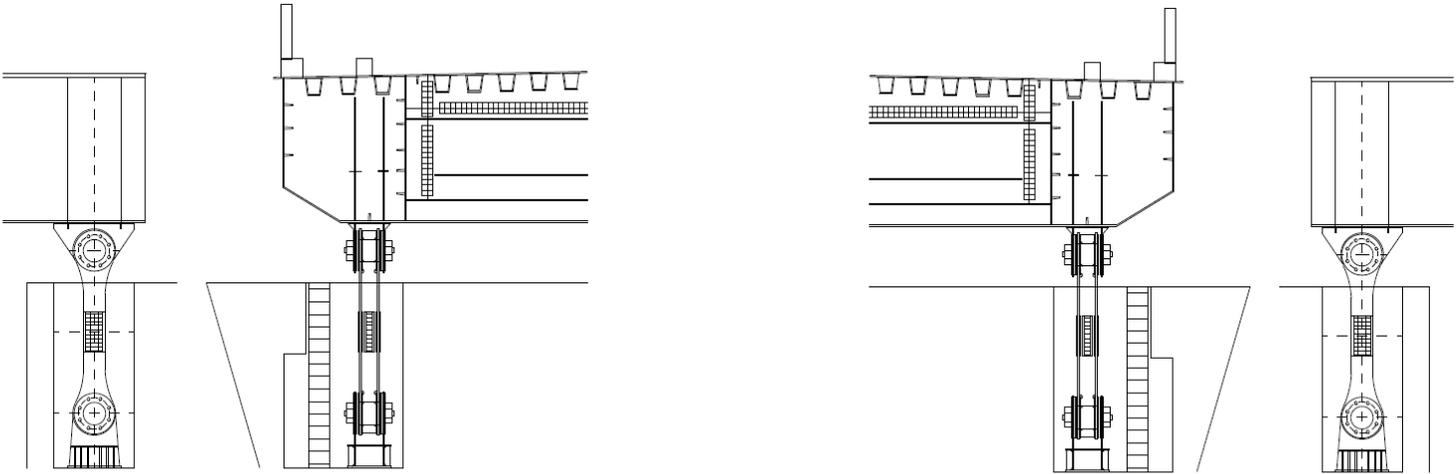
Sketch of Bridge Condition Inspection from Pier (4 of 8)
Diosdado Macapagal Bridge

P8
Left side

P8
Right side

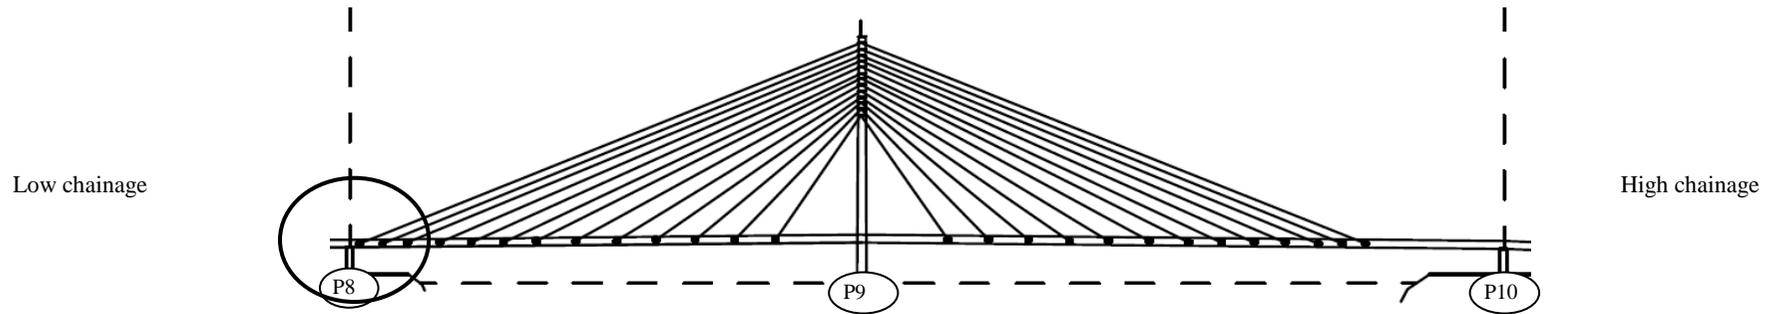
Sketch of Bridge Condition Inspection from Pier (5 of 8)
Diosdado Macapagal Bridge

P8
Left side

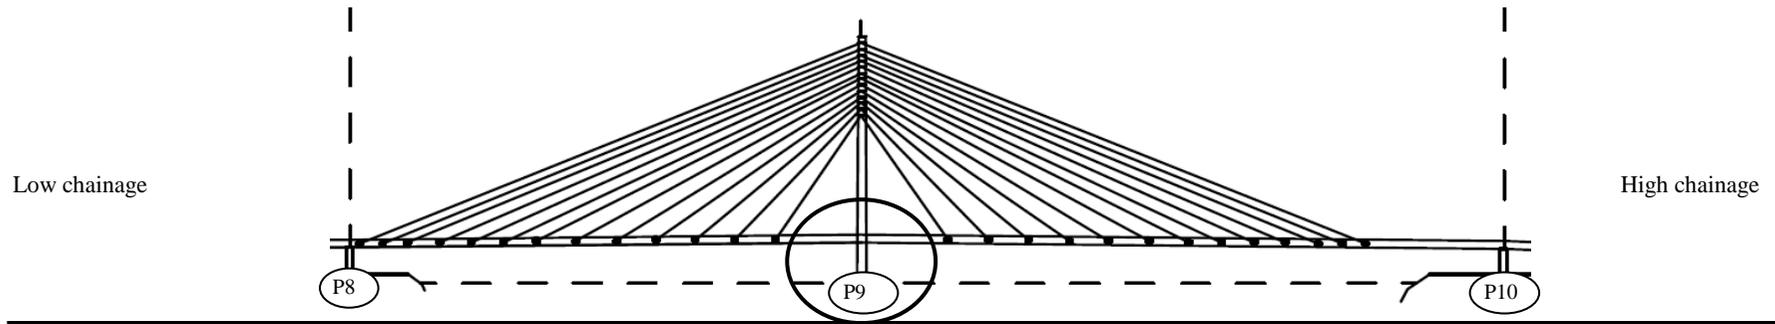
**Sketch of Bridge Condition Inspection from Pier (6 of 8)
Diosdado Macapagal Bridge**

P9
Left side

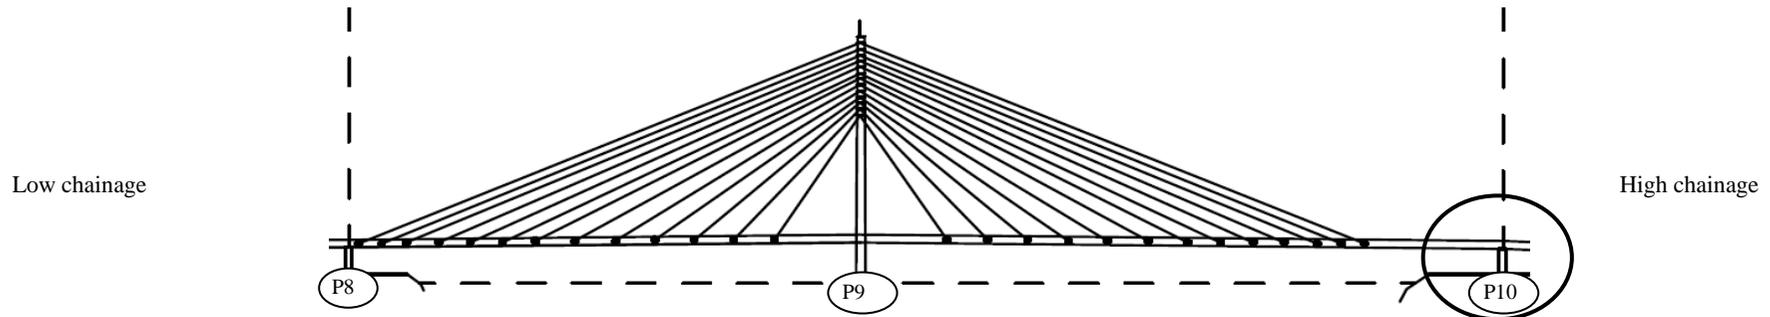
**Sketch of Bridge Condition Inspection from Pier (7 of 8)
Diosdado Macapagal Bridge**

P10
Left side

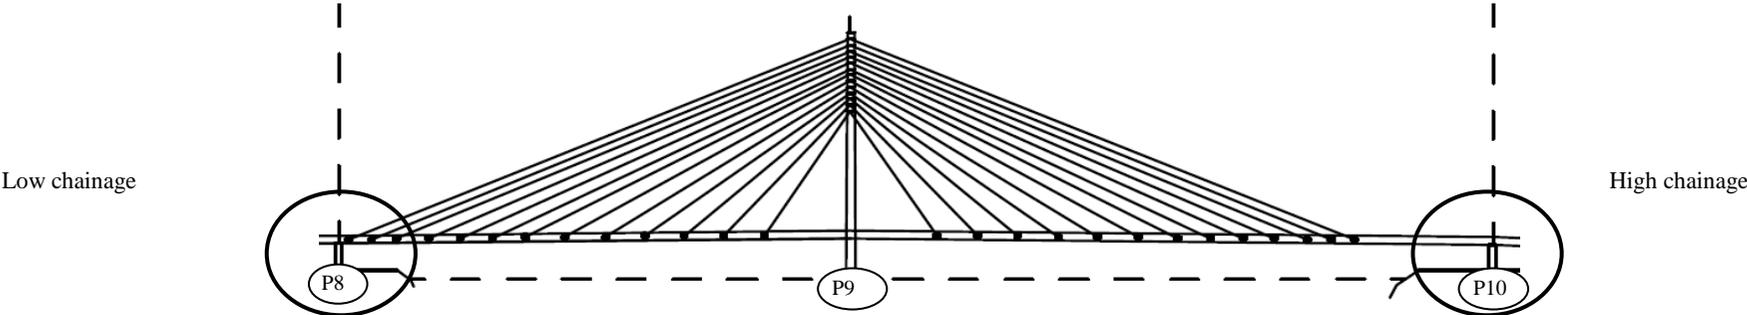
**Sketch of Bridge Condition Inspection from Pier (8 of 8)
Diosdado Macapagal Bridge**

<p>P8 Left side</p>		<p>P10 Left side</p>	
<p>P8 Right side</p>		<p>P10 Right side</p>

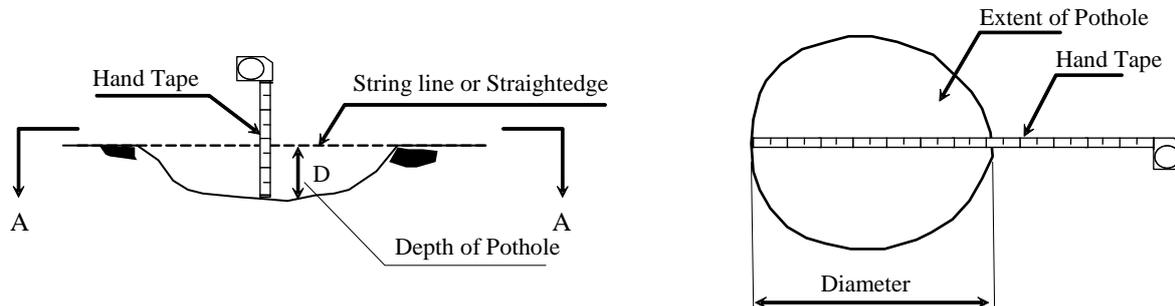
Potholes are bowl-shaped holes in the pavement caused by the penetration of water through the pavement due to heavy rains and breaking up of the pavement due to subsequent traffic action. Pavements already deteriorated with defects such as alligator cracking and raveling are prone to the occurrence of potholes.

Figure G-1
Method of Measuring Potholes

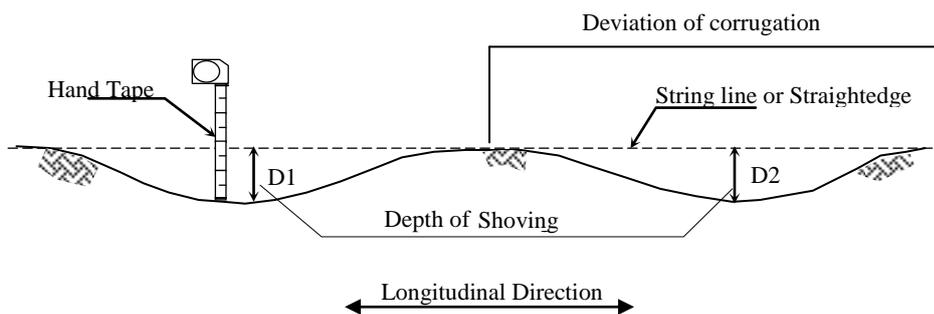
Shoving is defined as the unevenness of the roughness on the carriageway surface along the longitudinal direction of the road. This deformation, as it progresses, will lead to an increasingly severe impact loading under traffic, particularly at joints. It is usually the result of the combined effects of traffic and warm weather. Blisters are formed in the surface during warm weather while traffic normally prevents them from rising.

Figure G-2
Measurement of Waving Depth and Corrugation

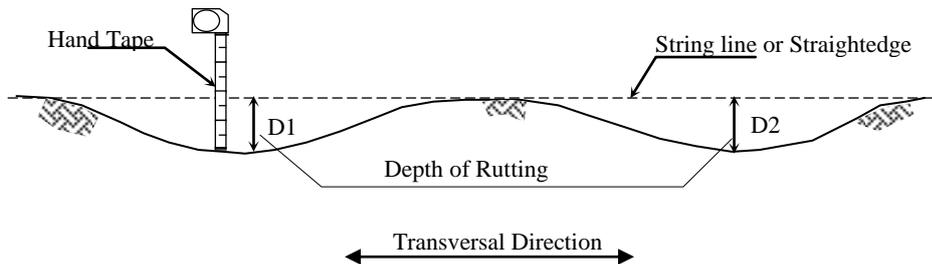
Rutting is defined as the unevenness on the carriageway surface in the transverse direction of the road. This deformation is caused by continuous heavy wheel loads passing along the carriageway in the longitudinal direction.

Figure G-3
Measurement of Rutting Depth

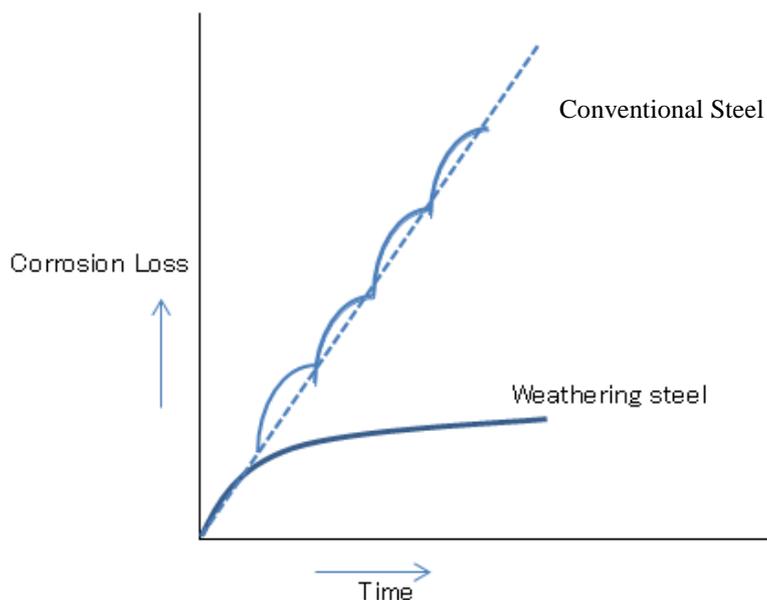
Figure G-5
Comparison Between Conventional Steel and Weathering Steel

Shown in Figure G-5 is the comparison between conventional steel and weathering steel.

Although stable rust is produced under suitable condition, abnormal rust (advanced rust) is developed under extreme environment which can lead to durability problems.
