**IMPROVEMENT OF QUALITY MANAGEMENT FOR
HIGHWAY AND BRIDGE CONSTRUCTION AND
MAINTENANCE, PHASE II**

**BRIDGE INSPECTION MANUAL
FOR
STEEL TRUSS BRIDGE
(SPECIAL BRIDGE)**

Department of Public Works and Highways
Japan International Cooperation Agency

SEPTEMBER 2014

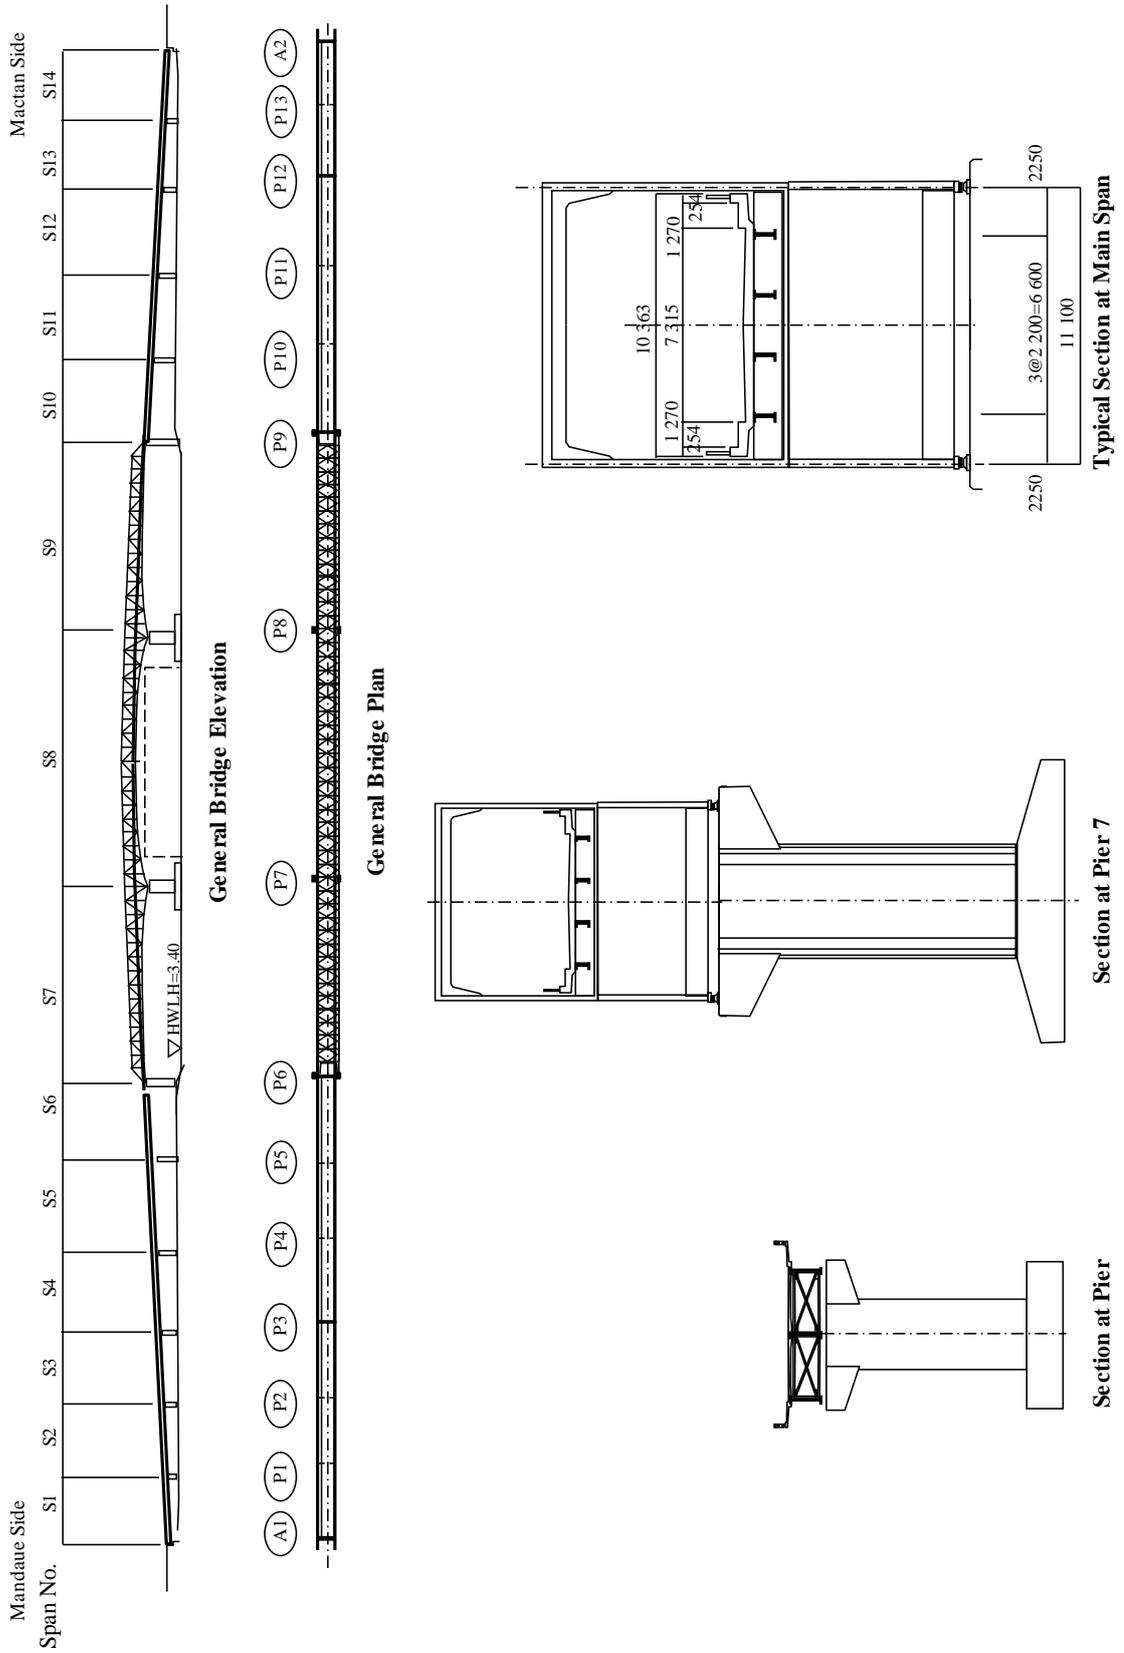
Figure 1-1 General Views of 1st Mandaue-Mactan Bridge

General views of the 1st Mandaue-Mactan Bridge are shown in Figure 1-1.

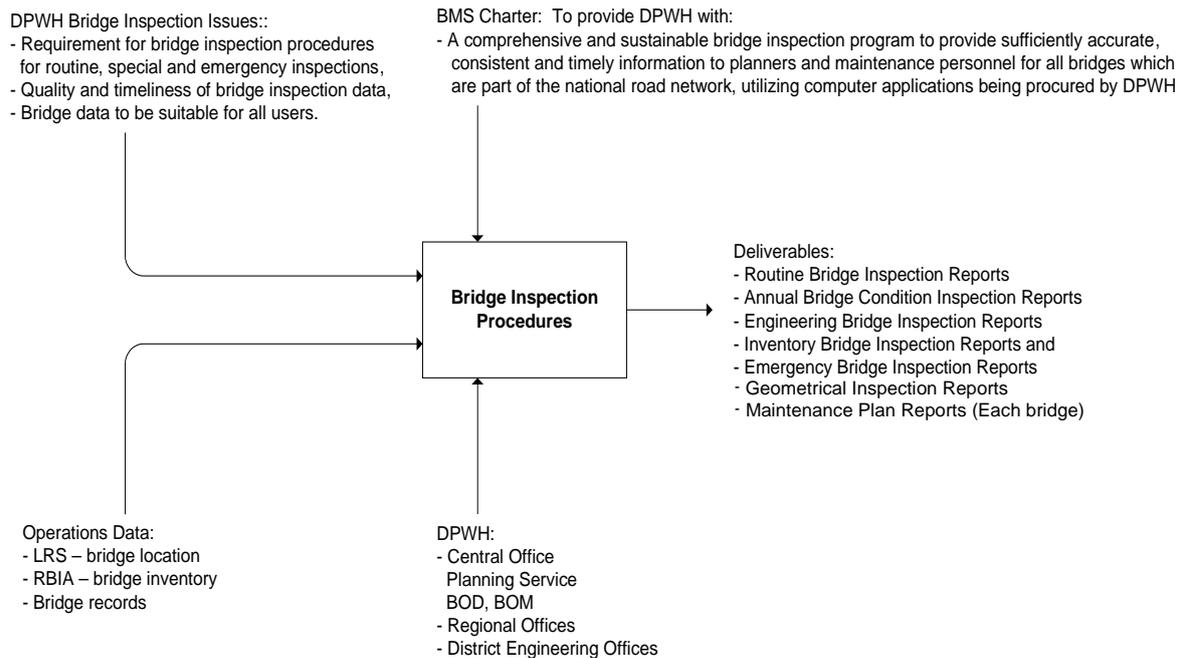
Figure 1-2
Bridge Inspection Procedures and Requirements

The bridge inspection procedures and requirements are shown in Figure 1-2.

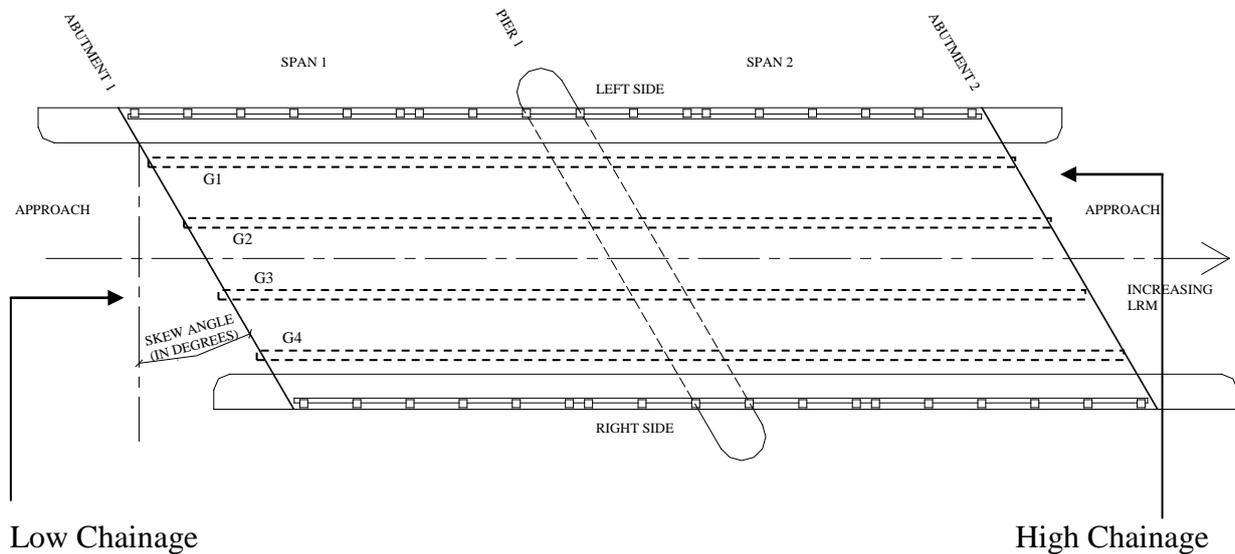
Figure 2-1
Bridge Geometry Definition

The standardized geometrical definition in the BMS Manual has been adopted by this Manual which is based on the Local Referencing System (LRS) used by the DPWH. The bridge is assessed in the direction of increasing chainage. Refer to Figure 2-1.

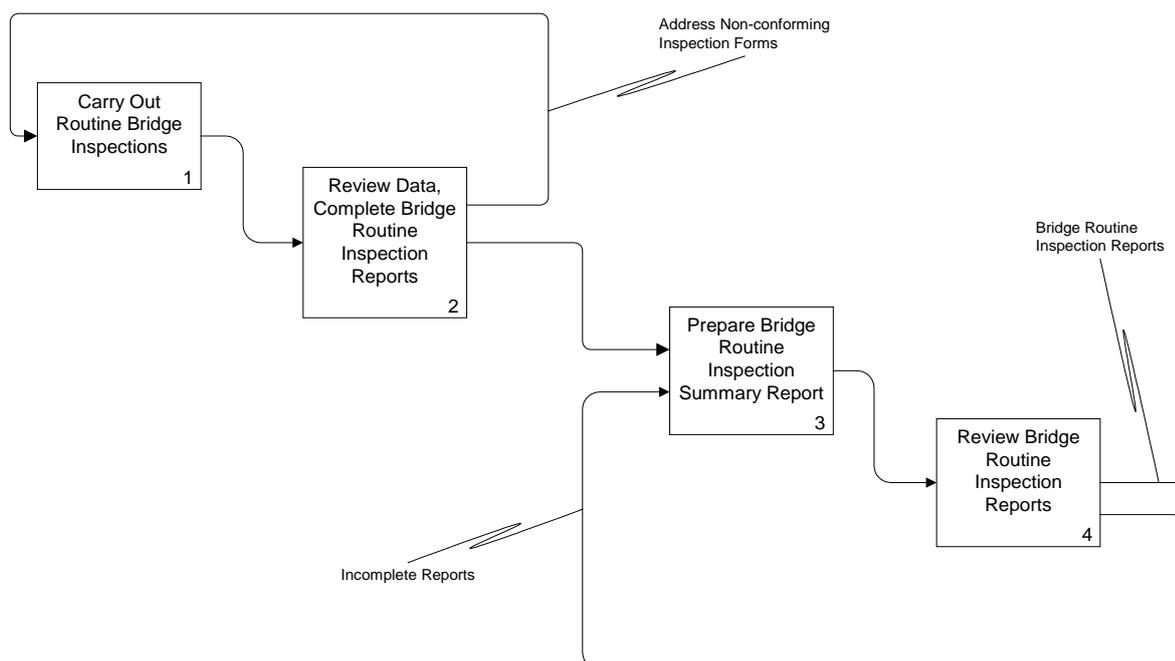
Figure 3-1
Routine Inspection

The process for conducting Routine Inspection is shown in Figure 3-1.

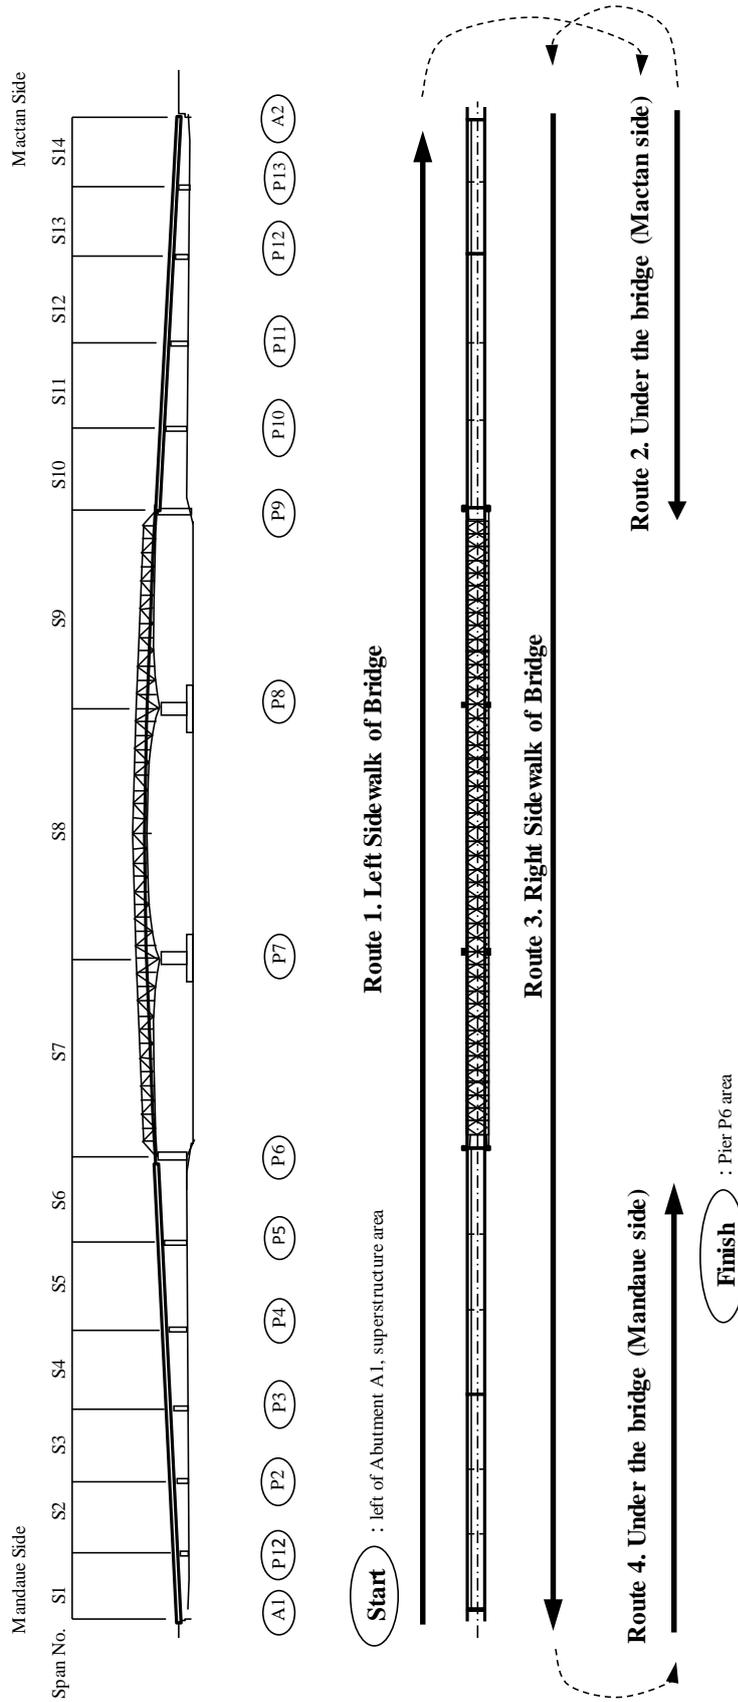
**Figure 3-2 Routine Inspection Route
1st Mandaue-Mactan Bridge**

Note: Inspection shall be done by walking through the route herein indicated.

For reference, the route and check points of Routine Inspection of MMB are shown in Figures 3-2 and 3-3, respectively. The routine inspection time table for MMB is shown in Figure 3-4 which is based on the actual routine inspection conducted on November 28, 2007.

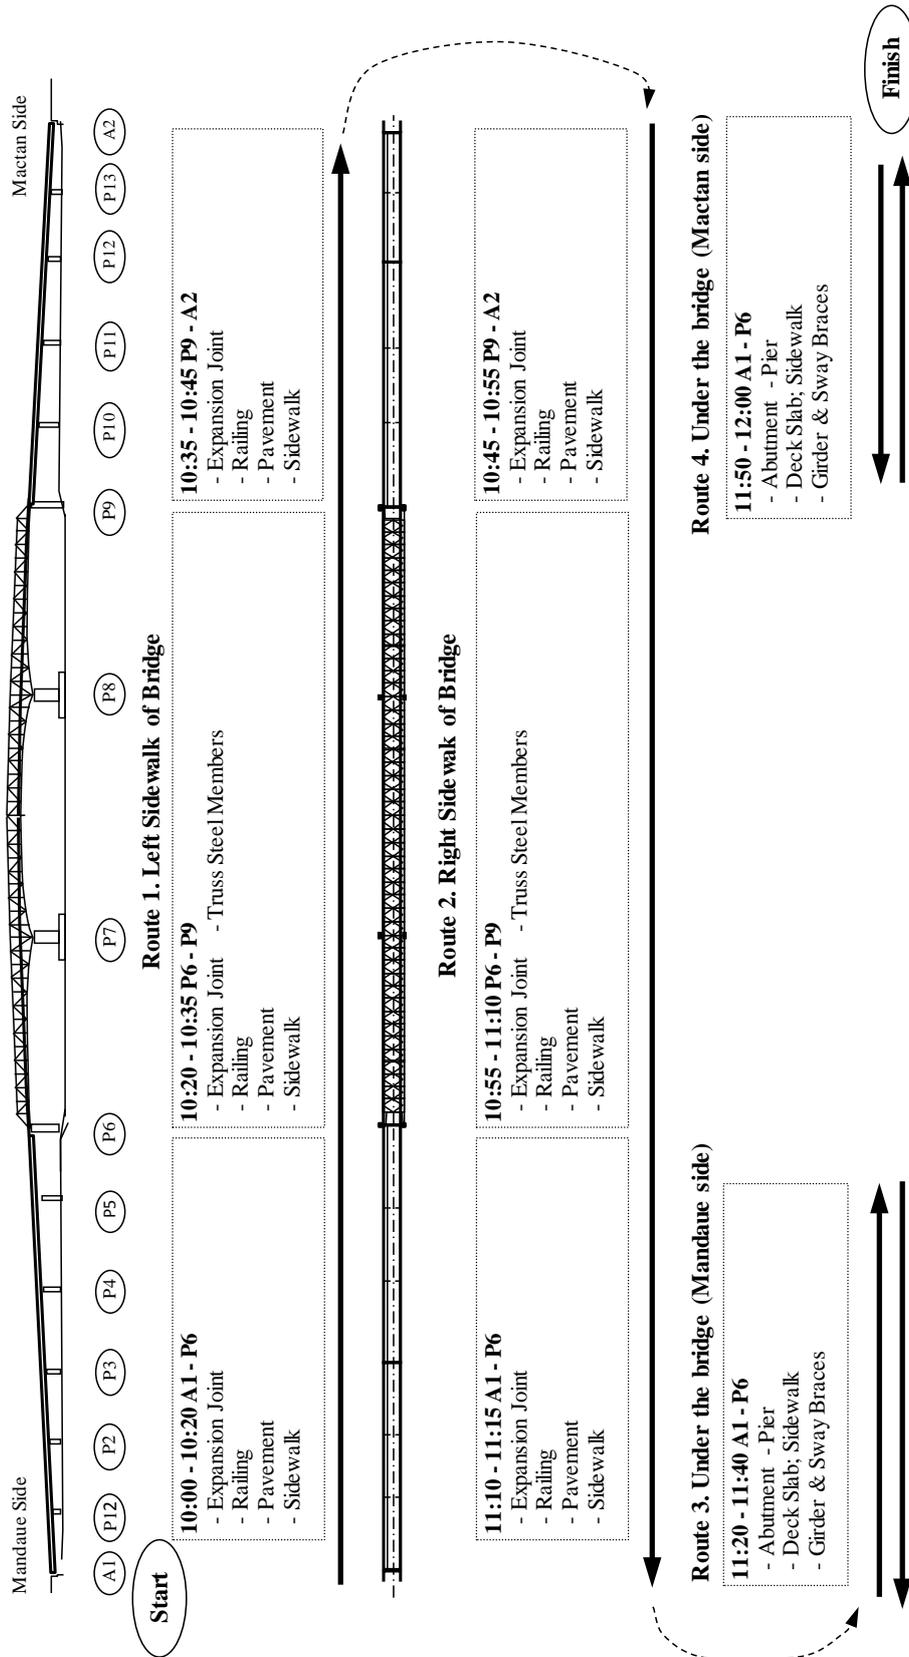
Figure 3-4 Sample of Routine Inspection Time Table
1st Mandaue-Mactan Bridge

Note: The time duration reflected above is the actual time table on the Bridge Routine Inspection conducted on November 28, 2007.
This Bridge Routine Inspection was jointly conducted by JICA Long-term & short-term Bridge Experts together with engineers from the DPWH Regional Office VII and Cebu 6th Engineering District.

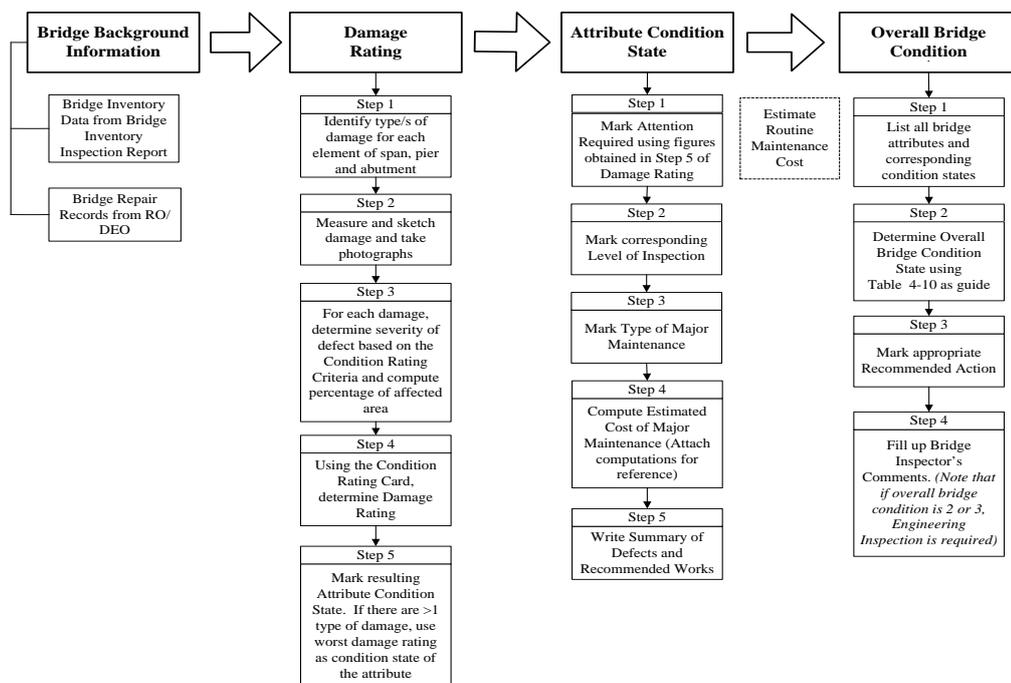
Figure 4-2

The step-by-step procedure for conducting the condition inspection is illustrated in the following flowchart.

Flowchart of Bridge Condition Inspection

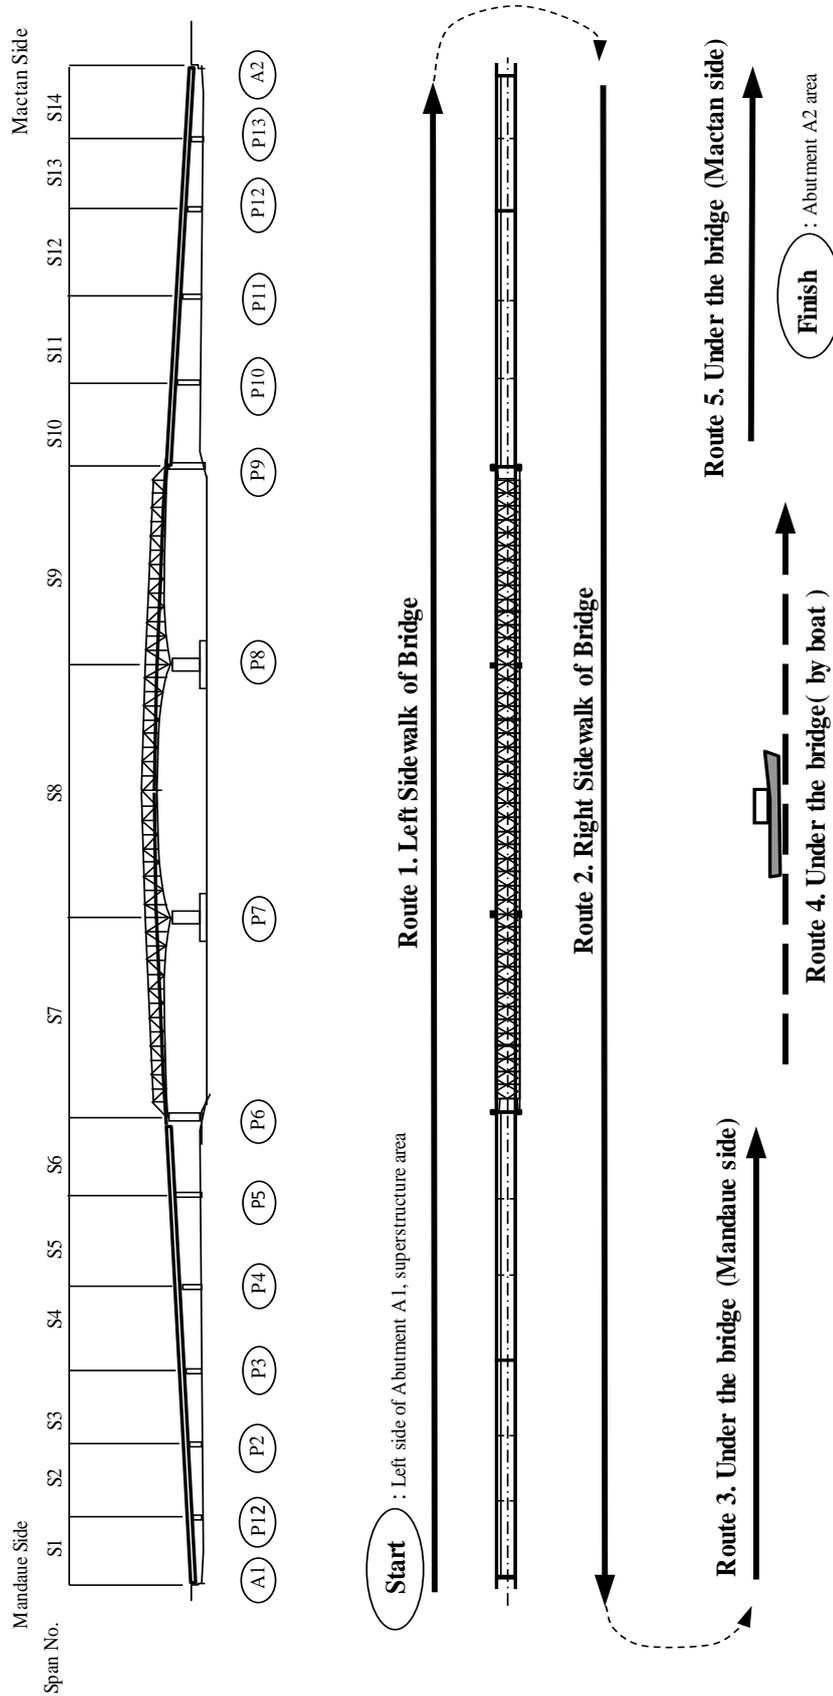
**Figure 4-3 Condition Inspection Route
1st Mandaue-Mactan Bridge**

- Note:
1. Inspection shall be done by walking through the route specified except at Route 4 which will be done by using boat.
 2. Whenever necessary, inspection equipment (e.g. bridge inspection vehicle, ladder etc.) may be used to conduct a more detailed inspection on any attribute member.

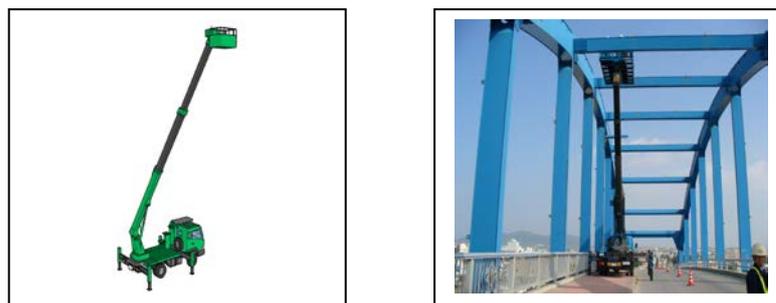
Figure 4-5
Photos of Bucket Type BIV

There are two types of BIV. One type is bucket type which is also called Aerial Work Platform. This type is widely used for maintenance and construction of bridge and for power and telecommunication industries. They can lift inspectors up to high level to inspect tower, cable band chord, etc. as shown in Figure 4-5.

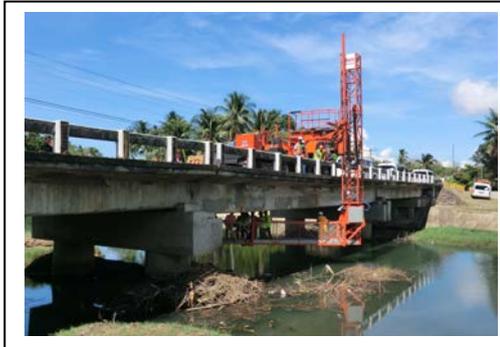
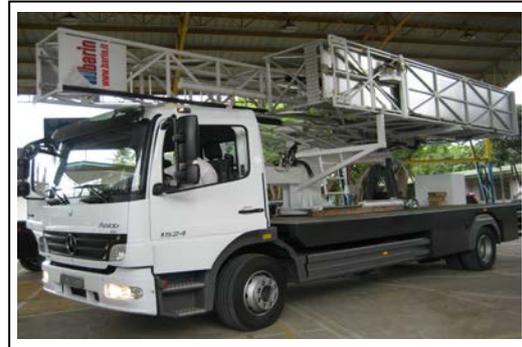
Figure 4-6
Photos of Telescoping Articulated Platform Type BIV

Another type is a telescoping articulated platform. It can carry inspector underneath the bridge to check girders, bottom of slab, etc. Figure 4-6 show pictures of telescoping articulated platform type BIV.

When BIV is used, a designated vehicle operator should accompany the inspection and operate the vehicle. Inspectors should use safety belt during inspection.

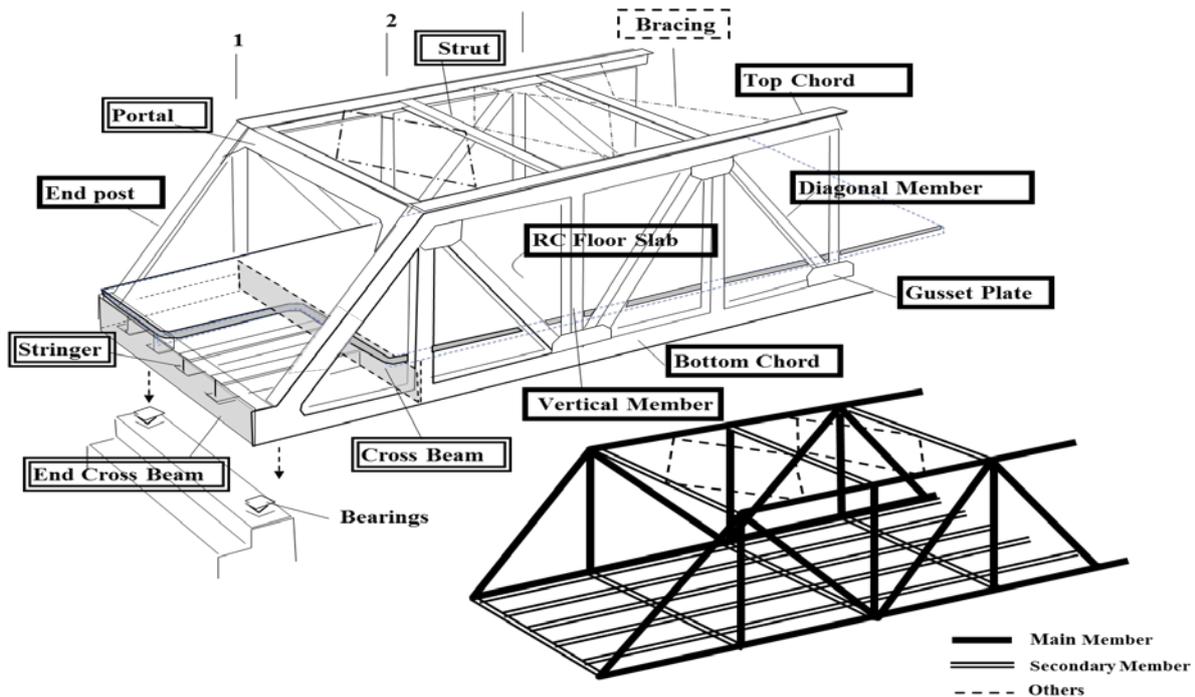
Figure 4-7 Attributes of Steel Truss Bridge

In the superstructure of a Steel Truss Bridge, the defined attributes of the main members or elements are the Top Chord, Bottom Chord, End Post, Vertical Member, Diagonal Member, Gusset Plate and RC Deck Slab. On the other hand, the secondary members are the Struts, Portals, Stringers, Cross Beams and Bracings.

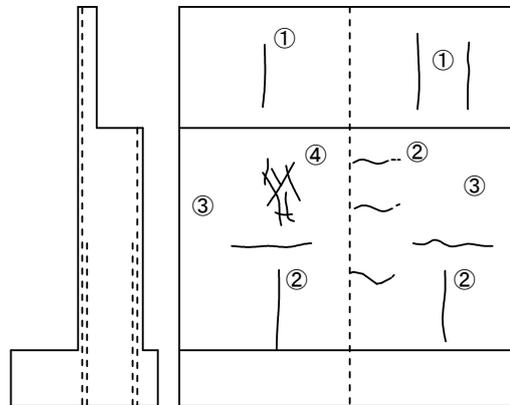
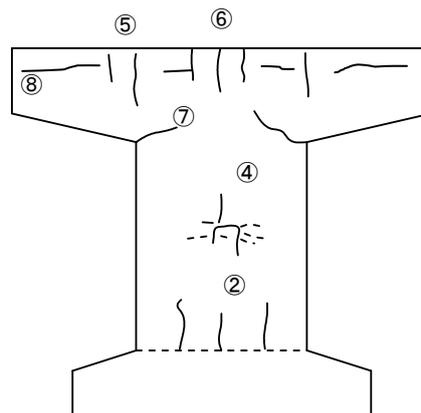
Figure 4-8 General Patterns of Crack Defects on Abutment and Pier

The general pattern of defects in a Steel Truss Bridge are shown in Figures 4-8, 4-9 and 4-10.

Abutment

Pier

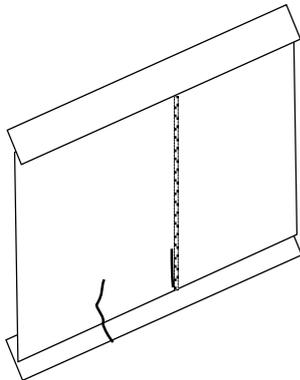
Figure 4-9 General Patterns of Crack Defects on Steel Attributes

Vertical crack on lower flange or web crack on welding

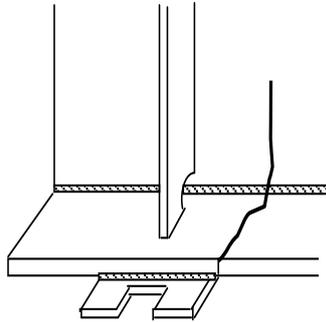
Crack around welding part of bearing's upper plate

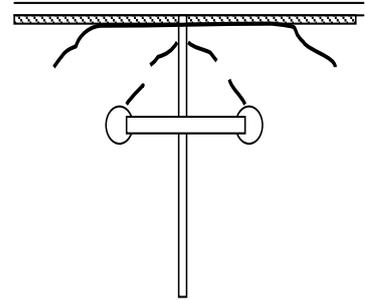
Crack on web connected with cross beam

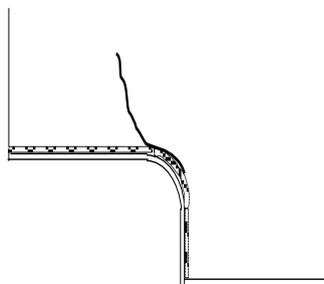
Crack on notch

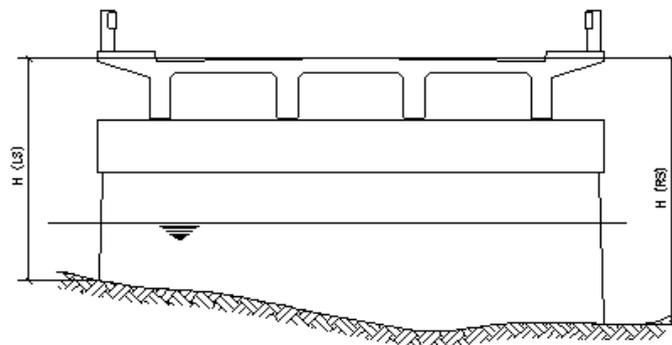
Figure 4-11
Measurement of Pier Scour Check

The scour check at a pier is undertaken as shown in Figure 4-11. The bridge inspector is required to measure the height from the top of the concrete deck or parapet to the ground or streambed level on each side of the bridge on the centerline of each pier.

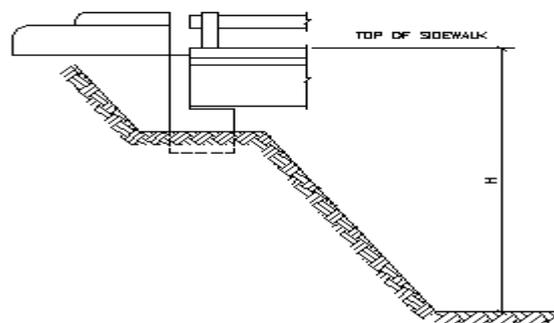
Figure 4-12
Measurement of Abutment Scour Check

The scour check at an abutment is undertaken as shown in Figure 4-12. The bridge inspector is required to measure the height from the top of the concrete deck or parapet to the ground or streambed level on each side of the bridge to the natural surface immediately adjacent to the abutment.

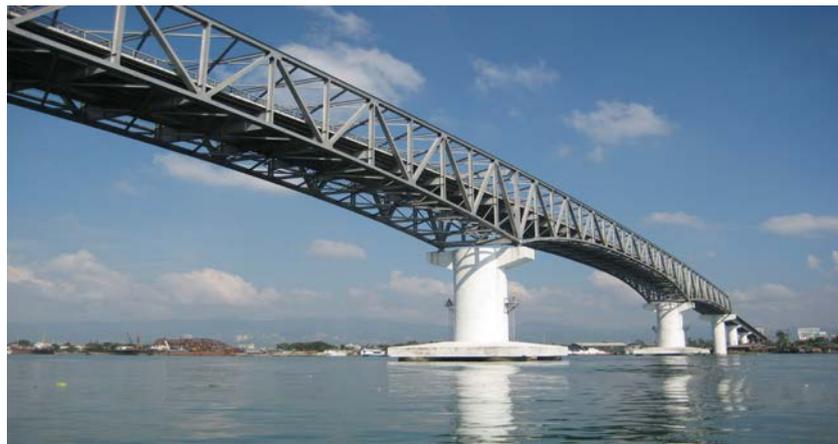
Figure 7-1 Photograph of 1st Mandaue-Mactan Bridge

The 1st Mandaue-Mactan Bridge is a steel truss bridge crossing the Mactan Channel from the island of Cebu to the island of Mactan. It has an overall length of 860m from Abutment A1 to Abutment A2 comprising of 14 spans, 13 RC Piers and 2 RC Abutments. The three (3) central spans are made up of steel trusses while the rest of the spans at the viaduct portion, are composed of steel plate girder spans. For navigation purposes, the clear vertical height is 22.86m while the clear horizontal distance is 112.78m.

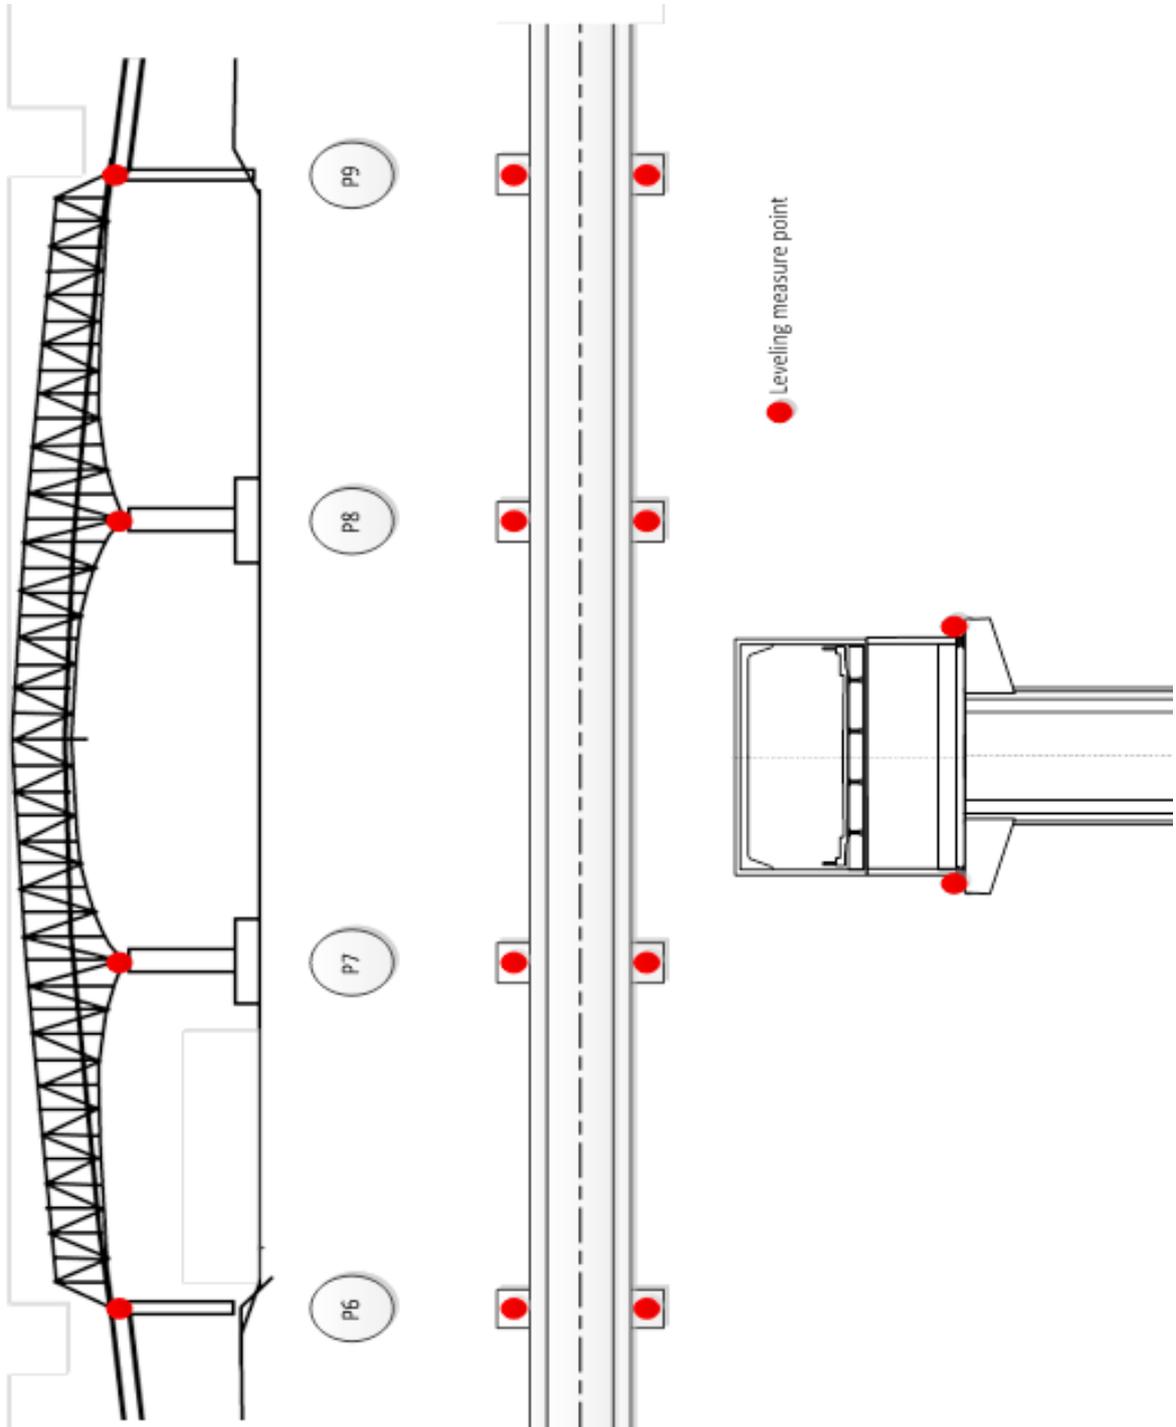
Figure 8-1
Geometrical Inspection of 1st Mandaue-Mactan Bridge:
Leveling of Piers

Geometrical inspection methods are shown in Figures 8-1, 8-2, 8-3 and 8-4. As a reference, forms of geometrical inspection of 1st Mandaue-Mactan Bridge are shown in Appendix G-1.

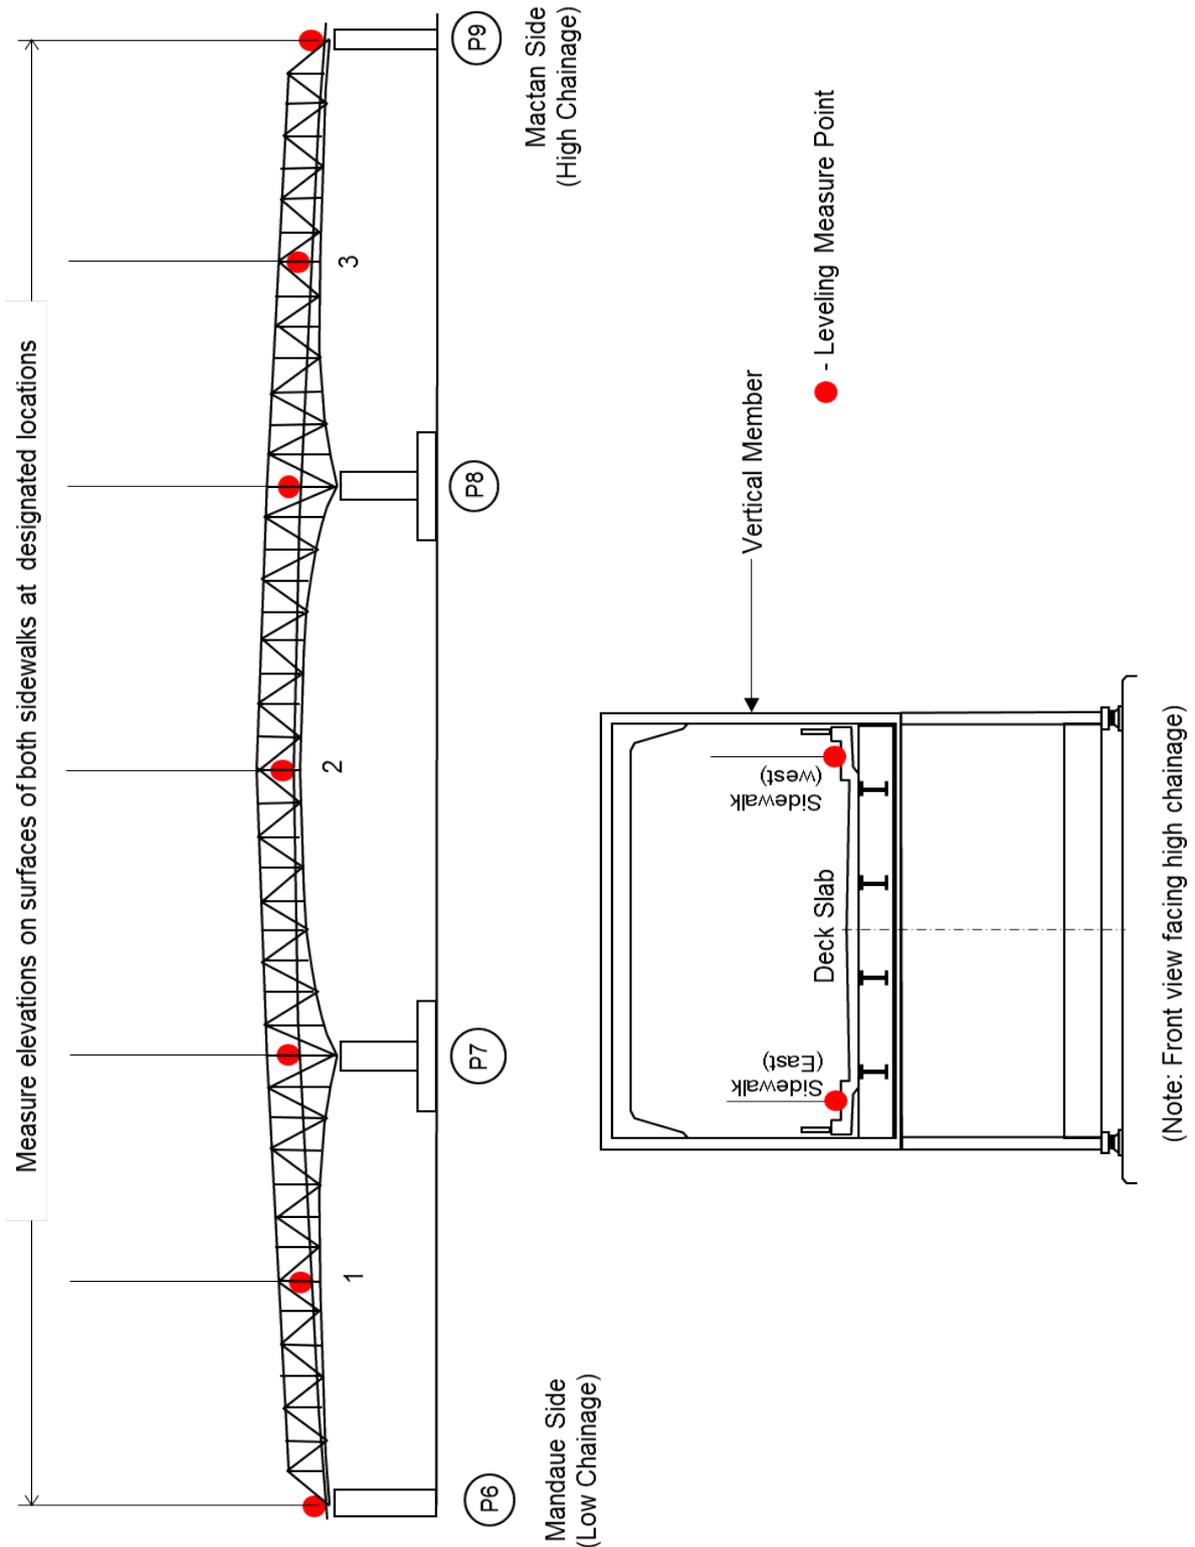
Figure 8-2
Geometrical Inspection of 1st Mandaue-Mactan Bridge:
Leveling of Longitudinal Alignment of Deck Slab Surface

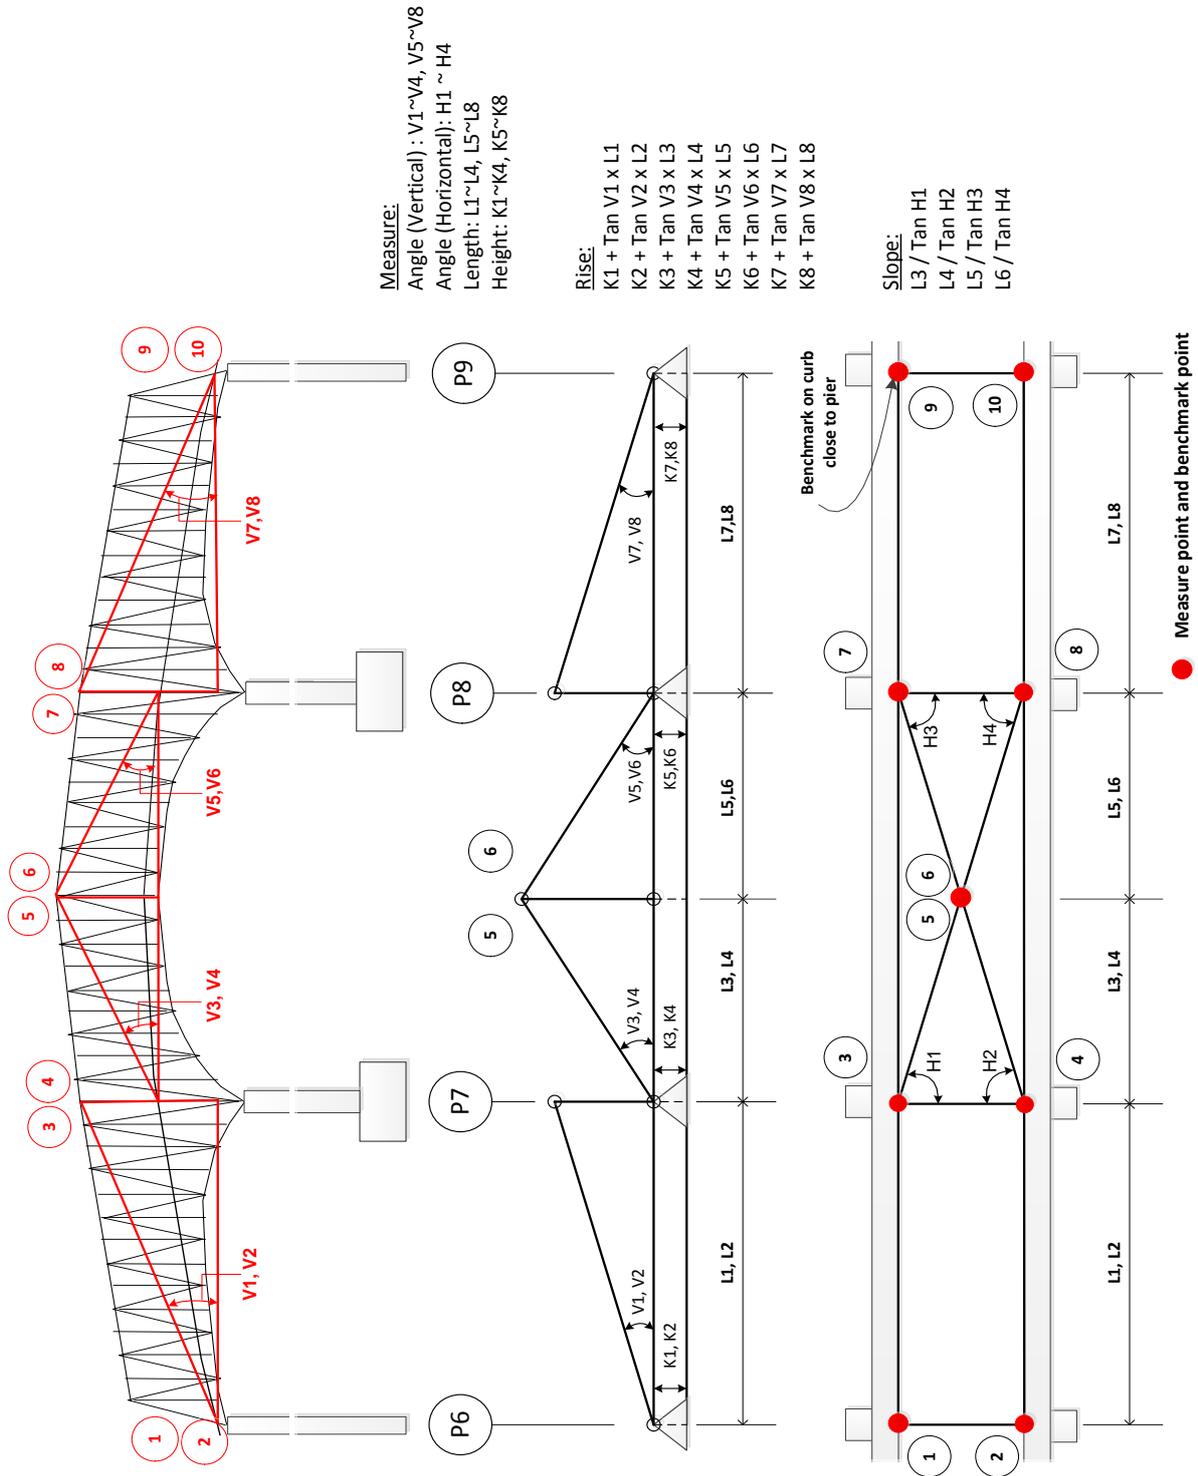
Figure 8-3
Geometrical Inspection of 1st Mandaue-Mactan Bridge:
Slope of Truss Top Chord

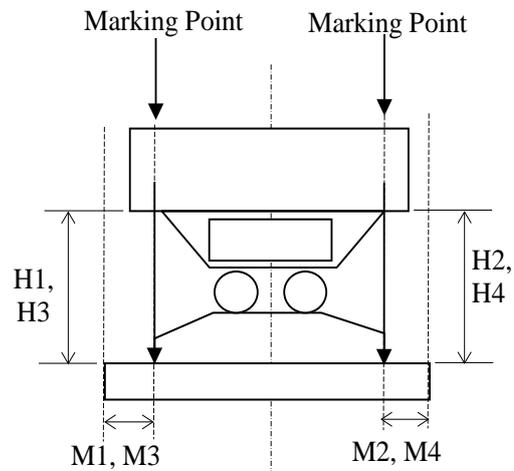
Bearing

Measure every bearing (everytime use same marking point)

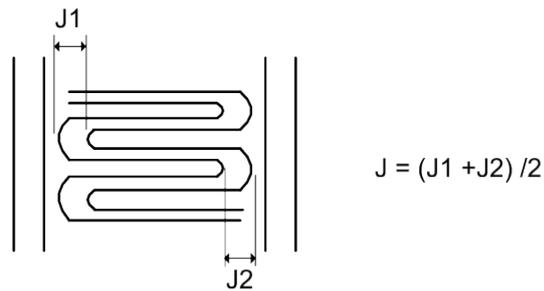
Expansion Joint

Measure 5 selected points in each joint and get the average
(everytime use same points)

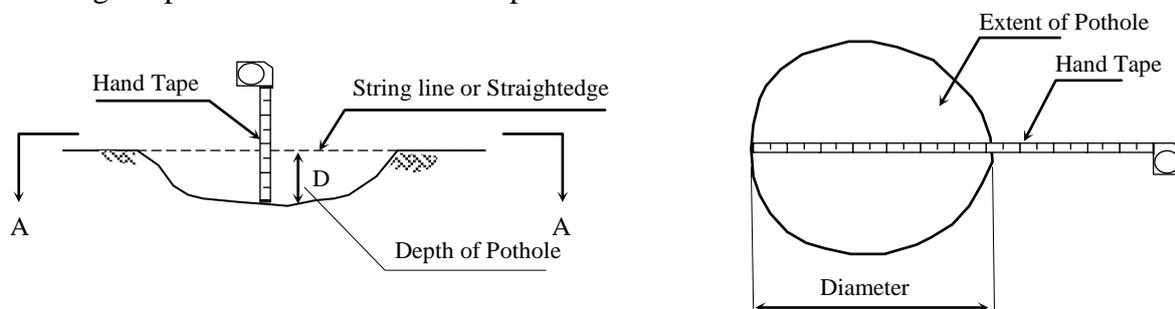
Potholes are bowl-shaped holes in the Asphalt Wearing Surface caused by the penetration of water through the surfacing due to heavy rains and breaking up of the wearing surface due to subsequent traffic action. Asphalt Wearing Surface with defects like alligator cracking and raveling are prone to the occurrence of potholes.

Figure A-1
Method of Measuring Potholes

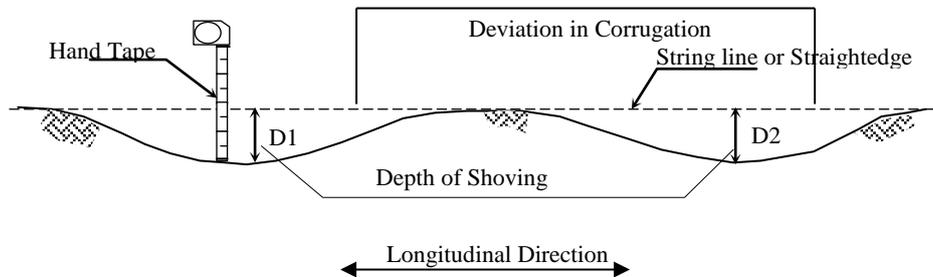
Shoving is defined as the unevenness to the roughness on the carriageway surface along the longitudinal direction of the road. This deformation, as it progresses, will lead to increasingly severe impact loading under traffic, particularly at joints. It is usually the result of the combined effects of traffic and warm weather. Blisters may form in the surfacing during warm weather while traffic normally prevents them from rising.

Figure A-2
Measurement of Shoving Depth and Corrugation

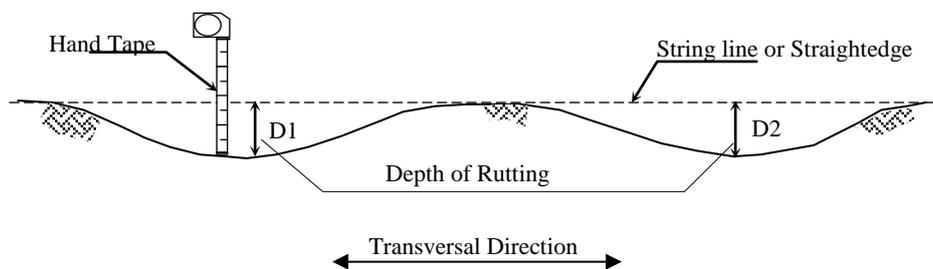
Rutting is defined the unevenness on the carriageway surface in the transverse direction of the road. This deformation is caused by continuous heavy wheel loads passing along the carriageway in the longitudinal direction.

Figure A-3
Measurement of Rutting Depth

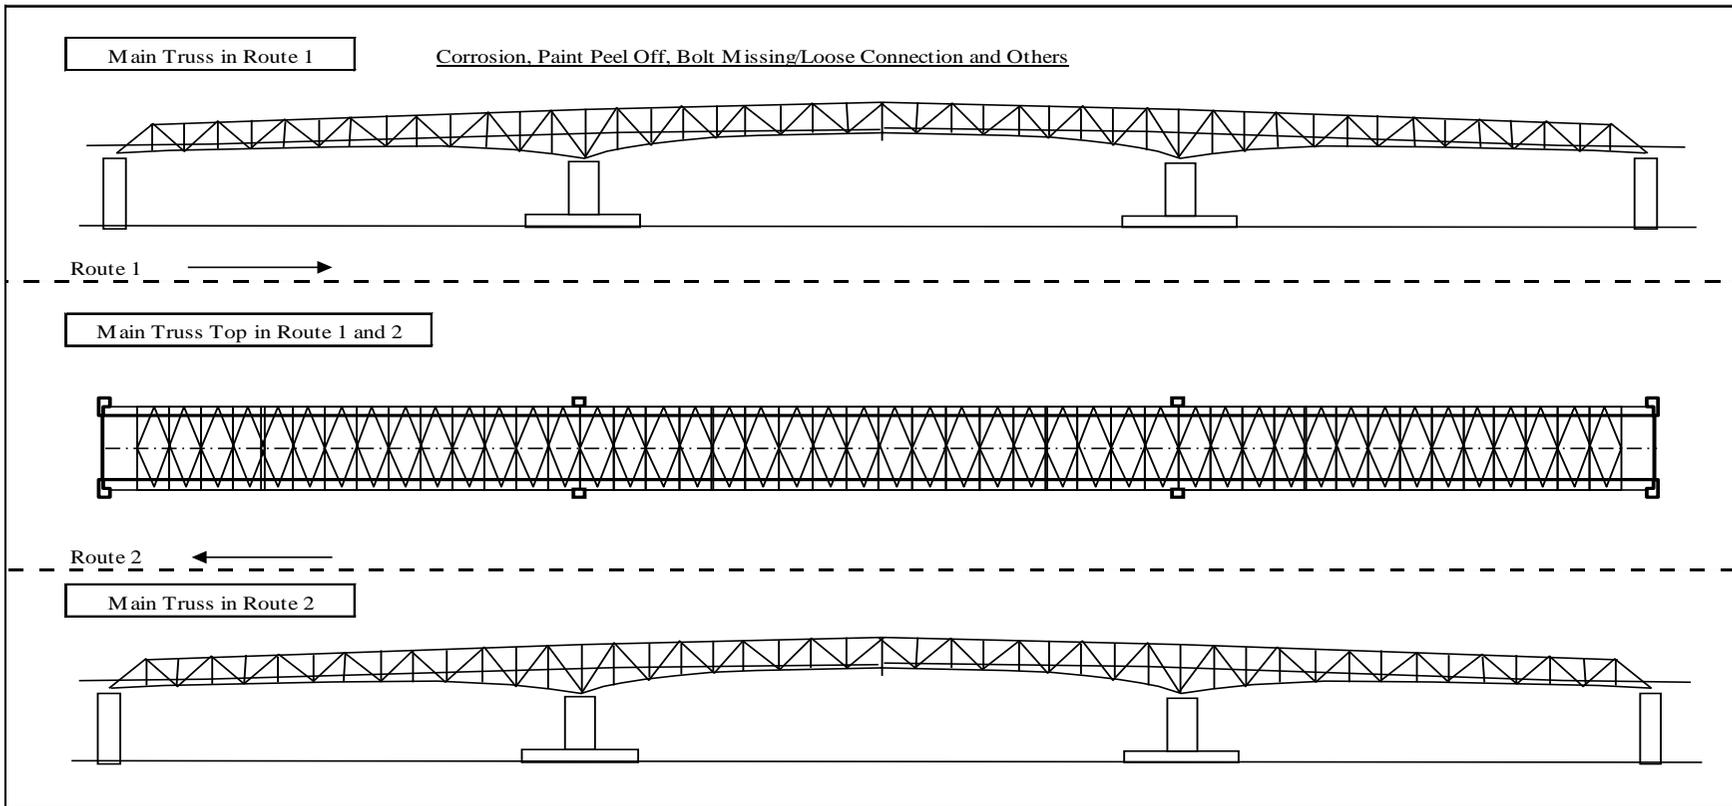
Sketches of Bridge Routine Inspection Findings at Main Bridge as noted from Bridge Roadway Level
1st Mandaue-Mactan Bridge
