**IMPROVEMENT OF QUALITY MANAGEMENT FOR
HIGHWAY AND BRIDGE CONSTRUCTION AND
MAINTENANCE, PHASE II**

**BRIDGE INSPECTION MANUAL
FOR
STEEL TRUSS BRIDGE
(SPECIAL BRIDGE)**

Department of Public Works and Highways
Japan International Cooperation Agency

SEPTEMBER 2014

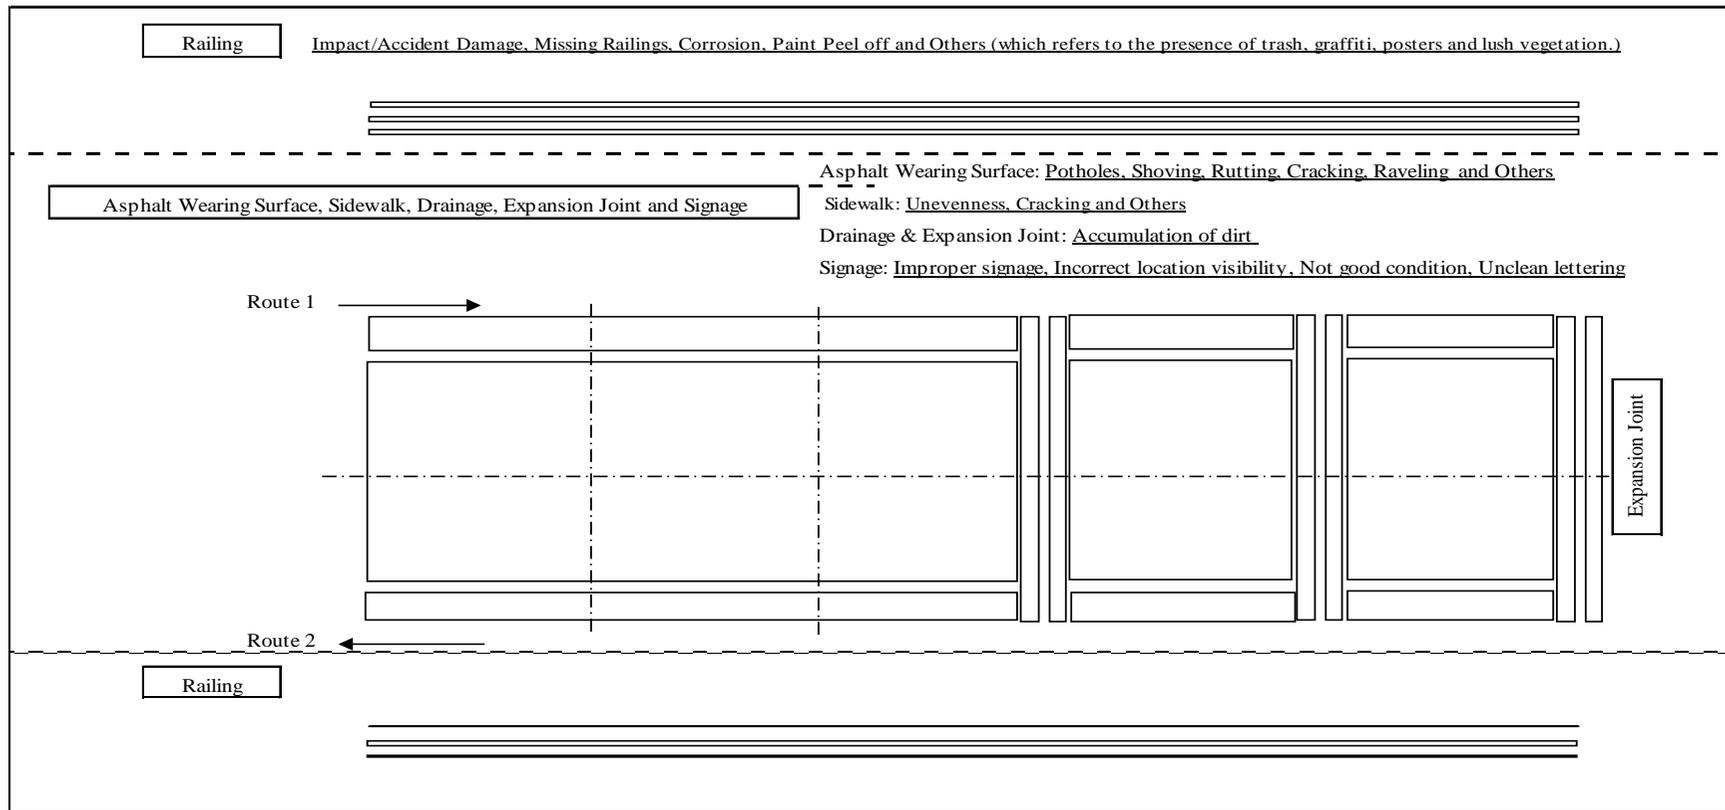
Sketches of Bridge Routine Inspection Findings at Mactan side Viaduct P9-A2 from Bridge Roadway Level
1st Mandaue-Mactan Bridge

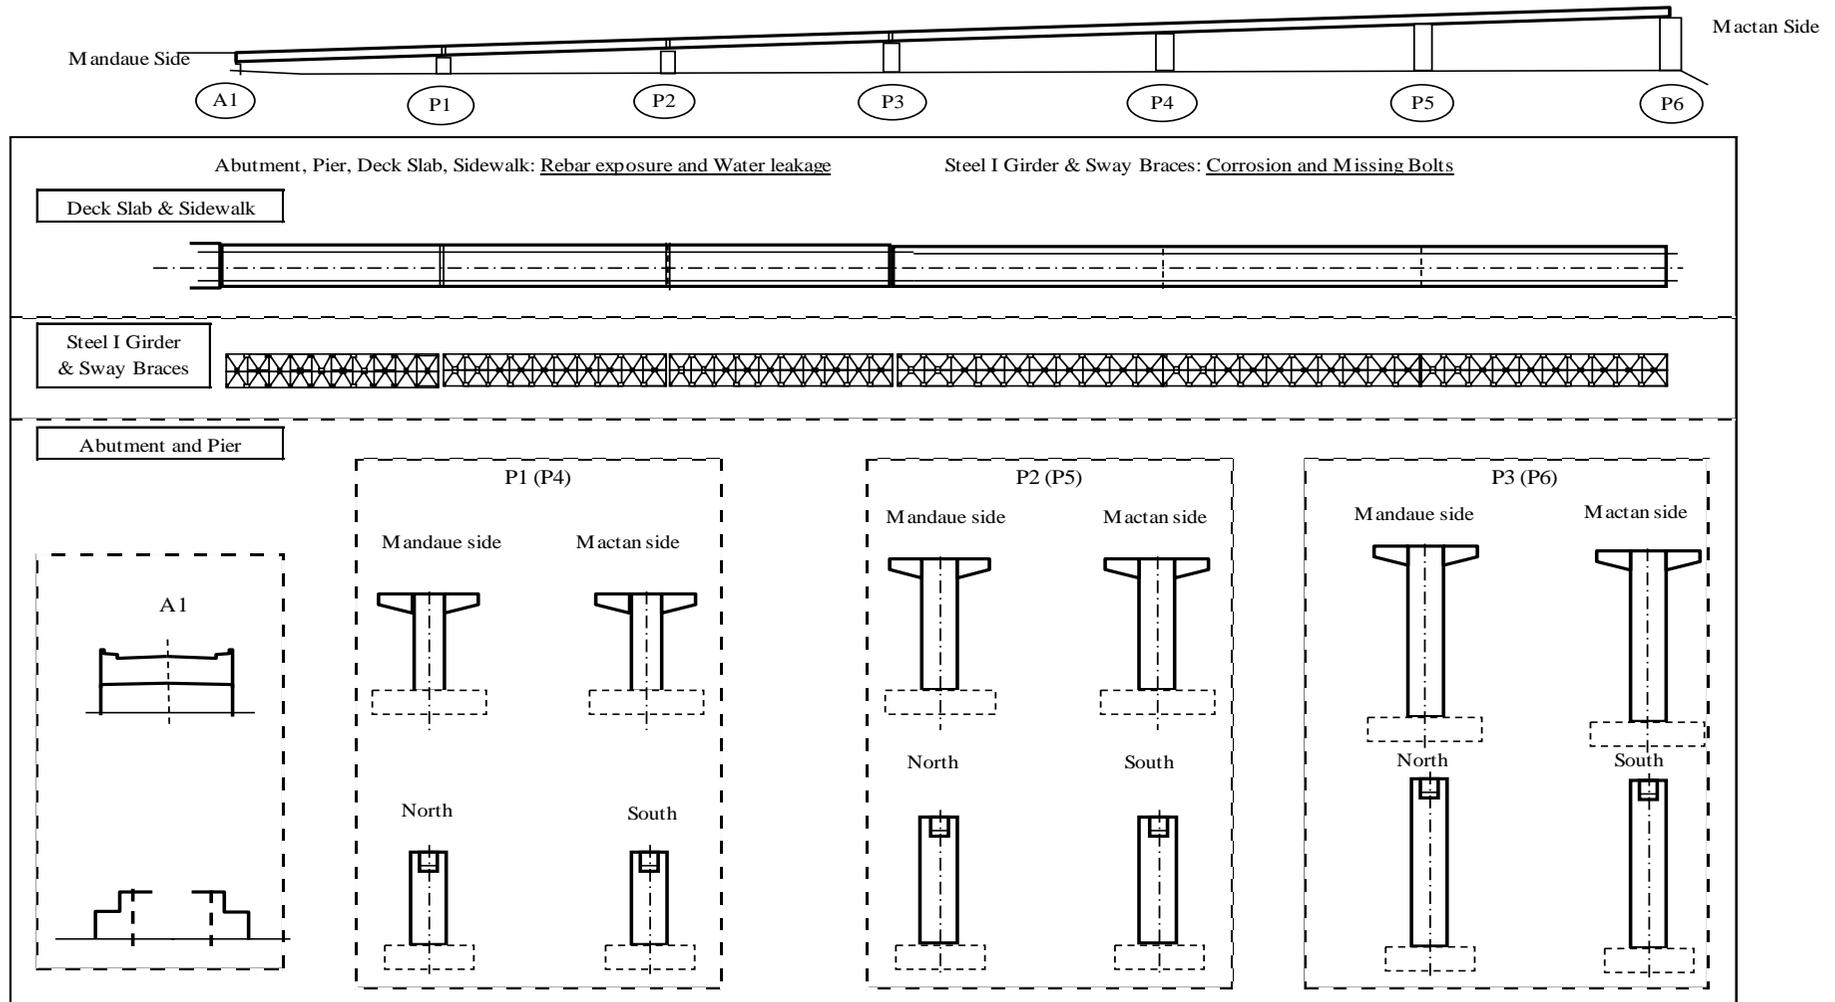
**Sketches of Bridge Routine Inspection Findings at Mandaue side Viaduct A1-P6 as noted from Ground Level under the Bridge
1st Mandaue-Mactan Bridge**

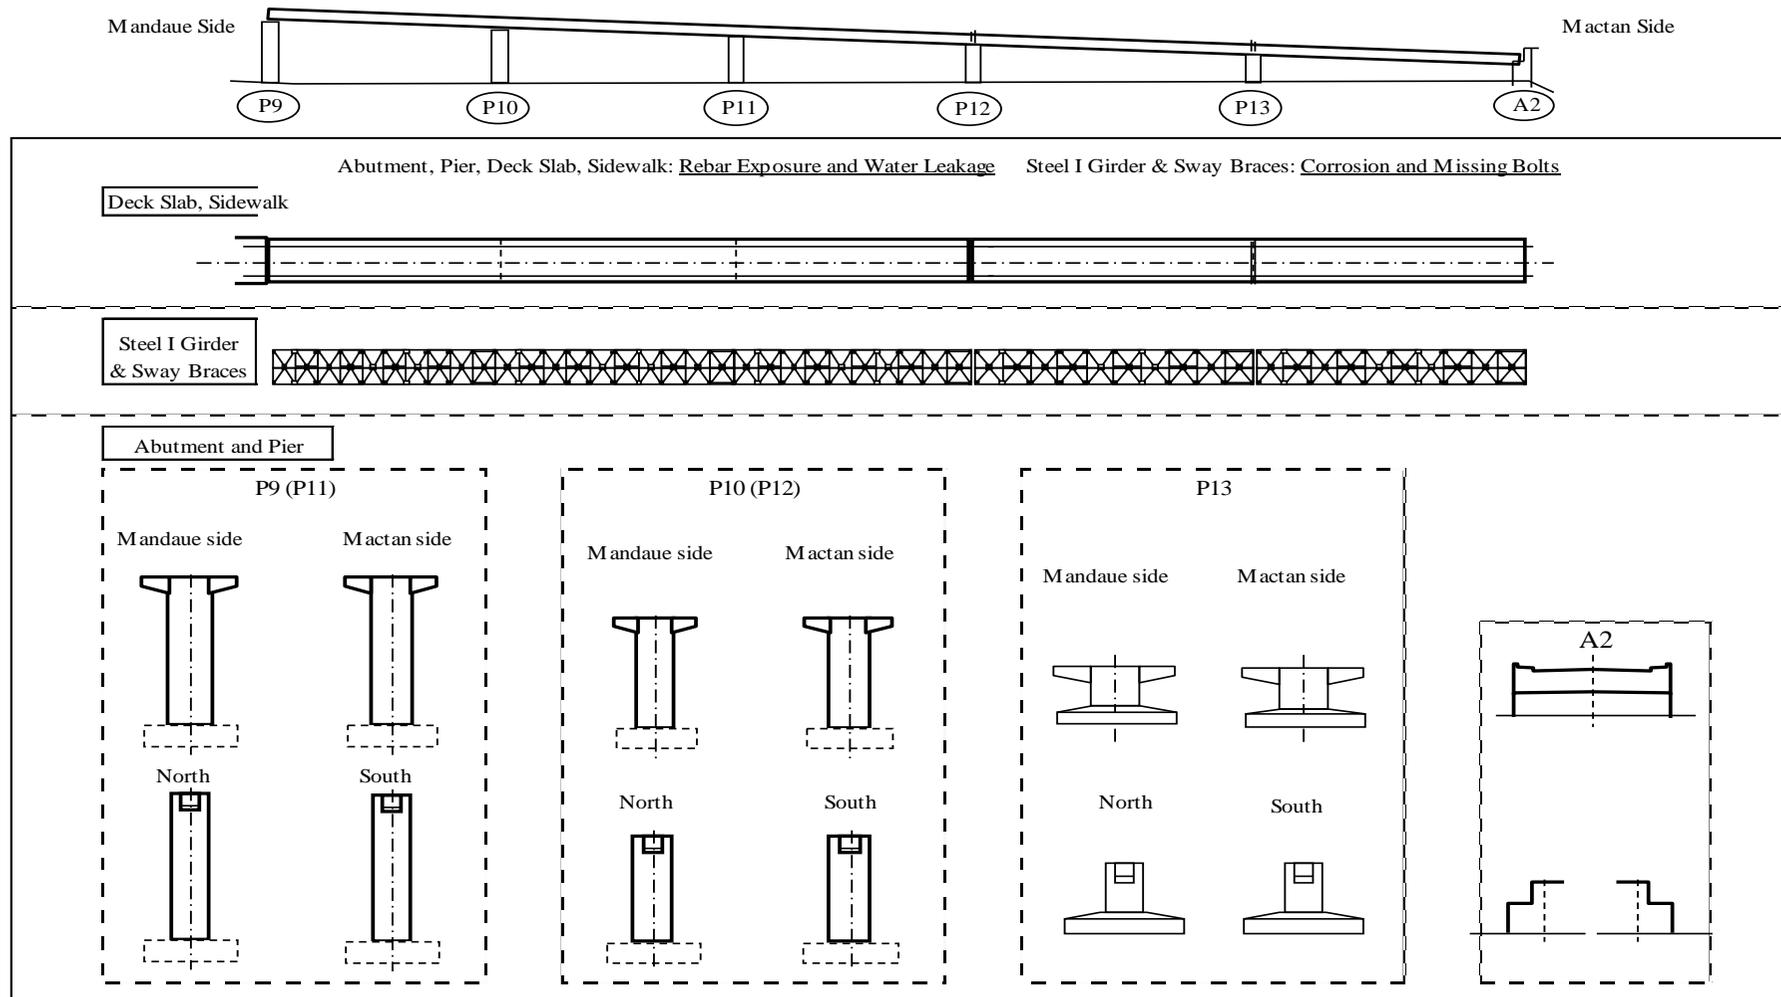
**Sketches of Bridge Routine Inspection Findings at Mactan side Viaduct P9-A2 from Ground Level under the Bridge
1st Mandaue-Mactan Bridge**

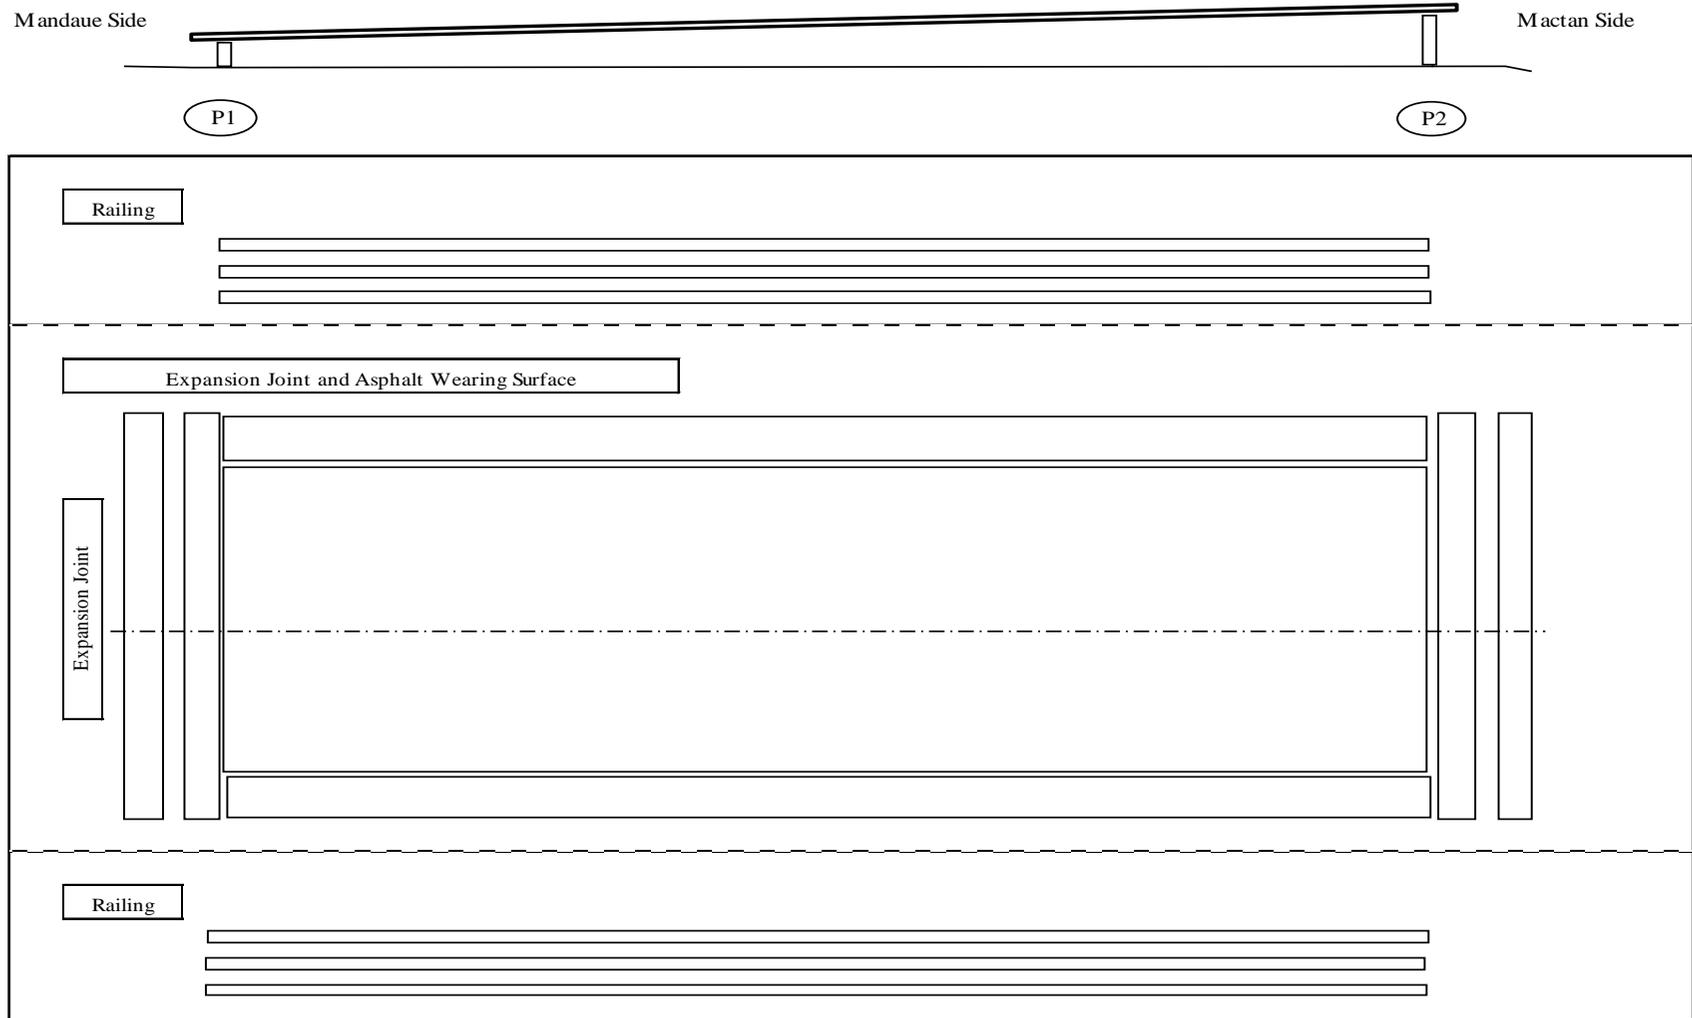
Sketches of Bridge Condition Inspection Findings at Mandaue side Viaduct P1-P2 as Observed from Bridge Roadway Level
1st Mandaue-Mactan Bridge

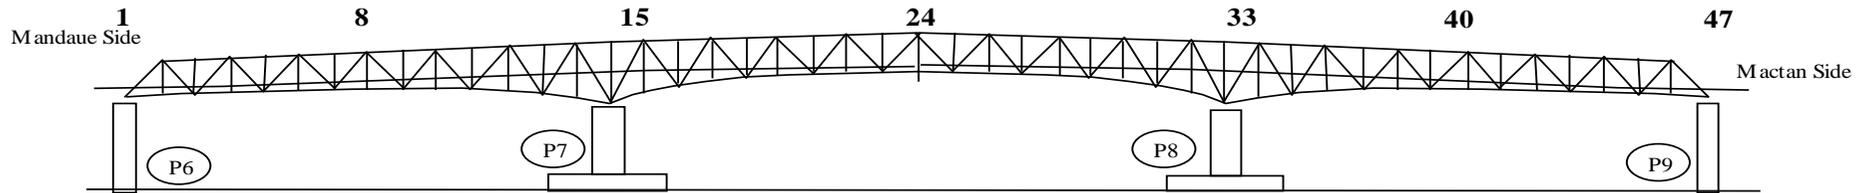
Sketches of Bridge Condition Inspection Findings at Main Bridge as Observed from Bridge Roadway Level
1st Mandaue-Mactan Bridge

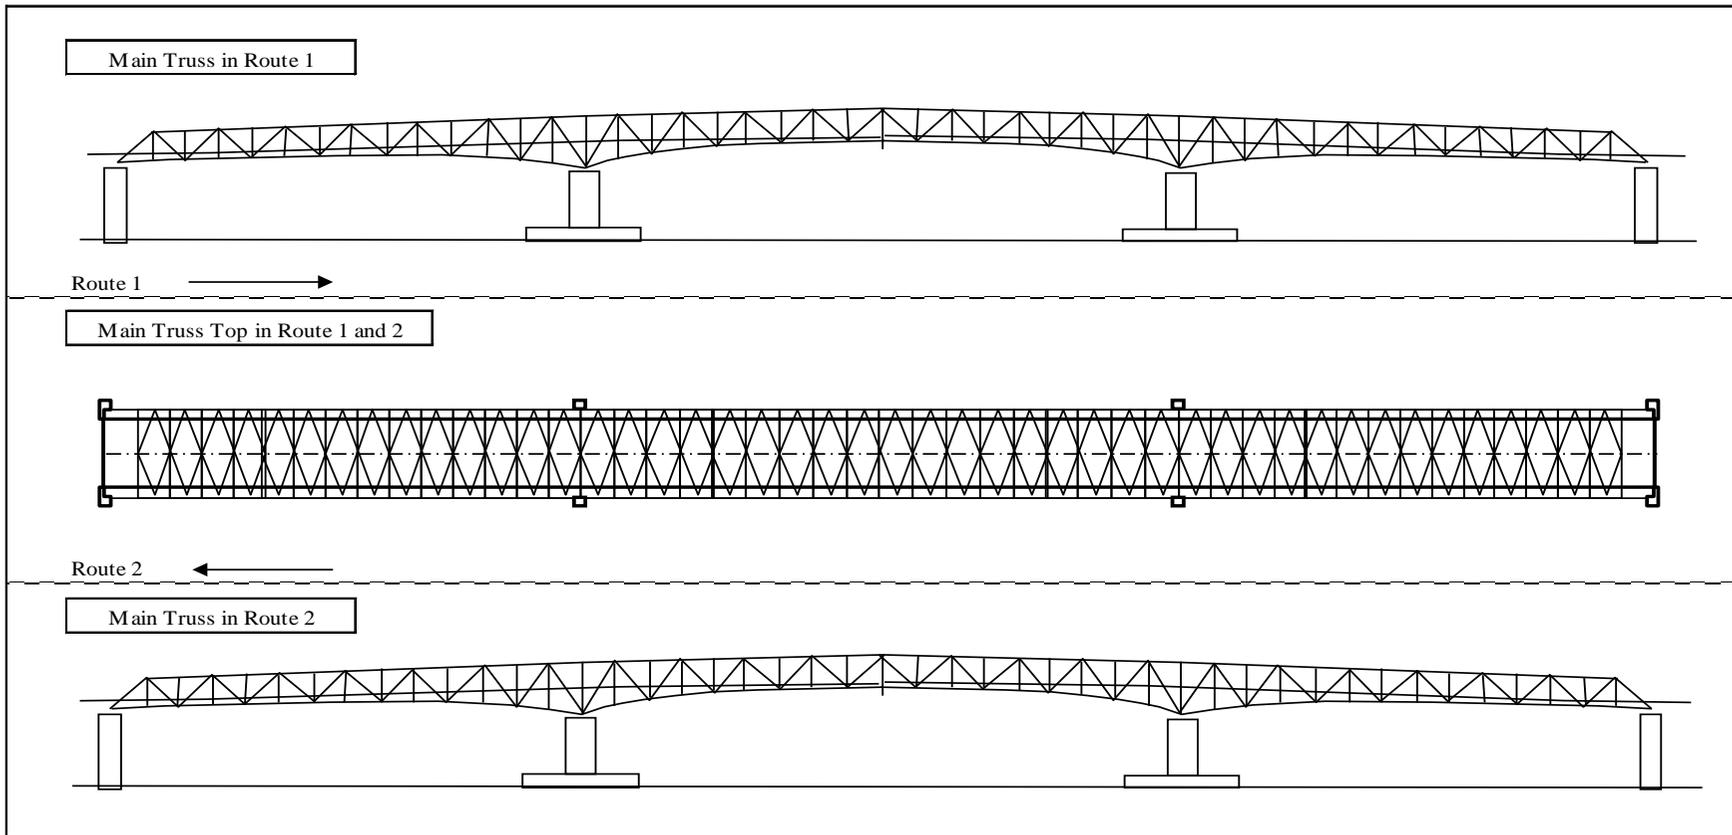
Sketches of Bridge Condition Inspection Findings at Main Bridge as Observed from Bridge Roadway Level
1st Mandaue-Mactan Bridge

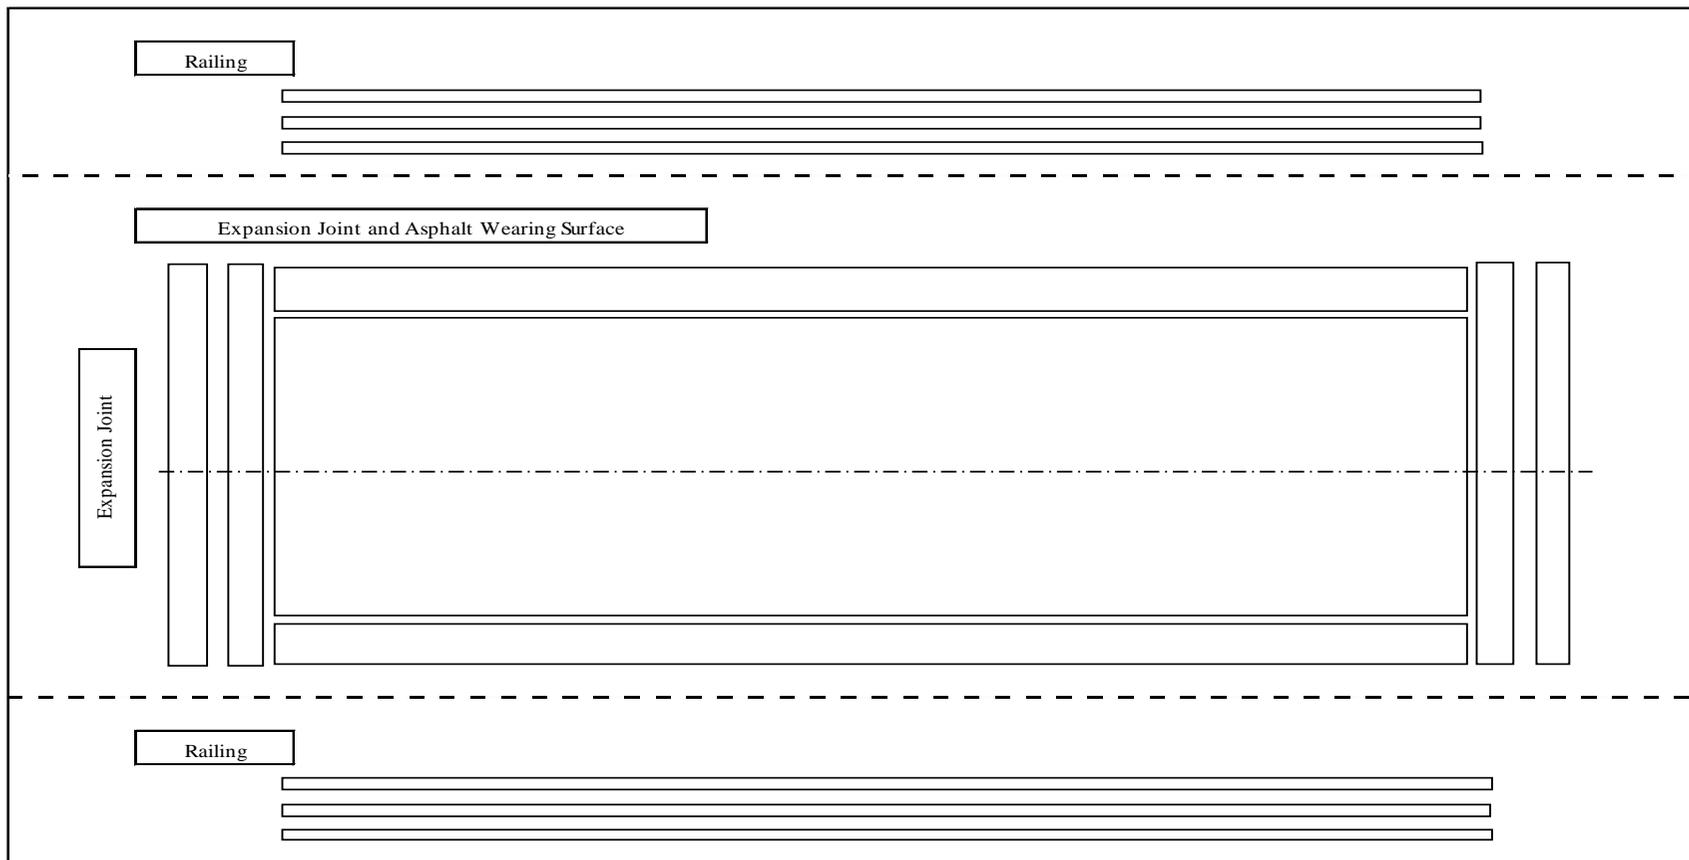
**Sketches of Bridge Condition Inspection Findings at Mactan side Viaduct P12-P13 as Observed from Bridge Roadway Level
1st Mandaue-Mactan Bridge**

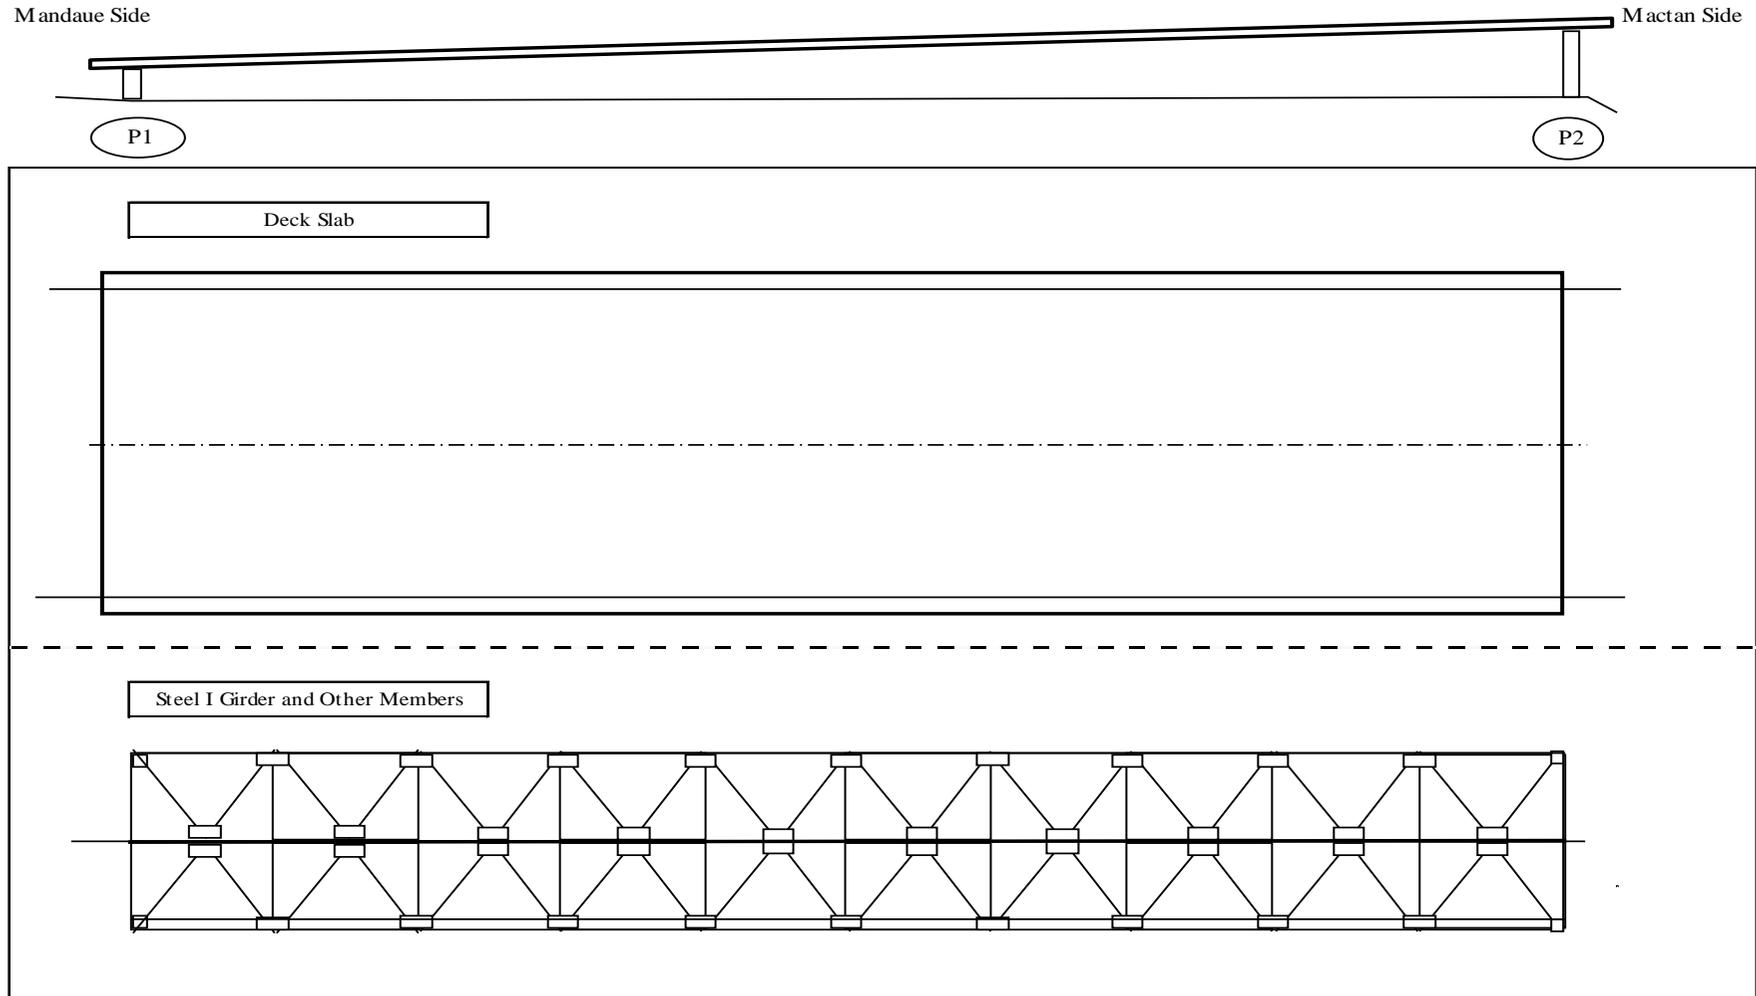
**Sketches of Bridge Condition Inspection Findings at Mandaue side Viaduct P1-P2 for Deck Slab, Girders and Other Members
as noted from Ground Level under the Bridge
1st Mandaue-Mactan Bridge**

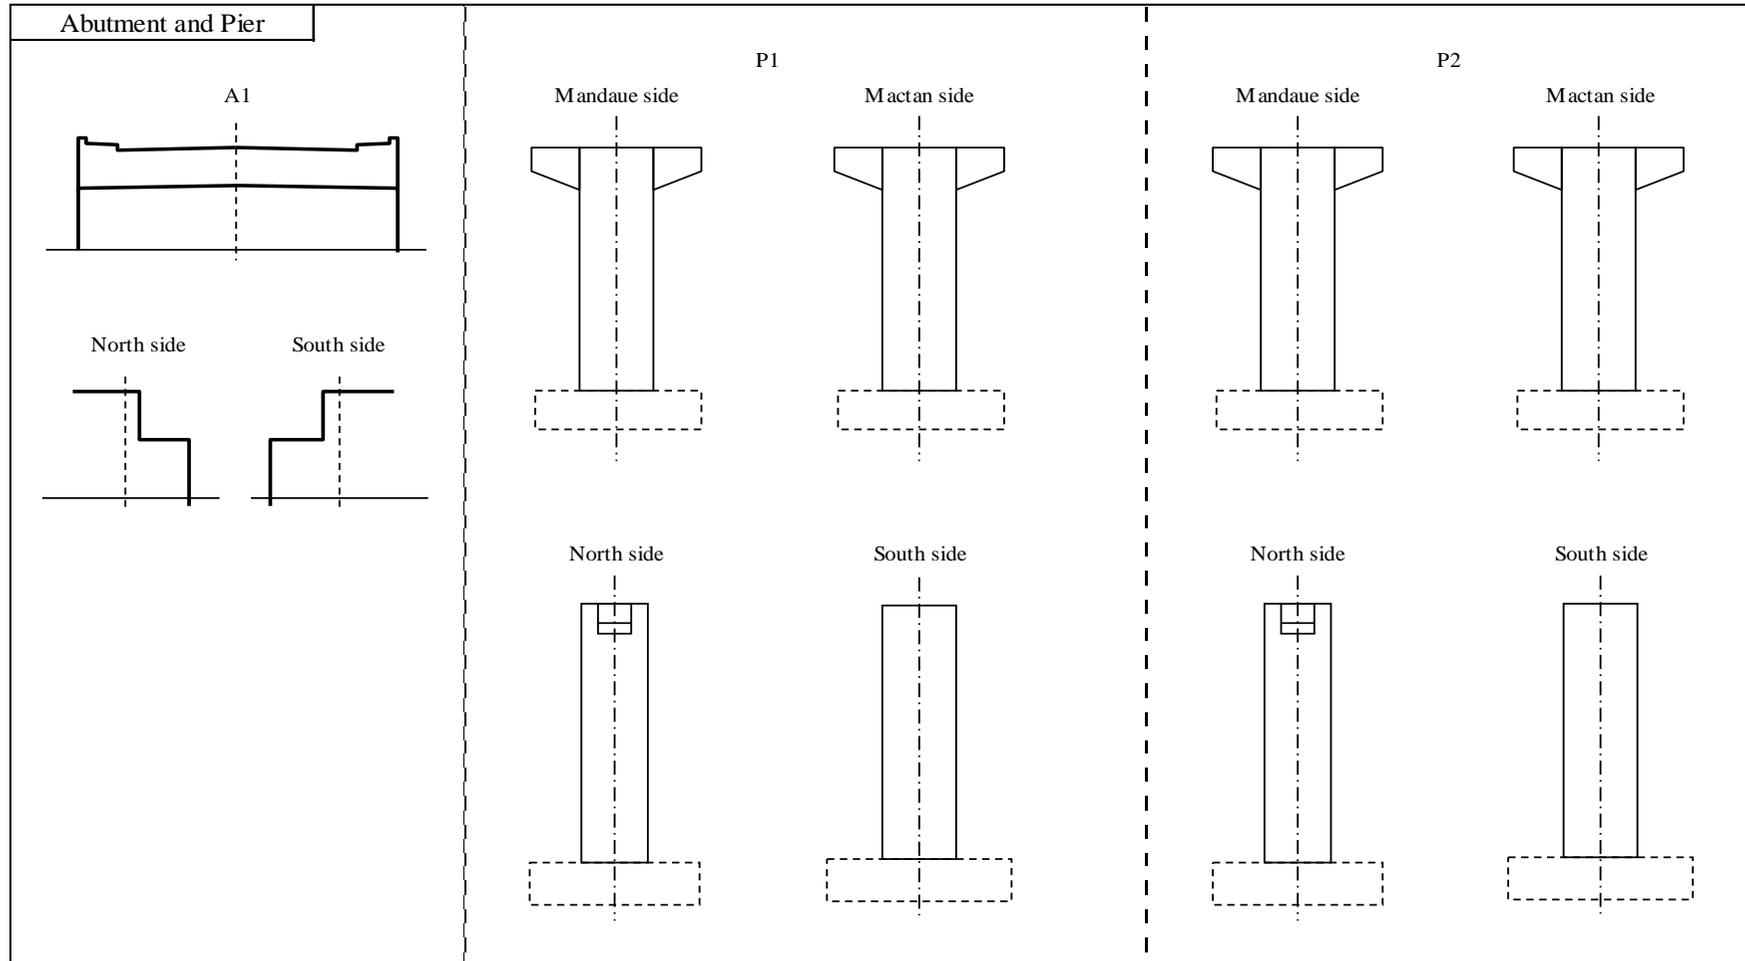
Sketches of Bridge Condition Inspection Findings at Mandaue side Viaduct for A1, P1, P2 as Observed from Ground Level under the Bridge
1st Mandaue-Mactan Bridge

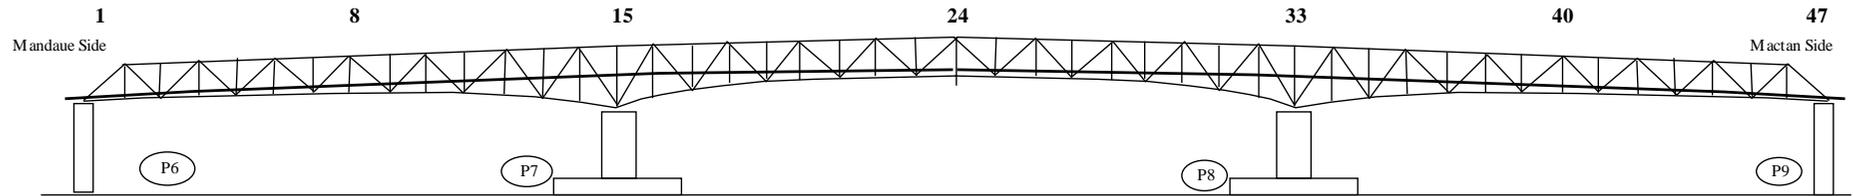
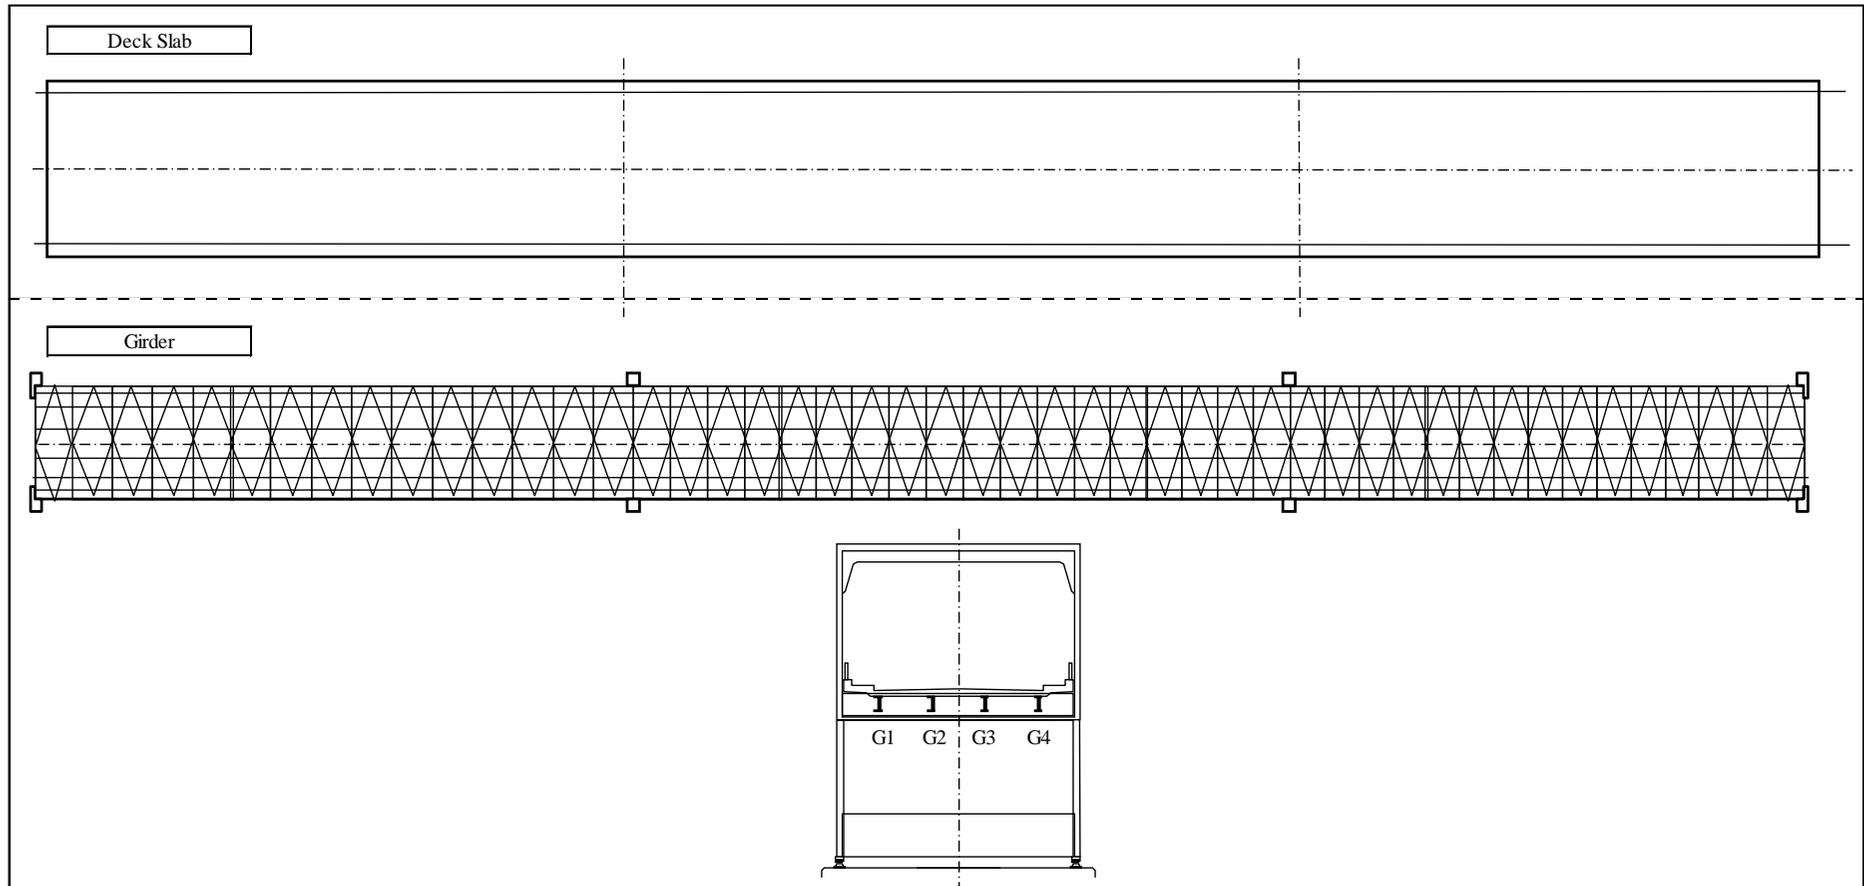
Sketches of Bridge Condition Inspection Findings at Main Bridge P6-P9 as Observed from Boat under the Bridge
1st Mandaue-Mactan Bridge

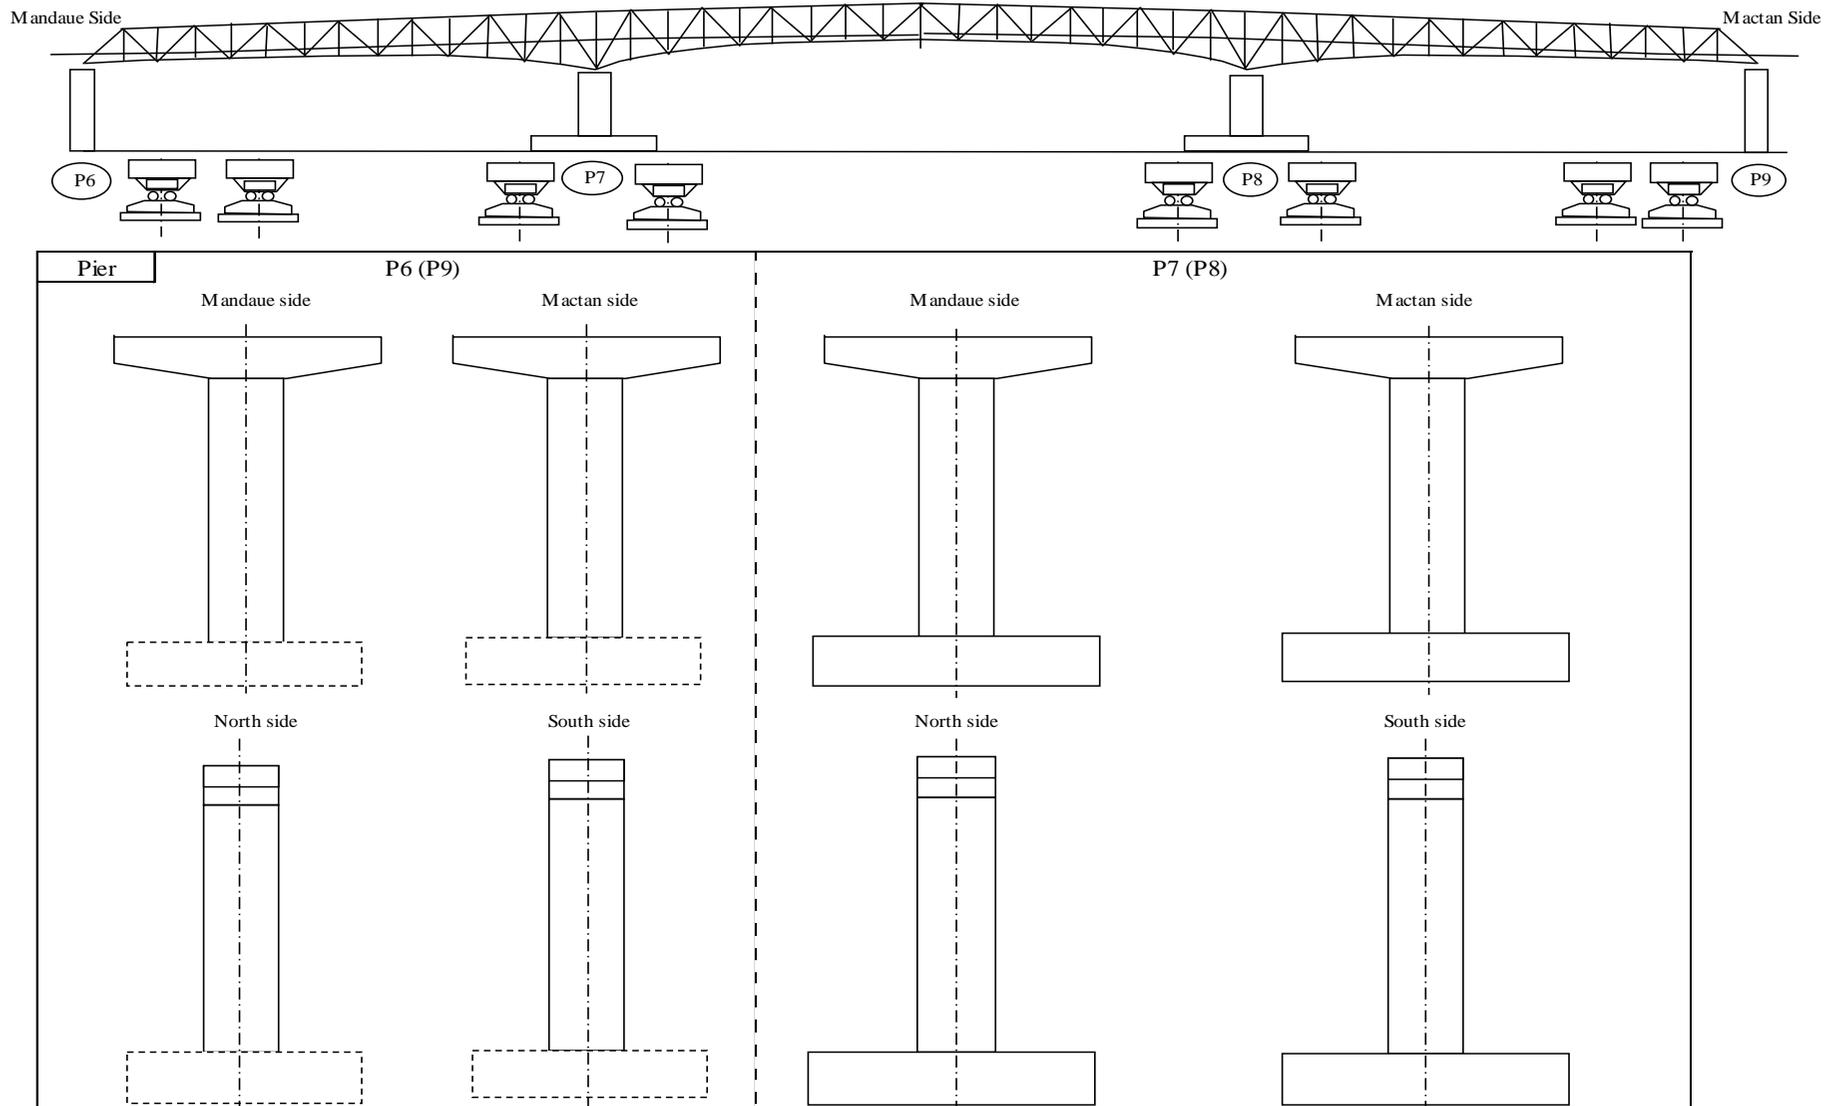
Sketches of Bridge Condition Inspection Findings at Main Bridge P6-P9 as Observed from Boat under the Bridge
1st Mandaue-Mactan Bridge

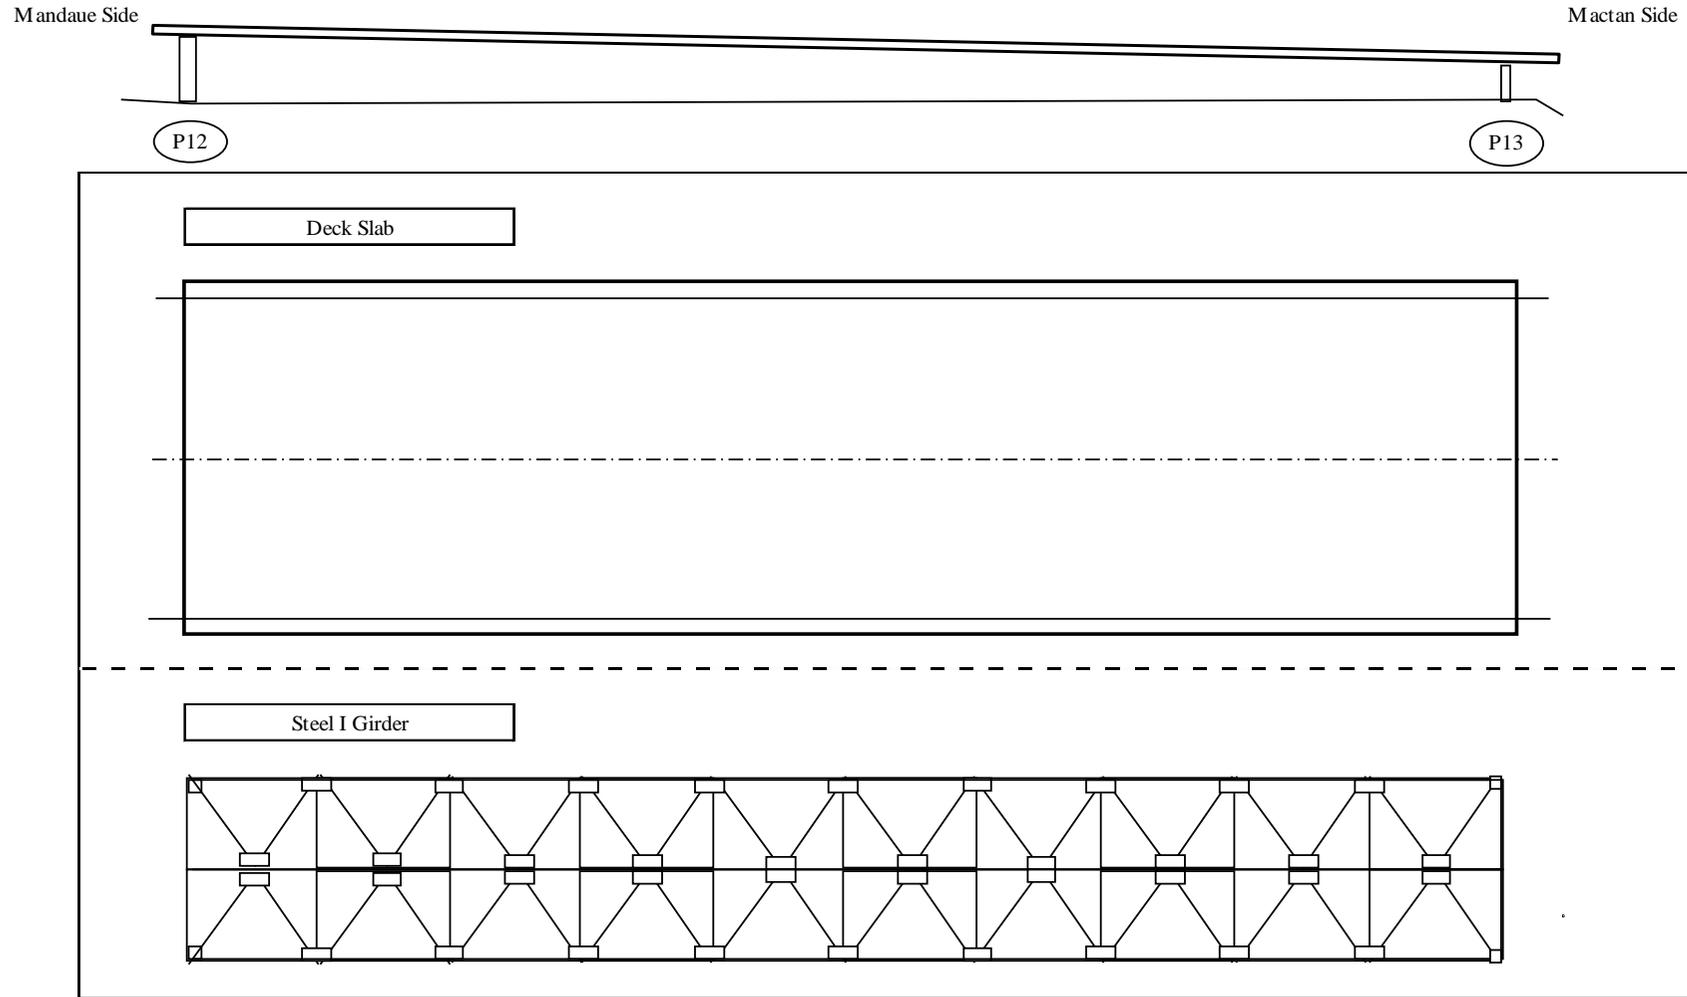
Sketches of Bridge Condition Inspection Findings at Mactan side Viaduct P12-P13 for Deck Slab, Girders and Other Members
as noted from Ground Level under the Bridge
1st Mandaue-Mactan Bridge

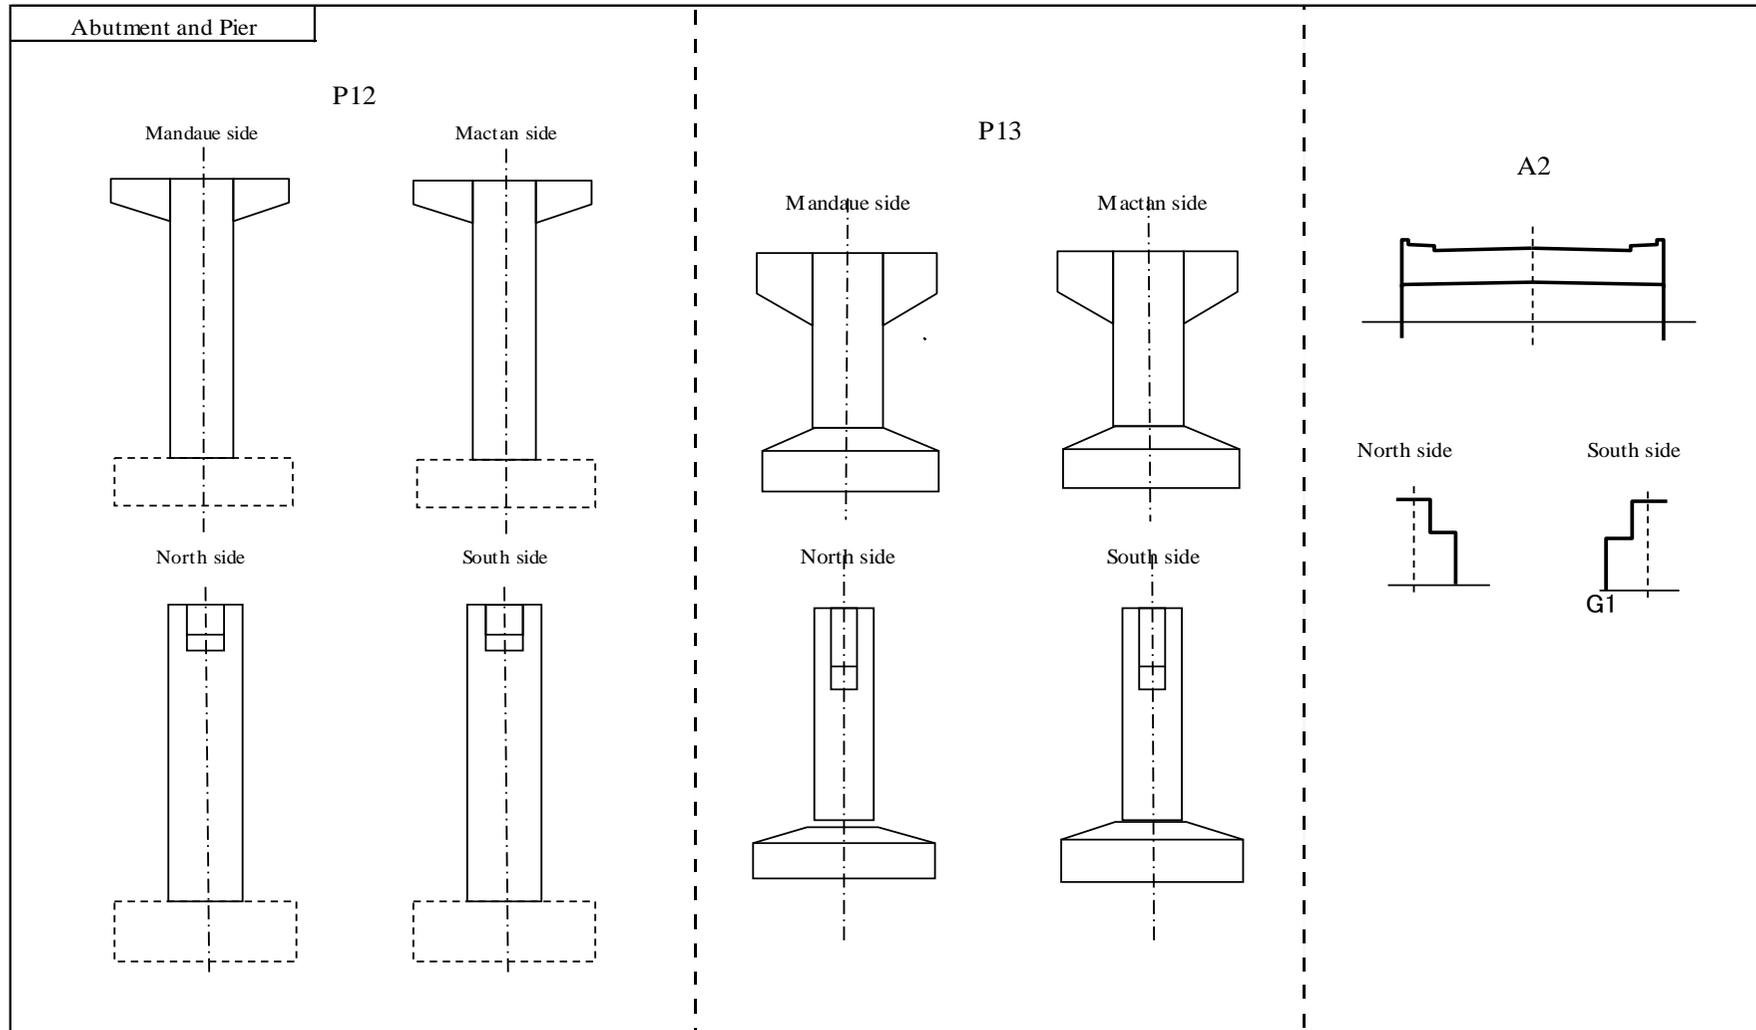
**Sketches of Bridge Condition Inspection Findings at Mandaue side Viaduct for A2, P12, P13 as Observed from Ground Level under the Bridge
 1st Mandaue-Mactan Bridge**

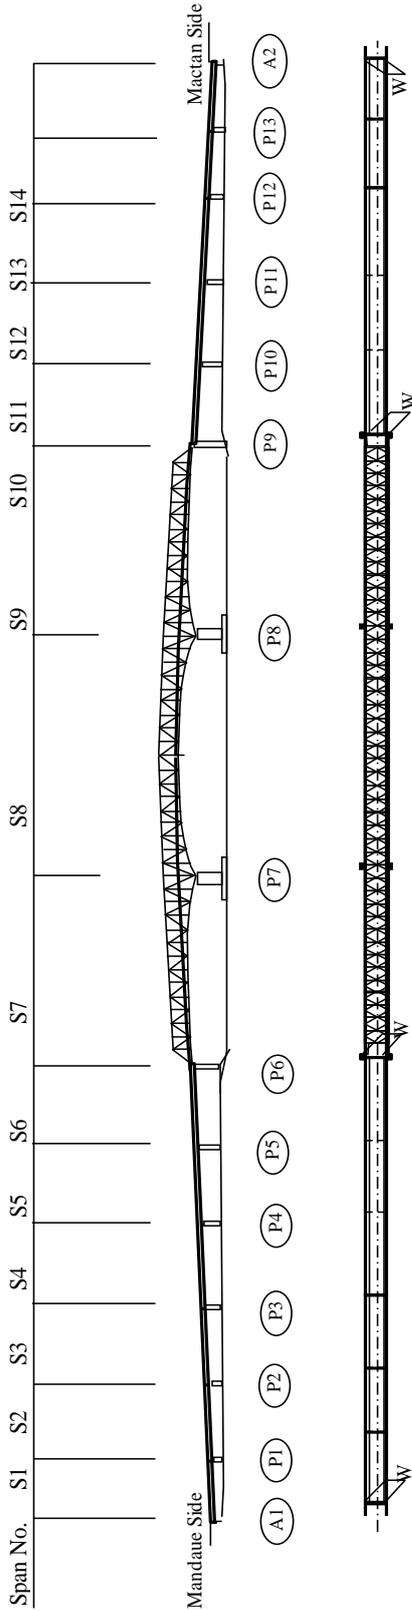
1st Mandaue-Mactan Bridge - General View

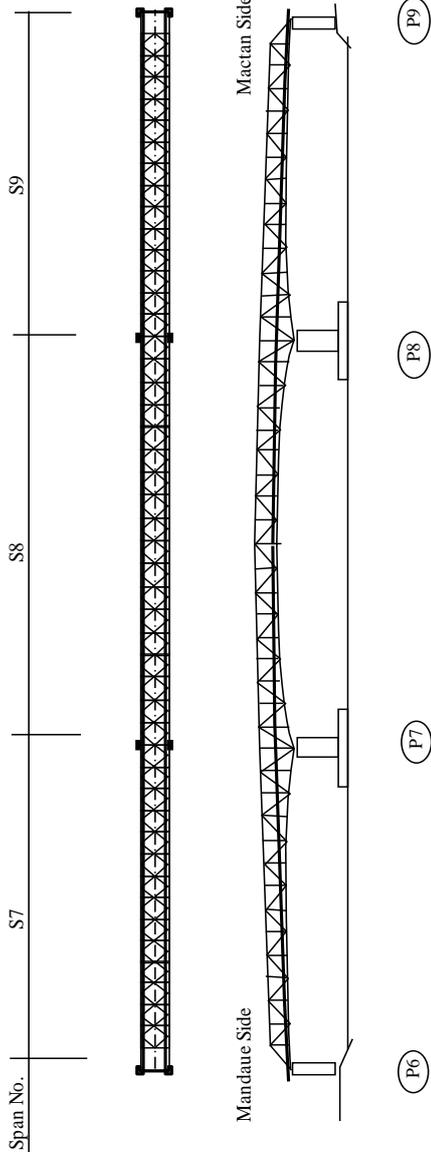
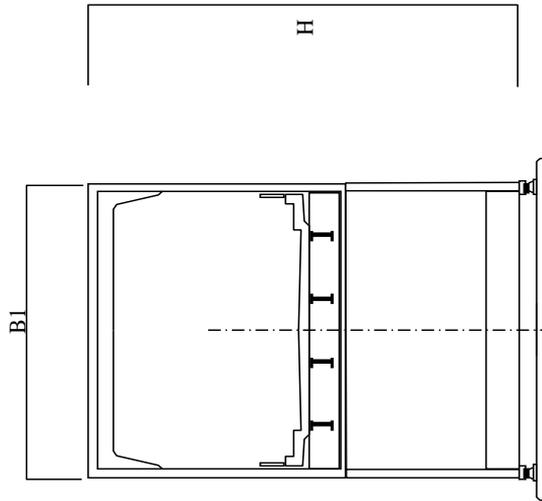
1st Mandaue-Mactan Bridge Superstructure Main Bridge
