**IMPROVEMENT OF QUALITY MANAGEMENT FOR
HIGHWAY AND BRIDGE CONSTRUCTION AND
MAINTENANCE, PHASE II**

**BRIDGE INSPECTION MANUAL
FOR
STEEL TRUSS BRIDGE
(SPECIAL BRIDGE)**

Department of Public Works and Highways
Japan International Cooperation Agency

SEPTEMBER 2014

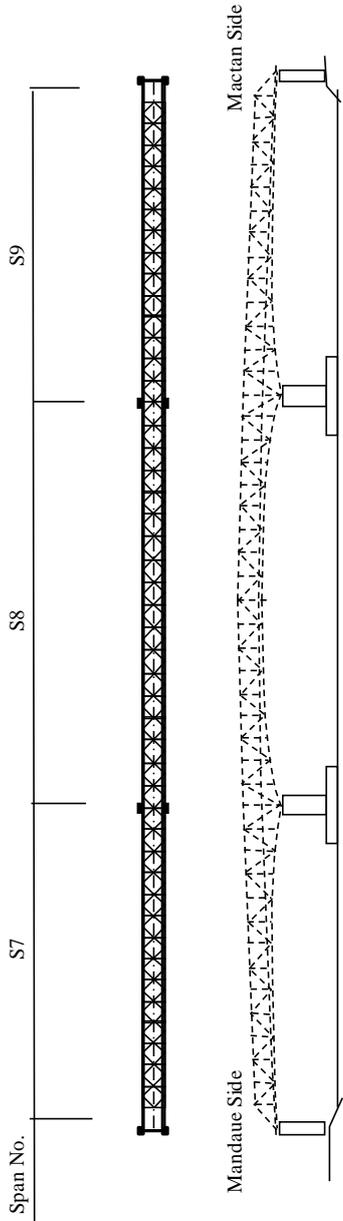
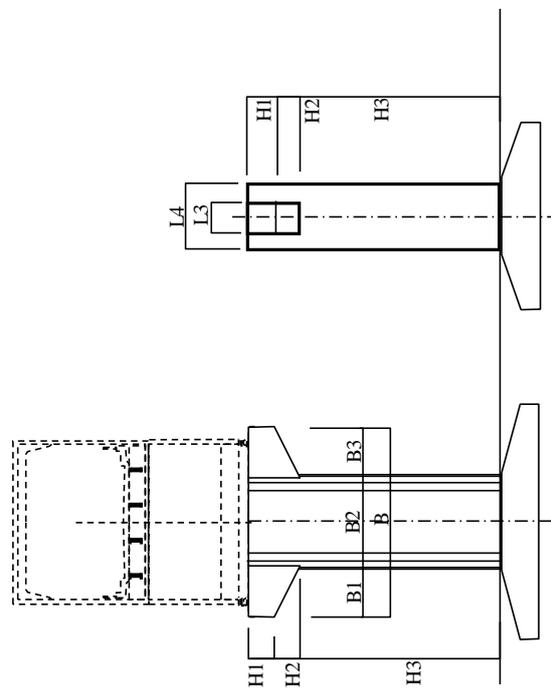
1st Mandaue-Mactan Bridge - Substructure Main Bridge

- (P6)
- (P7)
- (P8)
- (P9)

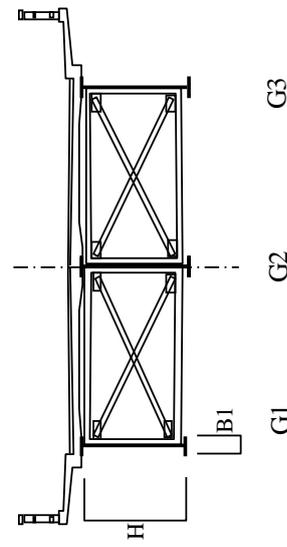
1st Mandaue-Mactan Bridge - Superstructure of Mandaue side Viaduct

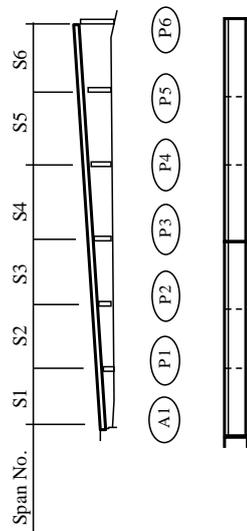
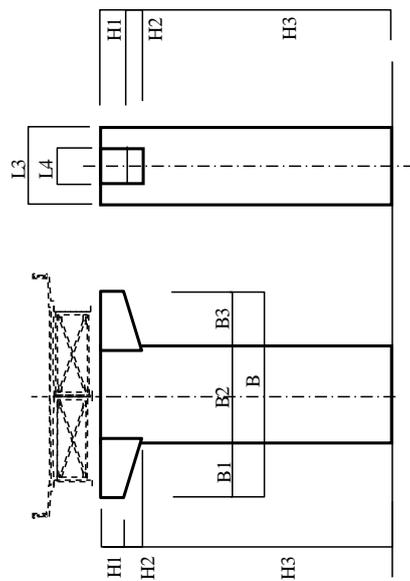
1st Mandaue-Mactan Bridge - Substructure of Mandaue side Viaduct

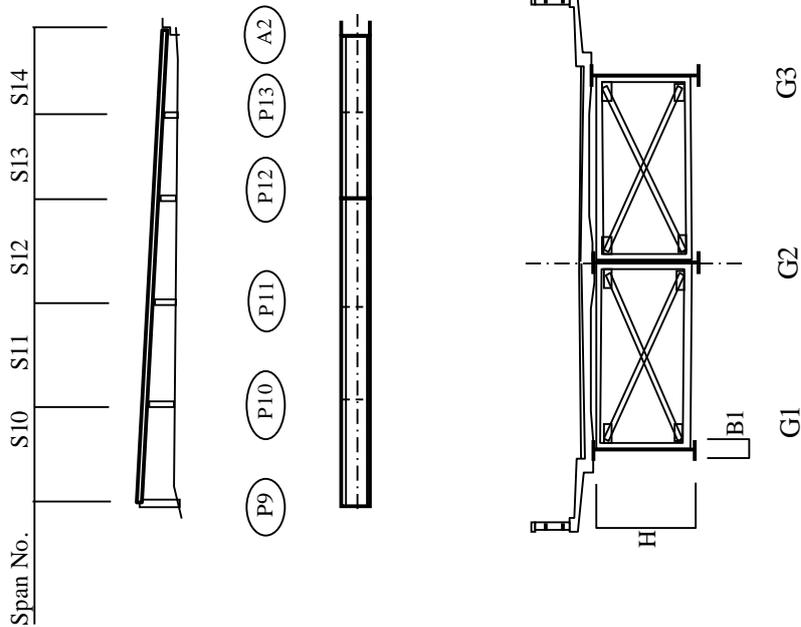
1st Mandaue-Mactan Bridge - Superstructure of Mactan side Viaduct

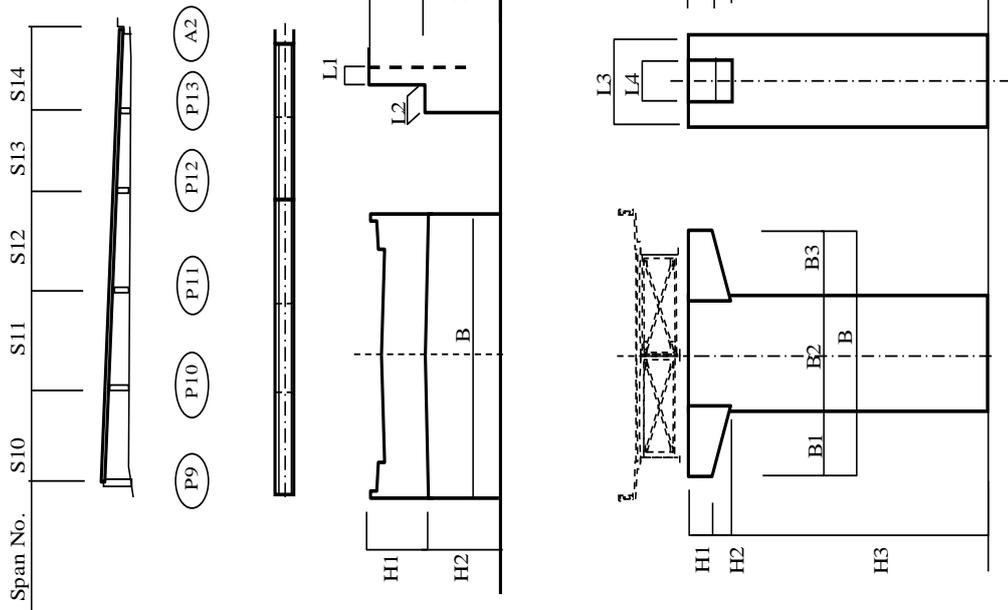
1st Mandaue-Mactan Bridge - Substructure of Mactan side Viaduct

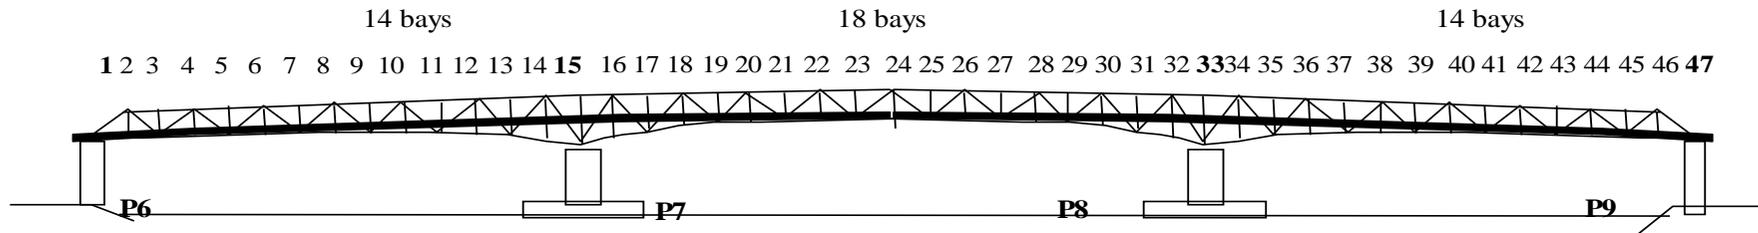
Numbering of Truss is marked on the Vertical Members only.

**NUMBERING OF TRUSS, PIER
AND ABUTMENT**

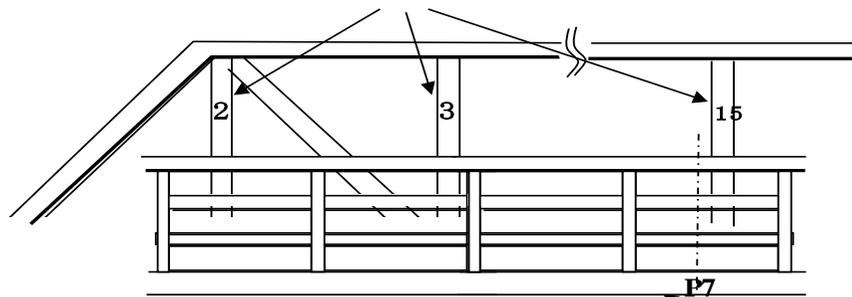
Numbering of Pier is marked along the curb of the sidewalk.

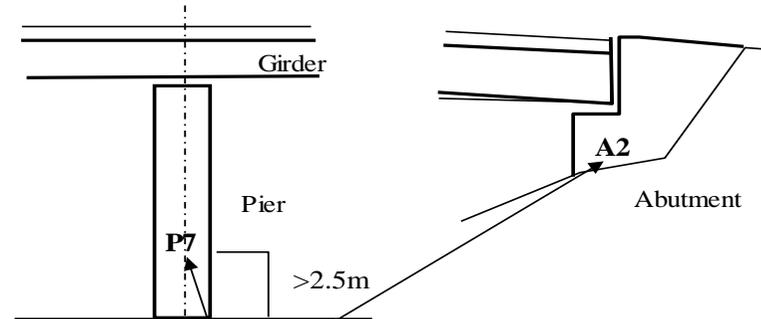
Numbering of Pier and Abutment is marked on the side of the substructures.

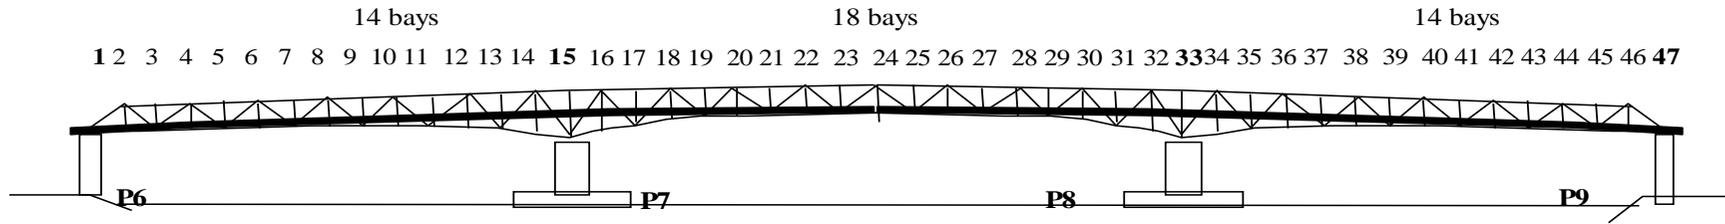
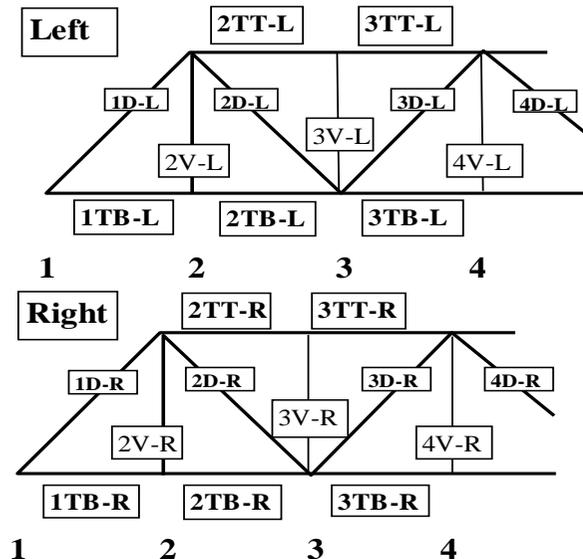
Note: The numbering of truss members indicated herein need not to be marked on the member itself. These numberings and the sequence it is arranged serve as guide in identifying each member during any type of inspection that will be undertaken on the bridge.

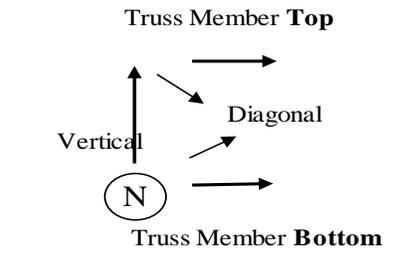
Sec./No. Member
 N- V:Vertical-L,R
 TT:Truss Top-L,R
 TB:Truss Bottom-L,R
 D: Diagonal-L,R
 N=1--47

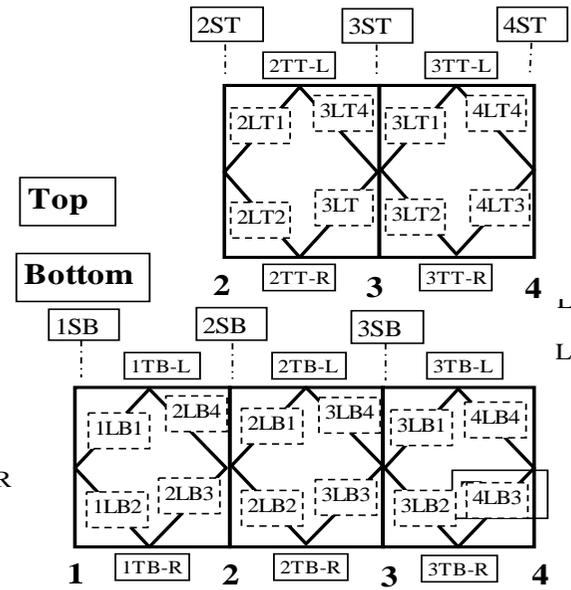
Sec./No. Member
 N- S:Strut - Top,Bottom
 L:Lateral-Top,Bottom
 -1,2,3,4

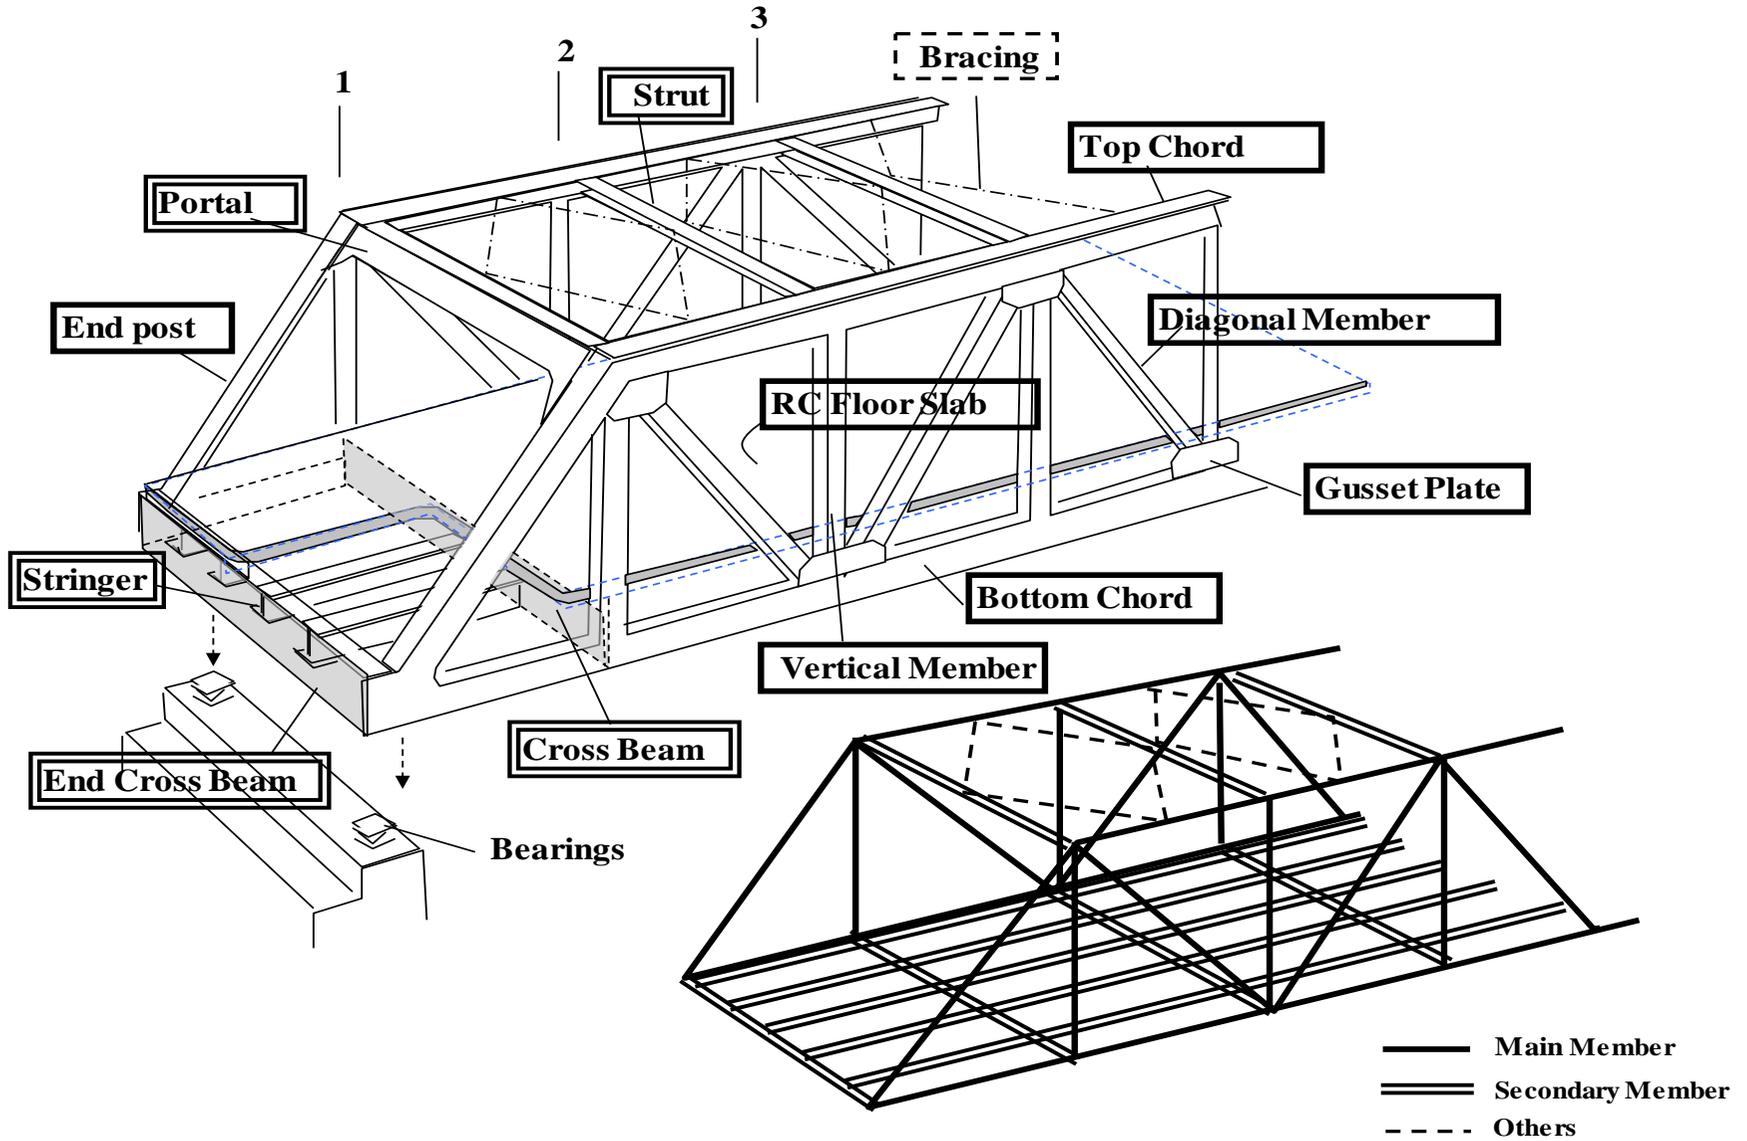
Numbering of Truss Member of Mandaue-Mactan Bridge

Identification of Truss Members (1st Mactan-Mandaue Bridge)
