**IMPROVEMENT OF QUALITY MANAGEMENT FOR
HIGHWAY AND BRIDGE CONSTRUCTION AND
MAINTENANCE, PHASE II**

**BRIDGE INSPECTION MANUAL
FOR
PRESTRESSED CONCRETE (PC)
EXTRADOSSED BRIDGE

(SPECIAL BRIDGE)**

2014

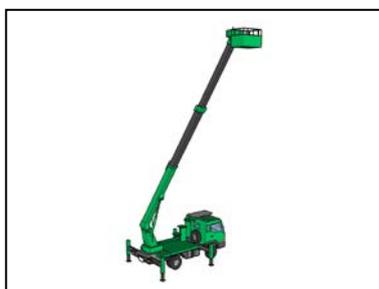
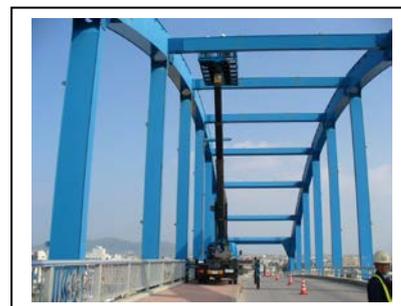
Figure 4-9
Photos of Bucket Type BIV

Generally two types of BIV are used in the inspection of bridges. One type is bucket type BIV which is also called Aerial Work Platform. This type of BIV is widely used for maintenance and construction of bridge and also for power and telecommunications industries. They can lift inspectors up to high level to inspect tower, cable band chord and etc. Figure 4-9 shows the picture of the Bucket Type BIV.

When BIV is used, a designated vehicle operator should accompany the inspection and operate the vehicle. Inspectors should be tied to the bucket by safety belt during lifting.

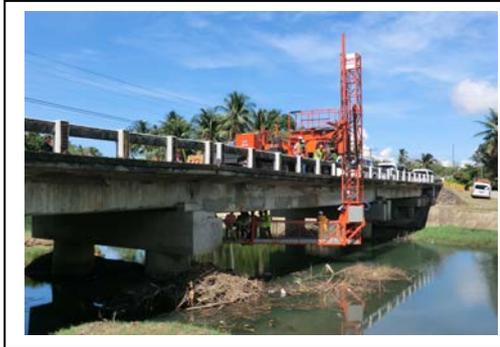
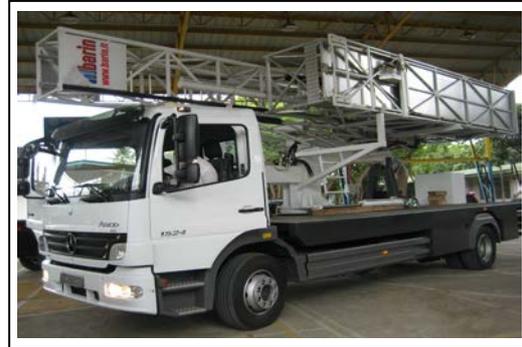
Figure 4-10
Photos of Telescoping Articulated Platform Type BIV

Another type is a telescoping articulated platform. It can carry inspector underneath the bridge to check girders, bottom of slab, etc. Figure 4-10 show pictures of telescoping articulated platform type BIV.

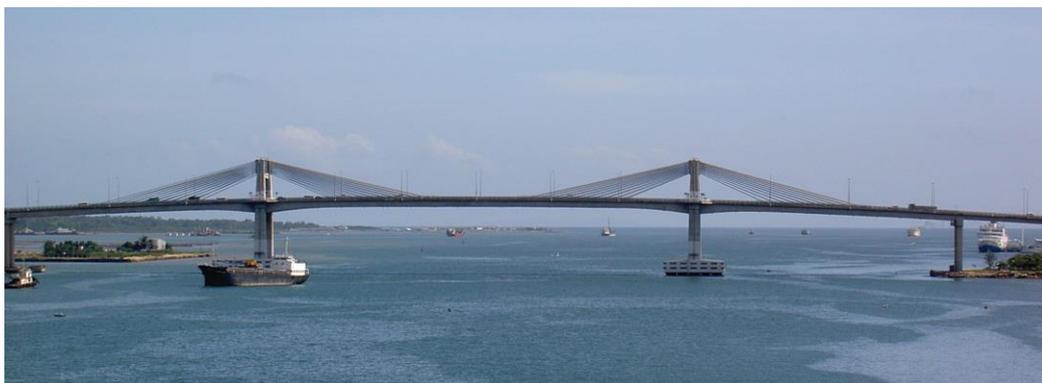
Figure 7-1 Photograph of Marcelo Fernan Bridge

Marcelo Fernan Bridge (MFB) is a PC Extradosed Bridge crossing the Mactan Channel from Cebu island to Mactan island. It has a total length of 1,237m from abutment A1 at Mandaue side up to Abutment RA at Mactan side, comprising of 25 spans, 8 groups of cables, 23 piers and 3 abutments. It starts with the low chainage at Approach Viaduct Mandaue side (L=360m) from Abutment A1 to Pier P9, followed by the 3 central spans made up of the Extradosed structure(L=410m) from Pier P9 to Pier P12, continues with the high chainage at Approach Viaduct, Mactan side(L=240m) from Pier P12 to Abutment A2-ARP and finally ends with the Off-Ramp Viaduct(L=227m) from Abutment A2-ARP to Abutment RA.
